On a scheduled cargo flight from Liège Airport to London Stansted Airport the crew diverted to Nottingham East Midlands Airport¹ due to unexpectedly poor weather conditions at Stansted. The weather conditions at EMA required a CAT IIIA approach and landing. On approach, at approximately 500 feet agl, the crew were passed a message by ATC advising them of a company request to divert to Liverpool Airport. The commander inadvertently disconnected both autopilots whilst attempting to reply to ATC. He then attempted to re-engage the autopilot in order to continue the approach.

The aircraft diverged to the left of the runway centreline and developed a high rate of descent. The commander commenced a go-around but was too late to prevent the aircraft contacting the grass some 90 m to the left of the runway centreline. The aircraft became airborne again but, during contact with the ground, the right main landing gear had broken off.

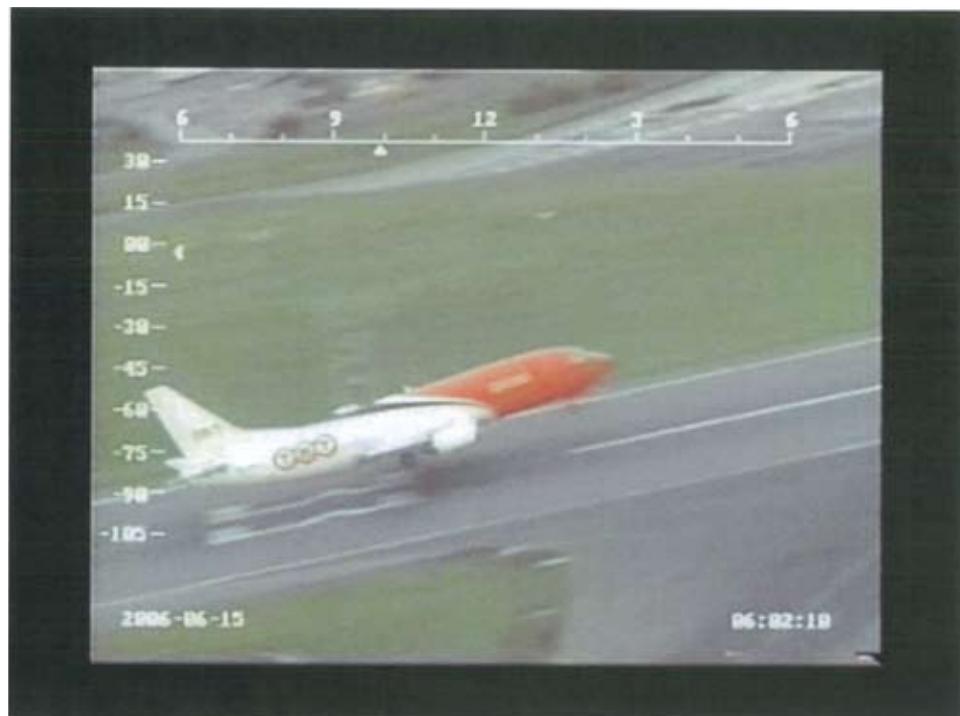
Figure 1

The aircraft touched down just to the left of the runway centreline and came safely to a stop on the centreline at 0602 hrs, Figure 1.

OO-TND about to touch down on Runway 33 at Birmingham

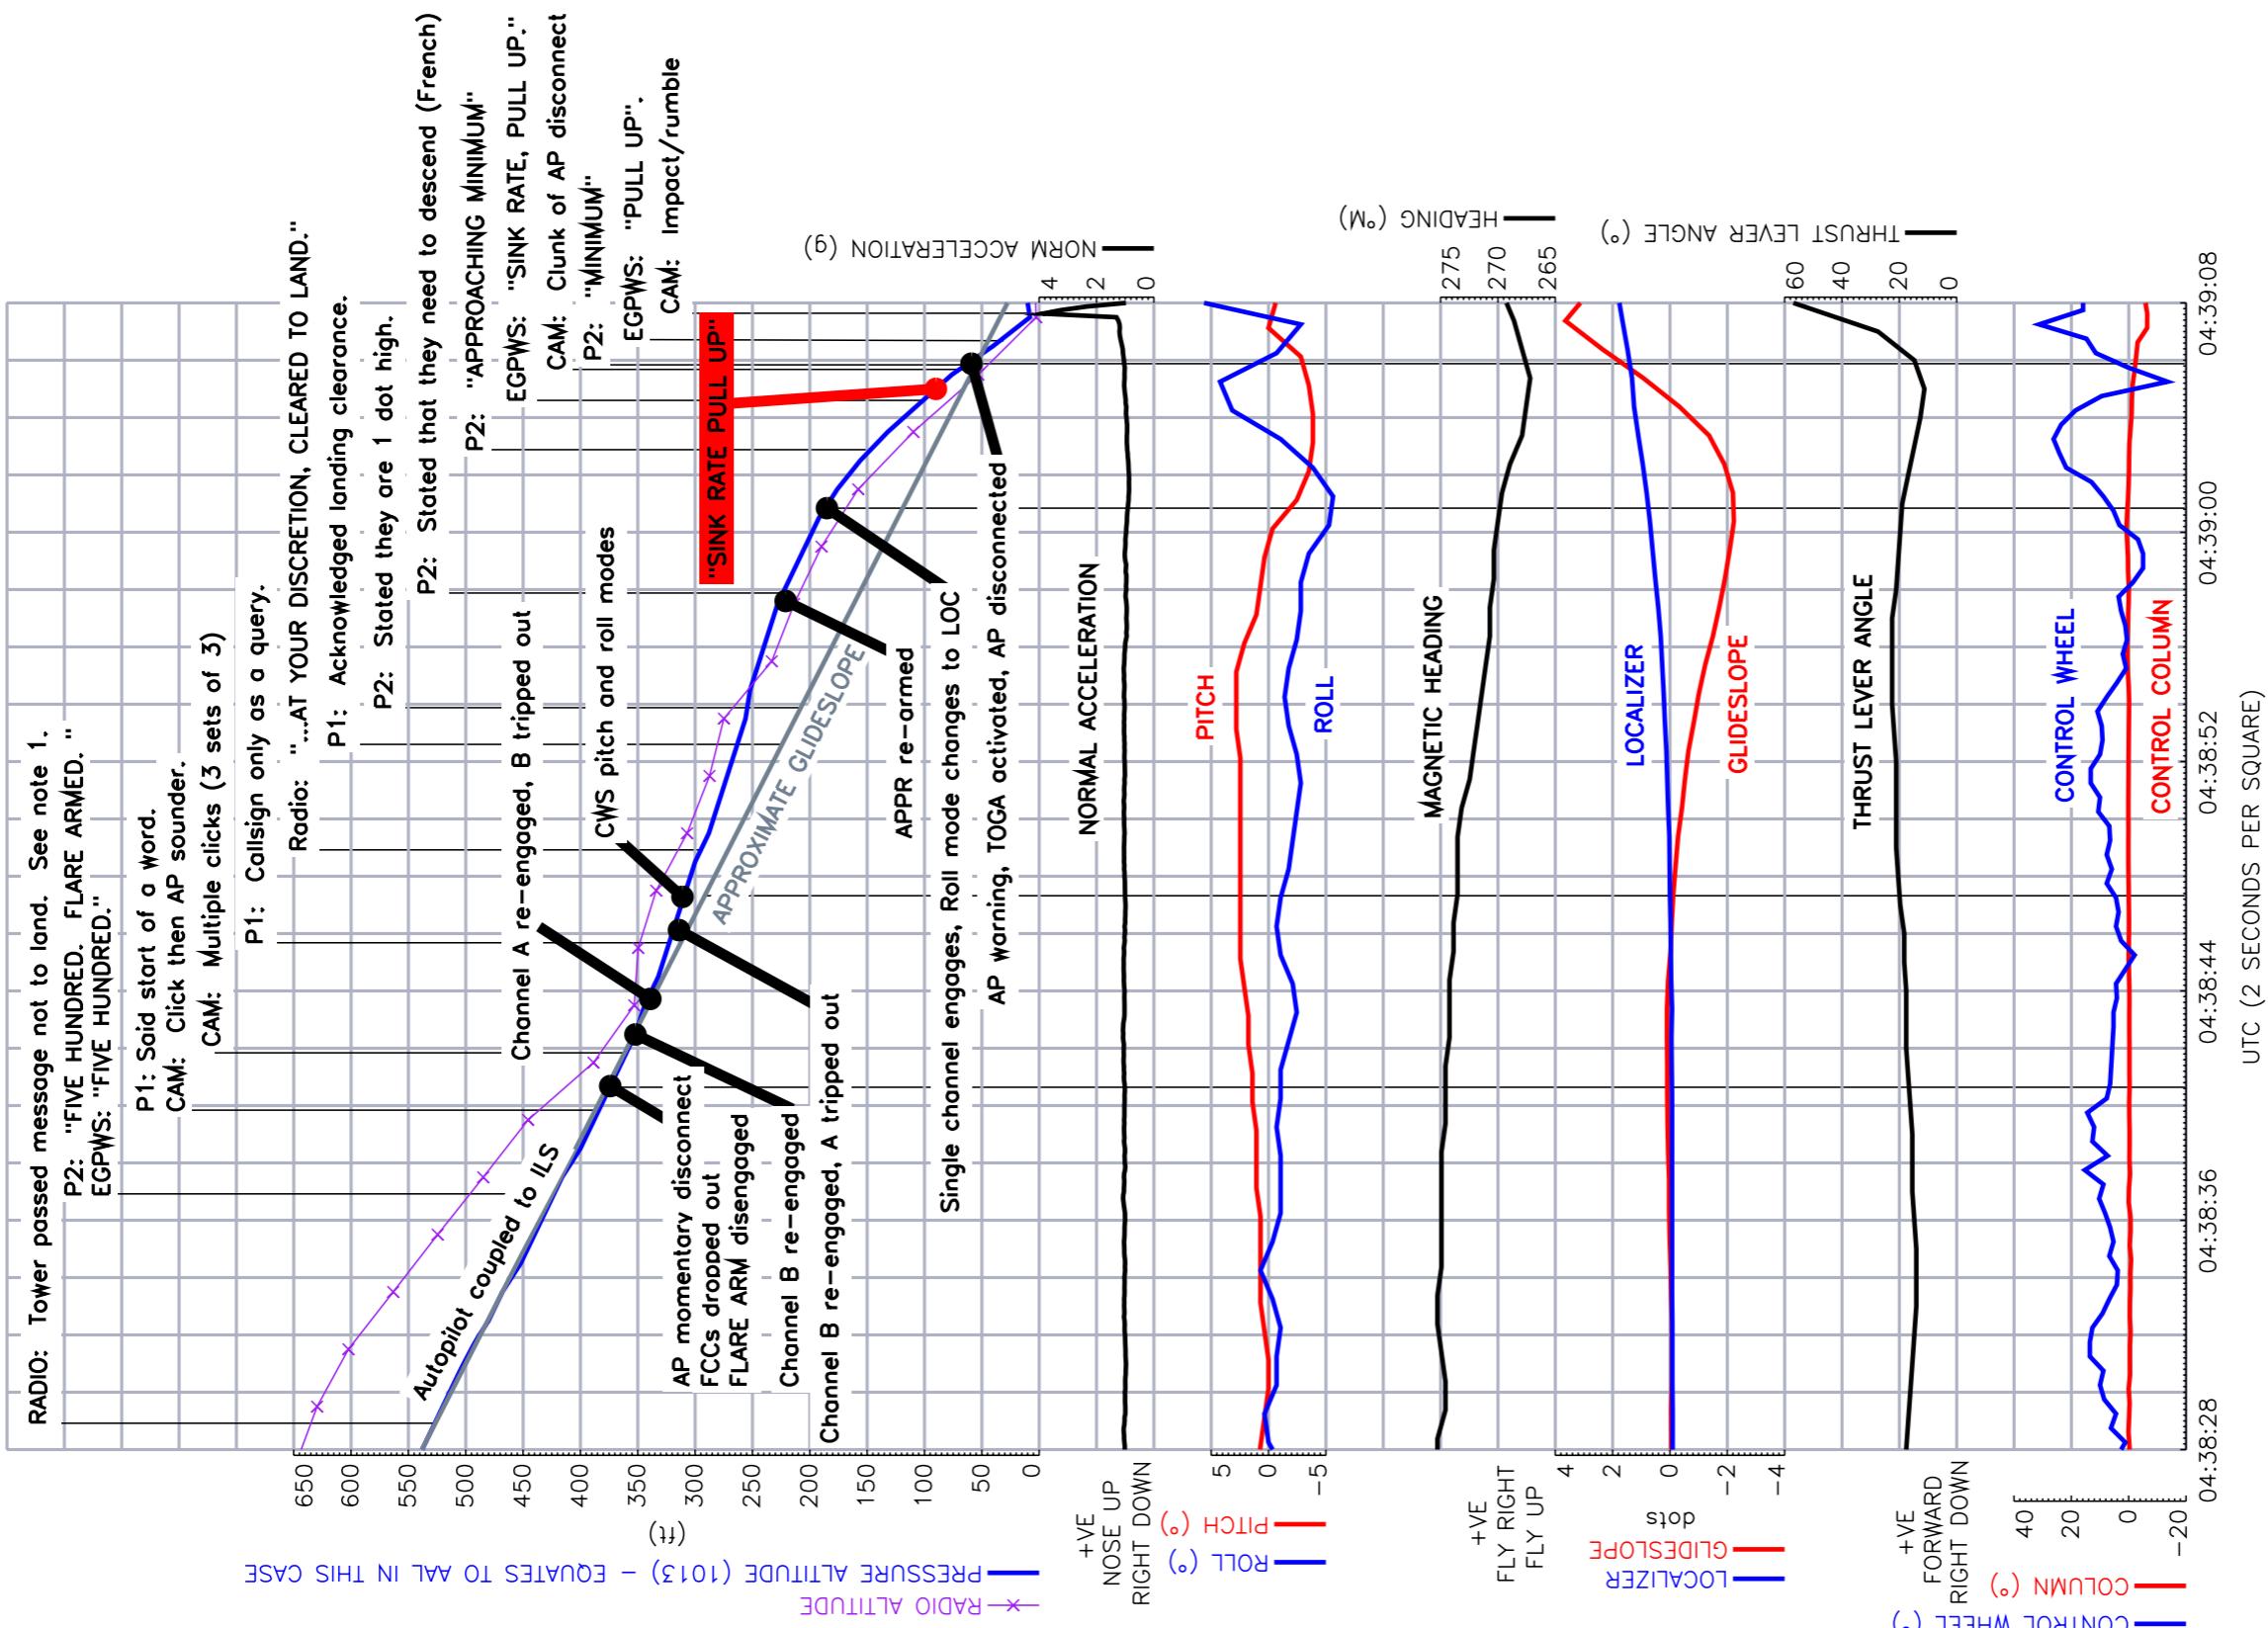
Plot 1

Approach to Runway 23 at Nottingham East Midlands Airport

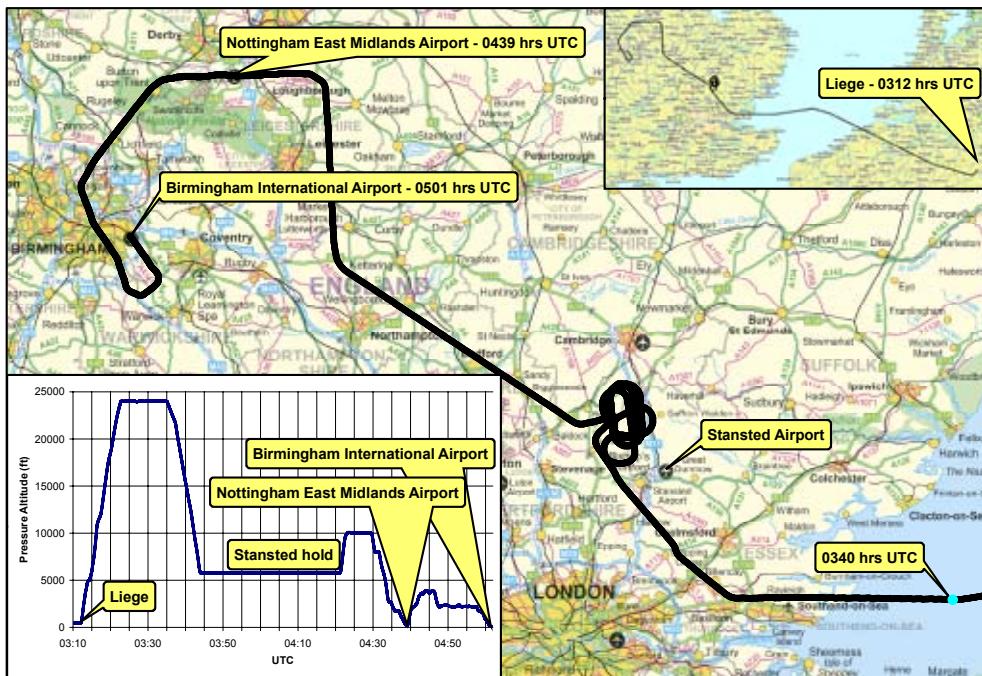
Figure 6
Overview of the flight from Liège, to Birmingham via EMA
