**Report of the Board of Review on the Accident to Boeing MD-11 B-150 at
Hong Kong International Airport on 22nd August 1999**

**Pursuant to Civil Aviation (Investigation of Accidents) Regulations,
Cap. 448, Laws of Hong Kong**

**Hong Kong SAR
November 2004**

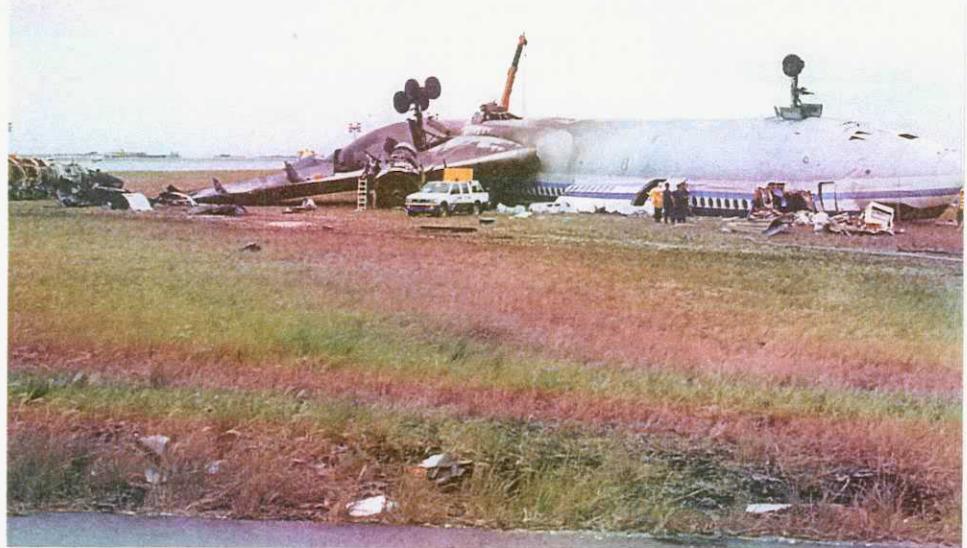
Main Wreckage (Figure 1)

The fuselage was found inverted at the main wreckage with severe impact damage and fire damage (Figure 1). The crown of the fuselage was crushed downward for the entire length (nose to tail). The pilot and co-pilot's windows were cracked and the side windows were pulled out and were lying outside the cockpit. There was no evidence of any bird strike or foreign object damage on the cockpit windows. The right side of the fuselage suffered slight impact damage just aft of the R1 entry door. The skin at this location was torn in the vertical direction (Figure 2).

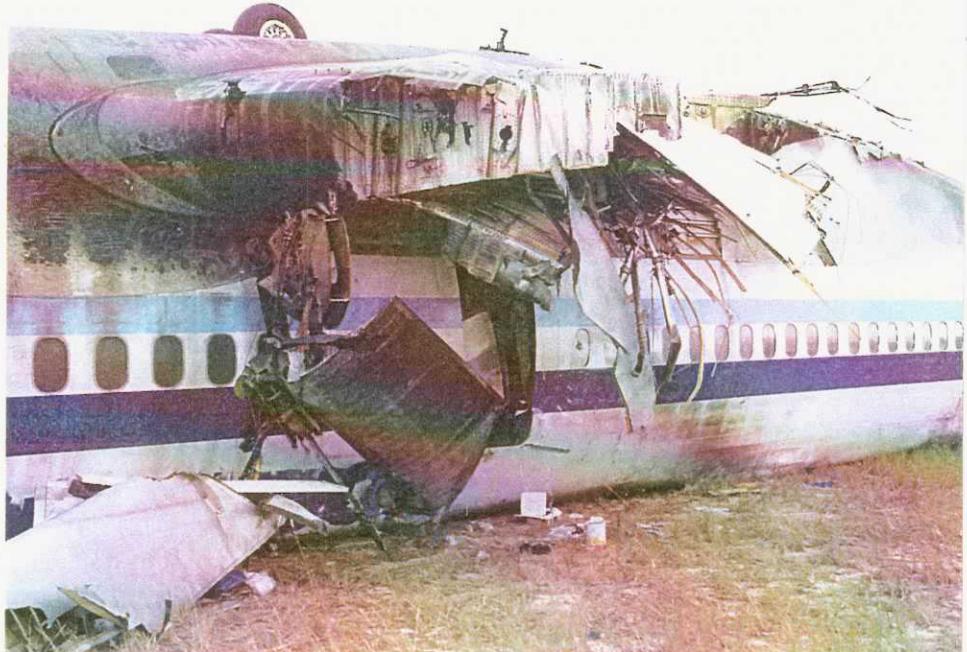
Right Wing Root Section (Figure 3)

About a 10-feet section of the right wing upper and lower skins with front and rear spars remained attached to the fuselage (Figure 3). The trapezoid fitting which connects the fixed and folding retractable side brace of the right main landing gear remained attached to the fuselage. This fitting suffered no fire damage and was fractured in tension at the brace connection. The fractured surface exhibited overload features. This fracture surface area was cut from the fitting for detailed metallurgical examination. The right main landing gear had separated from the wing and fuselage point and was found near the aft right side of the fuselage under the right horizontal stabilizer (Figure 4).

The right wing fractured between the no. 3 engine nacelle and the right side fuselage at Station 163 on the leading edge and Station 197 at the rear spar (Figure 3). About a 15-feet section of the front spar and a six-feet section of the rear spar remained attached to the fuselage. The upper and the lower skins

between the front and the rear spar of the inboard section remained attached to the fuselage and exhibited upwards bending. About a six-feet section of the outboard front spar separated from the upper skin near the fractured end and the spar cap was cracked. The remaining nine-feet section remained attached to the upper skin and exhibited no bending. The stringers between the front and rear spar exhibited upward bending. The fractured surface exhibited overload features. There was evidence of slight fire damage and soot damage on the front spar and associated structure. Some of the fractured surfaces were sooted. The soot/fire damage was not very significant as compared to the outboard section of the wing.

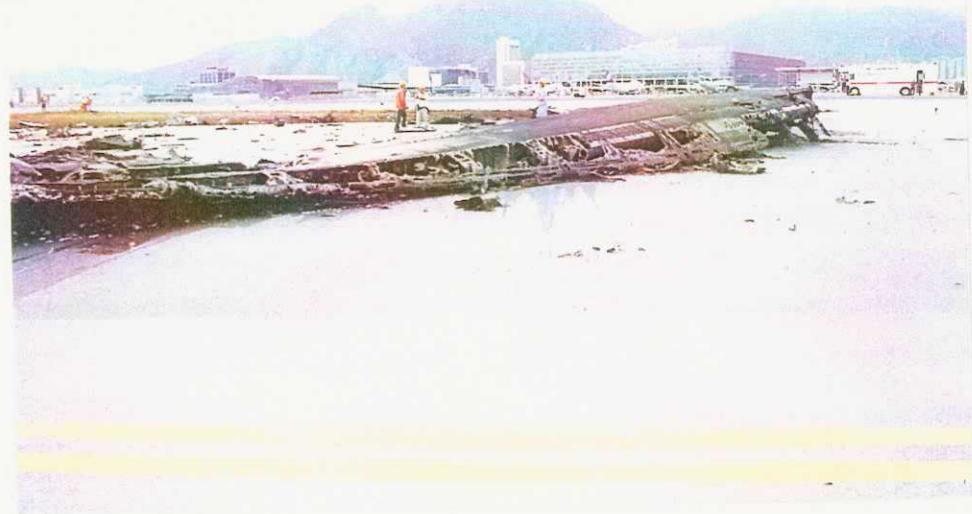
Right Wing Detached from Main Fuselage (Figure 7)

The wing outboard from the fracture was in one section and was found about 300 feet from the nose of the airplane in the main wreckage (Figure 7). The upper skin exhibited sooting from the fracture to Station 772 and was consumed by fire from Station 772 to the tip. There was a crack of about 30 inches long at the middle of the upper skin in a span-wise direction. The fractured surface on this crack was sooted. The upper skin was bulged upward 12 inches forward of the rear spar on the upper skin and the side rib. The upper skin bulge was 38x46 inches in area and bulged up for about two inches. The leading edge suffered severe impact damage and fire damage. The inboard slat was detached and recovered at the site. The middle and outboard slats suffered severe fire damage and remained attached to the leading edge. The leading edge from the fracture to Station 538 suffered fire damage. The inboard end of the leading edge suffered severe impact damage and was dented at various locations. The leading edge outboard of Station 538 was consumed by fire. There was no evidence of heavy scrape marks on the upper skin. Only light scrape marks were observed at the inboard end on the upper skin in a fore and aft direction. The wing tip suffered severe fire damage on the upper skin. The strobe lens reflector and the case with the bulb remained intact and suffered fire damage. There was no evidence of any scrape marks on the wing tip structure on the lower skin. The right wing lower skin was intact from the inboard fracture location to the tip and suffered severe fire damage. There was no evidence of any heavy scrape marks on the lower skin.

The inboard fractured end of the lower skin exhibited severe scrape marks and grinding on the edge of the skin at a 45-degree angle.

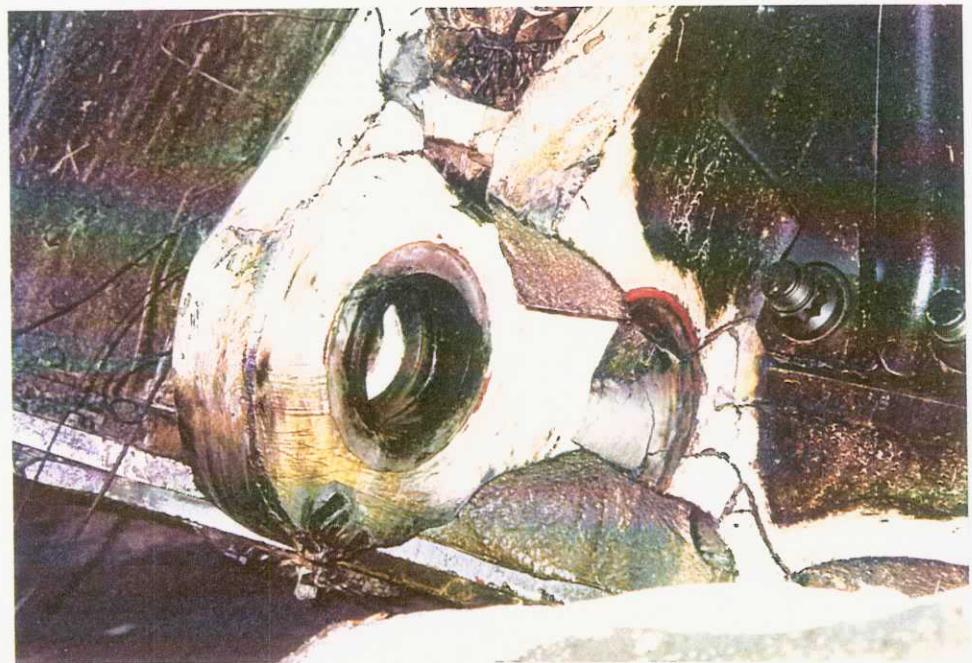
Right Main Landing Gear (RMLG) Forward Attachment Fitting (Figure 8)

The forward and aft main landing gear attach fitting suffered severe damage. The aft lug of the forward mount fractured between 4 o'clock to 10 o'clock position (view looking forward - see Figure 8). The fractured surface exhibited soot accumulation and slight discoloration. The forward mount was cracked and exhibited impact damage in an upward direction. The forward mount shear pin was sheared off and a portion of the shear pin remained with the forward lug (Figure 9). The remaining piece was attached to the landing gear. The fractured surface on the shear pin was heavily sooted. The aft mount was fractured, and both the lugs along with a large piece of fitting remained attached to the landing gear including the shear pin (Figure 10). The entire area of the main landing gear fitting and fractured surfaces exhibited evidence of sooting. The piece of the head-end of the main landing gear actuator remained attached to the fitting.

The right main landing gear was separated from its mount. The forward shear pin was sheared off from the forward mount and half of the shear pin remained in the forward lug of the forward mount. This section of the shear pin was pushed out and exhibited severe soot damage on the fracture surface. The remaining portion of the shear pin remained on the forward lug of the landing gear and exhibited some bending. The fractured surface on this portion exhibited surface rust and the fractured surfaces could not be examined. The aft lug of the forward mount fractured between the 4 o'clock and 10 o'clock positions. This section of the lug fractured into two pieces and was found on the runway between the touchdown point and the main wreckage. The mating fractured surface on the wing forward mount aft lug exhibited some discoloration but the mating fractured surface of the lug that was found on the runway did not exhibit any discoloration. All surfaces on the aft lug exhibited evidence of overload features. There was no evidence of fire or soot on the pieces of lug found on the runway. The forward fitting that remained attached to the landing gear fitting suffered soot damage. The forward mount fractured in the middle and exhibited impact damage in an upward direction (Figure 8).

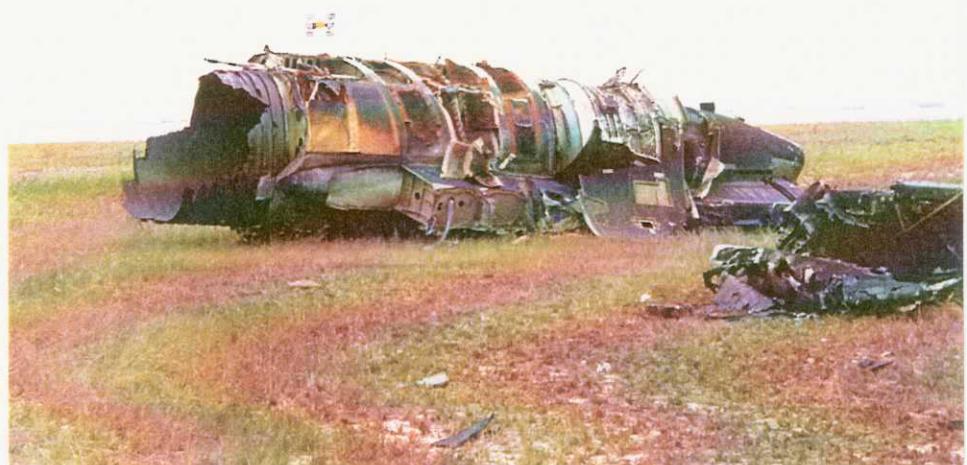
No.2 Engine (Figure 18)

6.2. No. 2 engine; s/n: 723968 (Figure 18)

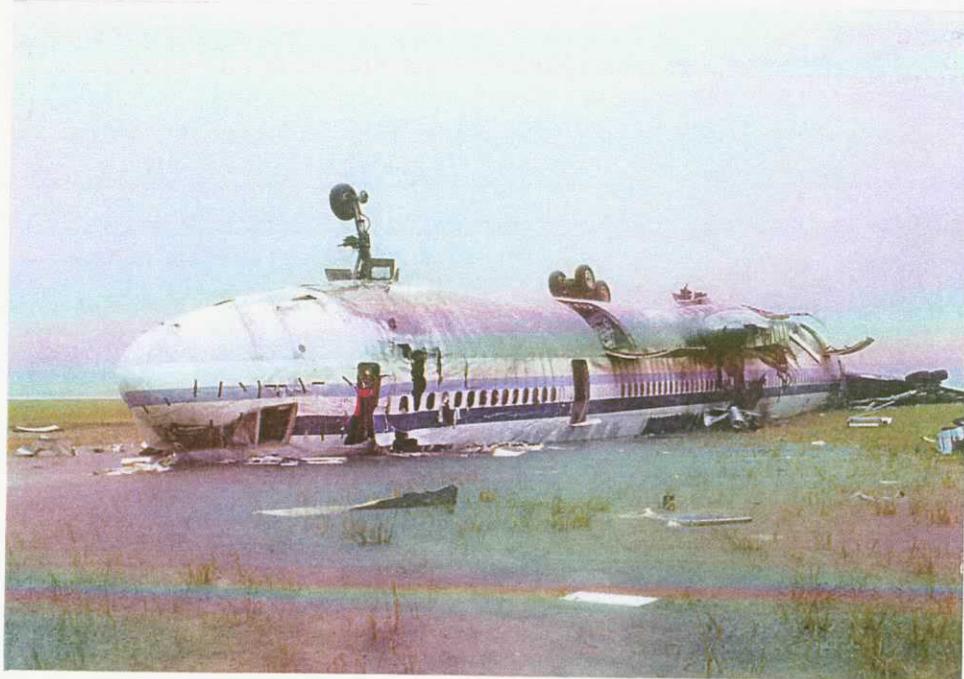
1. General view of main wreckage.

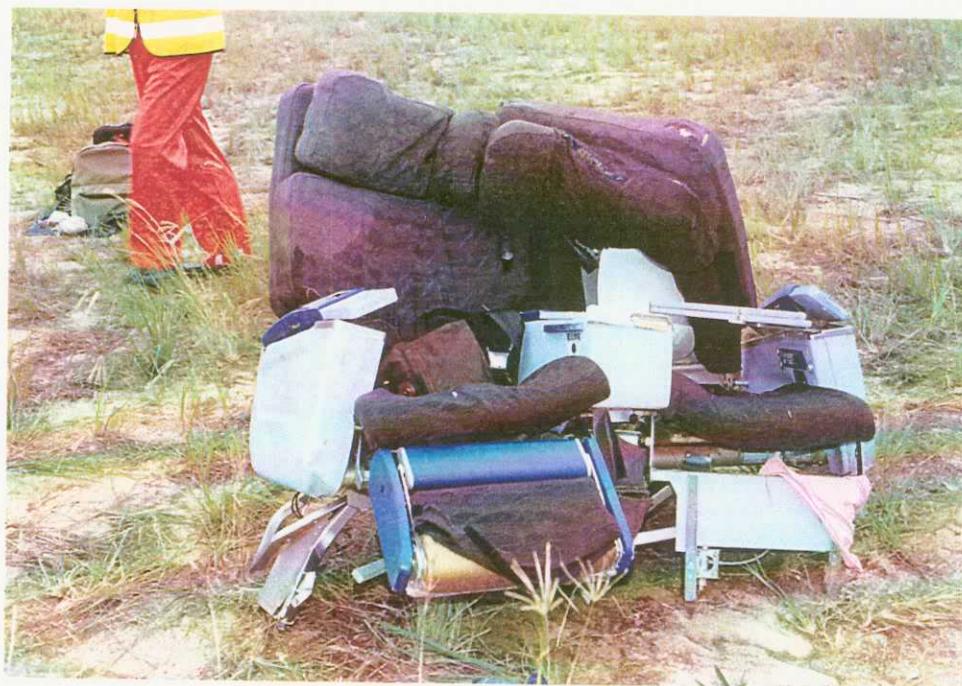
2. View of seats 1J and 1K.

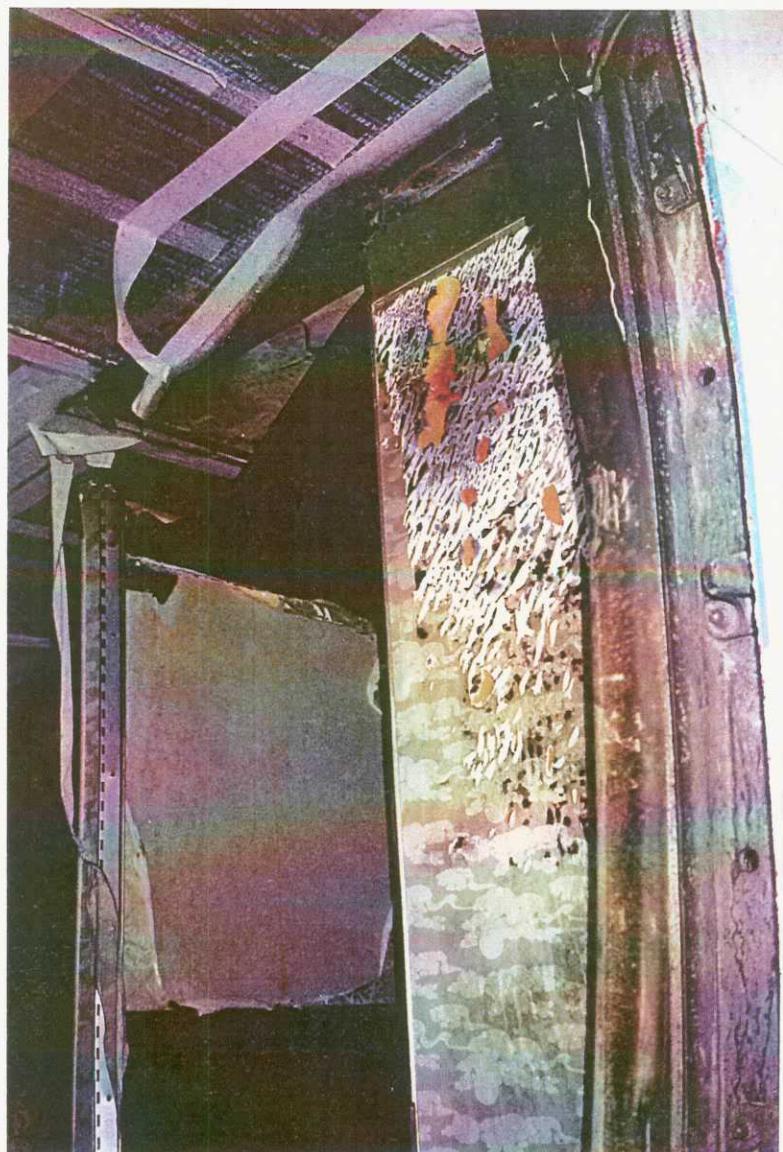
3. View of the lavatory just inside Door 3R.

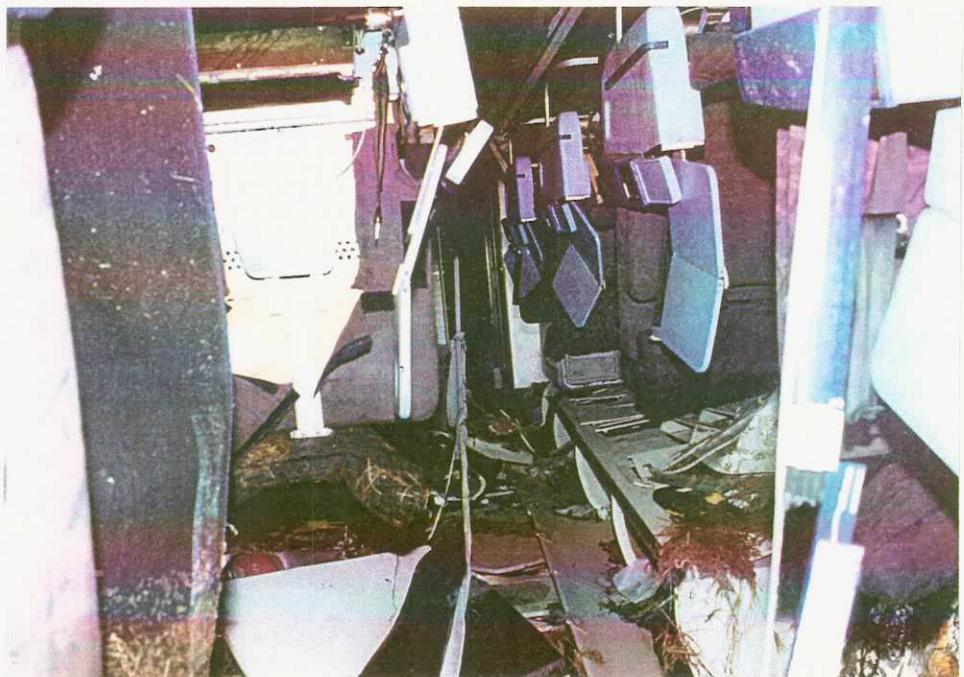
4. View of the Business Class section of the cabin.

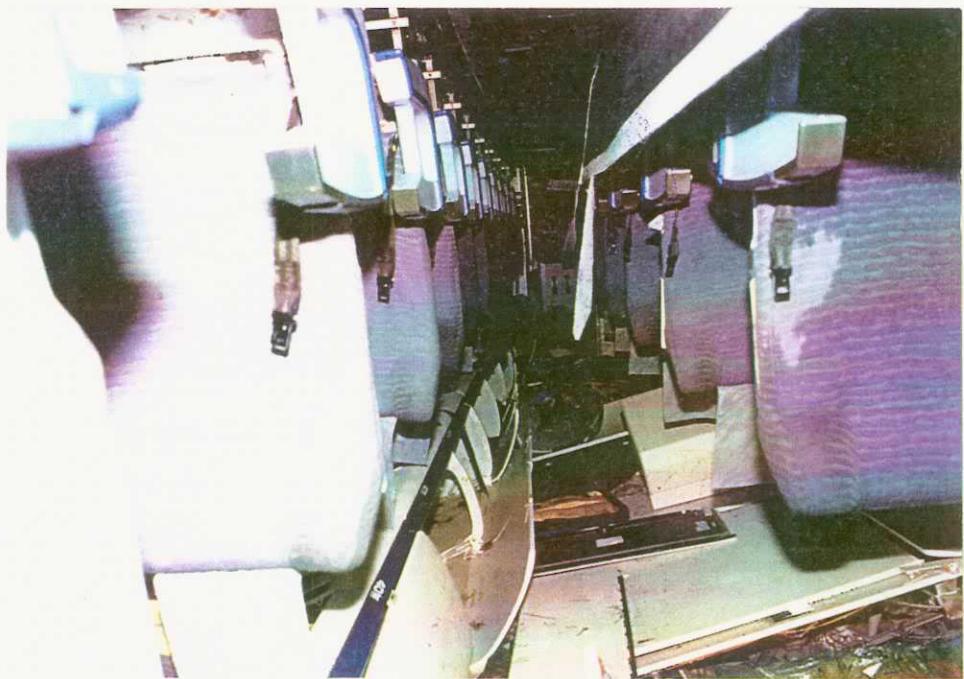
5. View of the Economy Class section of the cabin.

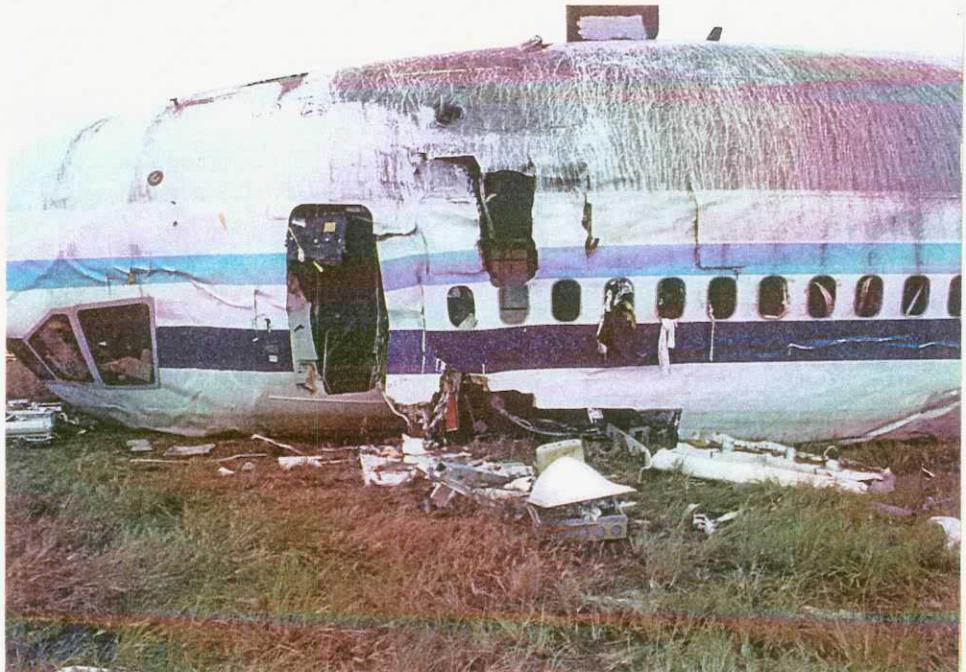
6. View of right side of fuselage including Door 1R.

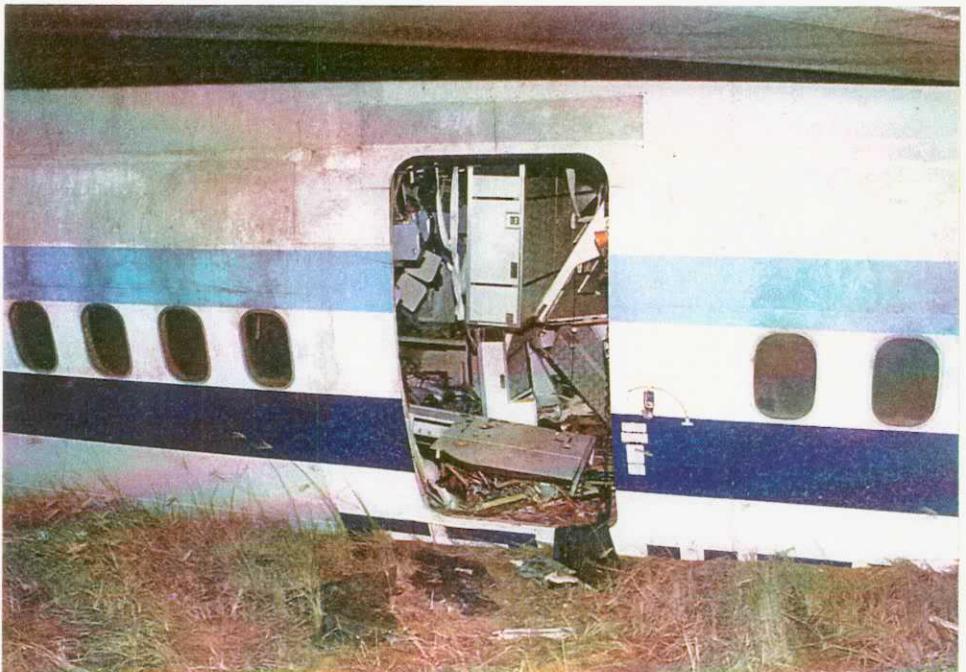
7. View of left side of fuselage including Door 3L.

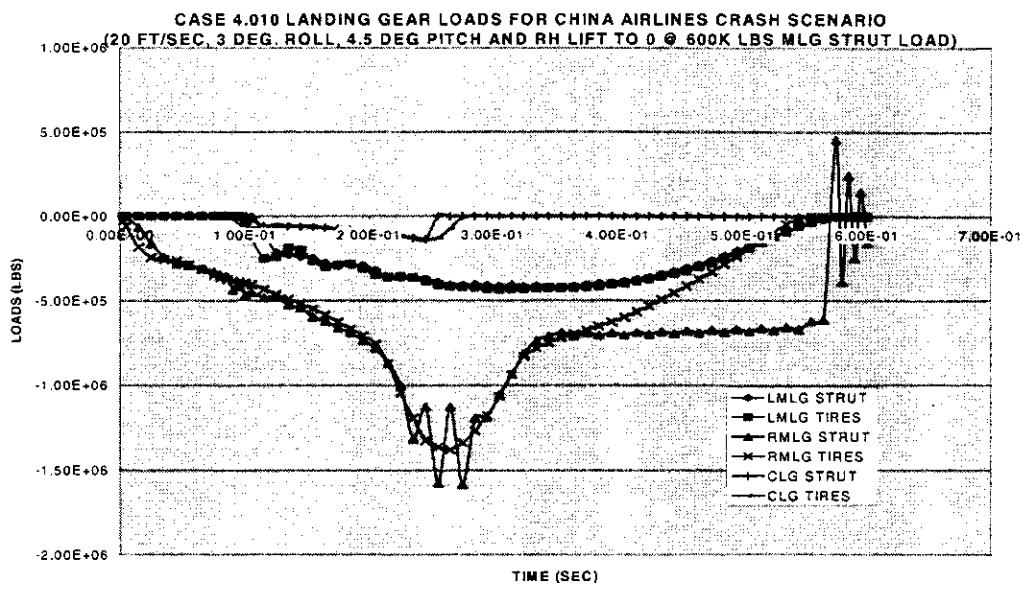
Figure 3. Case 4.010 Landing Gear Loads for China Airlines Crash Scenario

The strut and total-tire load time histories should be equal for a given gear (note that the right main landing gear strut load oscillates near its peak and separates after the peak due to NASTRAN convergence problems). These convergence problems do not have a significant effect on the time history of the other gear loads or the peak value of the right main landing gear total-tire load.

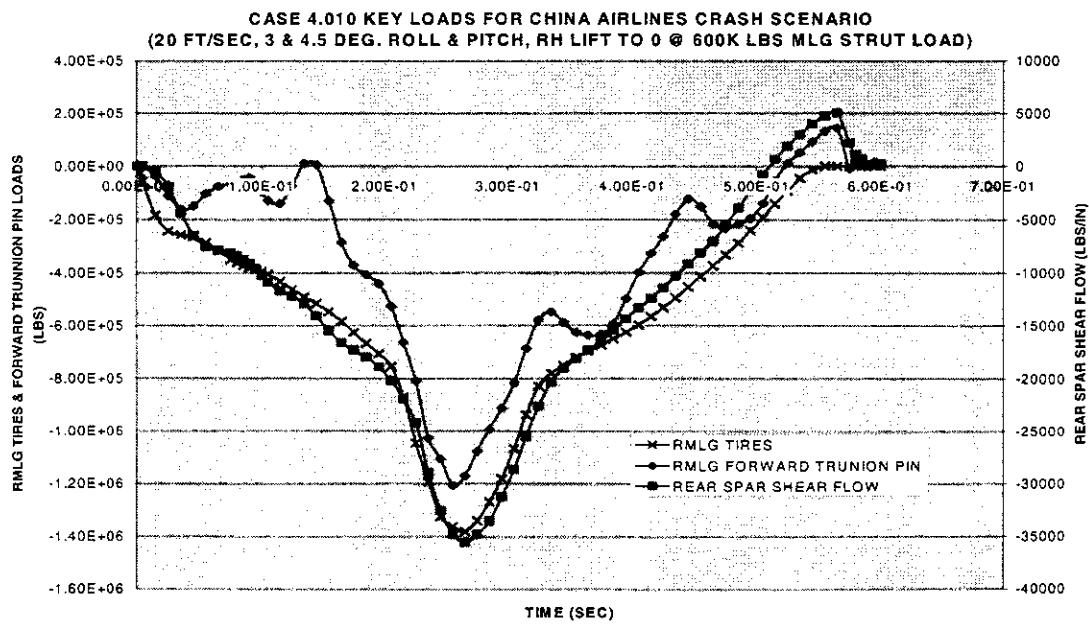
Figure 4. Case 4.010 Landing Gear Loads for China Airlines Crash Scenario

Time histories of key loads from Case 4.010 are plotted in Figure 4. From the figure, the right main landing gear strut load peaks at 1.4 million pounds, the peak rear spar shear flow is 35,000 lbs/in, and the peak load on the right main landing gear forward trunnion bolt is 1.2 million pounds. The rear spar shear flow is well in excess of what is required to fail the rear spar shear web and the forward trunnion bolt load is roughly that which is required to fail it.

The results of this analysis, although not rigorous, confirm that loads high enough to fail the forward trunnion bolt and the rear spar shear web are feasible, and that the failure sequence described in the following sections is reasonable.

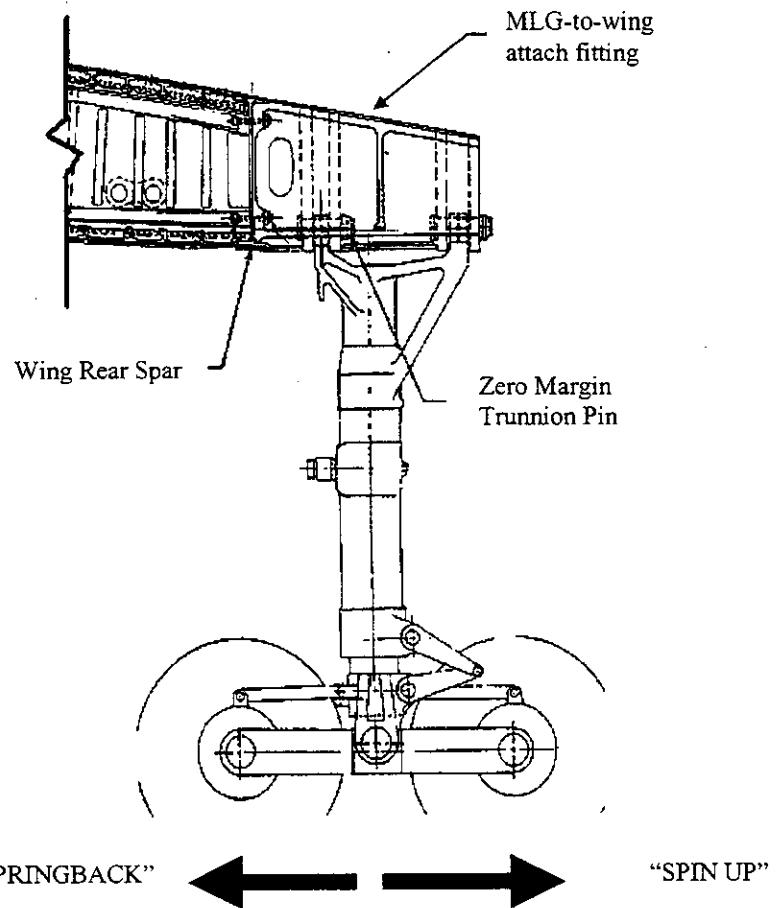
Figure 5. Main-Landing-Gear-to-Wing Attach Arrangement

The first structural element thought to have failed in this accident is the forward trunnion bolt, also known as the “zero margin trunnion pin”. This bolt is designed to reliably shear at a predetermined load (approximately 1.2 million lbs) and acts as a “fuse” when the main landing gear is subjected to excessive drag loads. Figure 5 shows the location of the zero margin trunnion pin.

When acting as a fuse against excessive drag load the zero margin trunnion pin fails by shearing downwards (i.e. the forward trunnion of the main landing gear moves downward relative to the wing attach fitting). In this accident this bolt failed in the *upwards* direction due to a combination of high landing gear vertical load, and a high “springback” moment. Both the high vertical load and the high “springback” moment were a result of the excessive (18-20 ft/sec) sink rate.

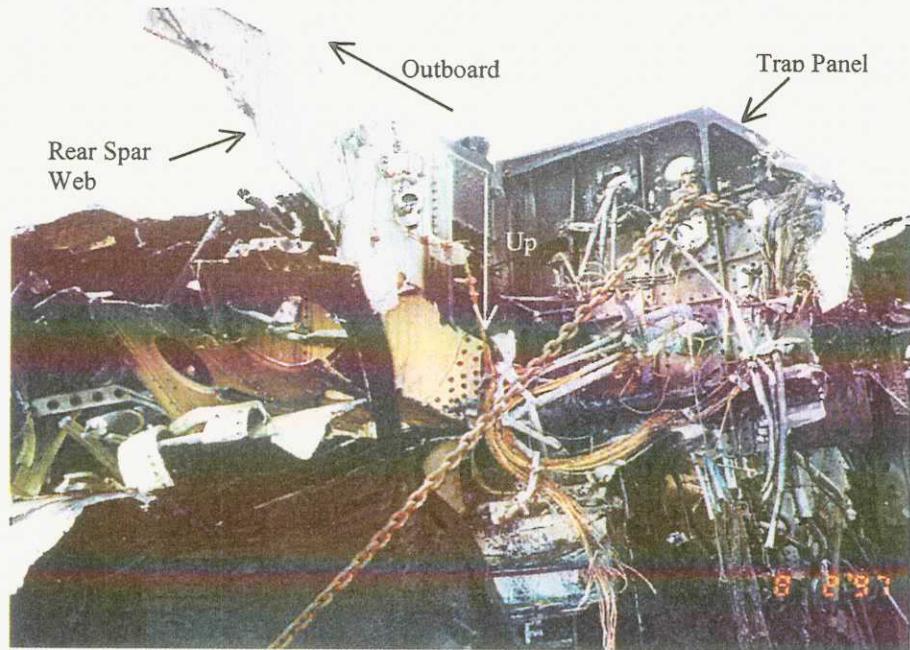
Figure 7. Right Wing Rear Spar Web Fracture from Ship 553 (FedEx - Newark)

The rear spar web was identified as the first structural element thought to have failed in the FedEx accident that occurred in Newark, New Jersey on August 31st, 1997. A significant amount of analysis was conducted to validate the FedEx failure sequence, so this failure mode was quickly recognized when the wreckage of the China Airlines aircraft was examined.

A photograph of the FedEx aircraft showing the right wing rear spar web fracture is included as Figure 7. Note that the aircraft is inverted in this photograph.

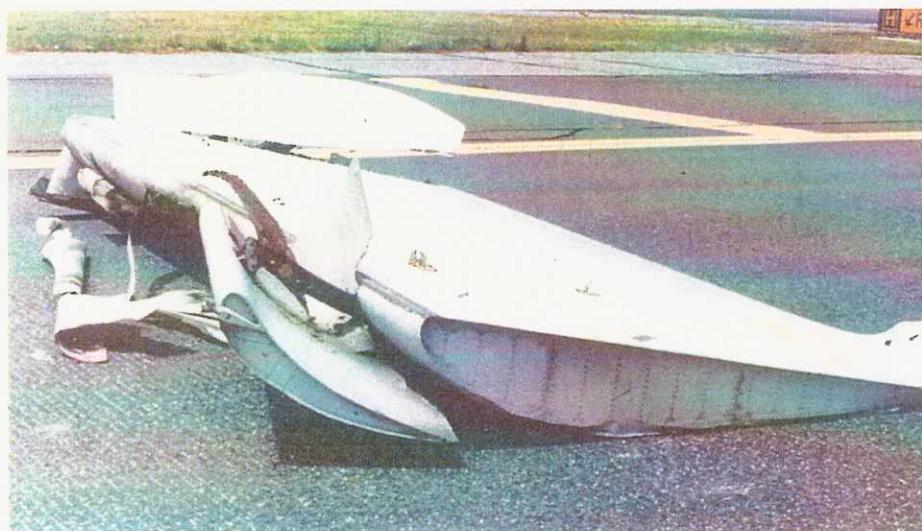
Figure 16. Right Inboard Flap from Ship 553 (FedEx - Newark)

The China Airlines inboard flap was found off to the left of the runway and is thought to have been carried there by the crosswind (which was blowing right-to-left) after it departed the aircraft. The flap, as it was found, is pictured in Figure 15. The FedEx inboard flap was found on a taxiway to the right of the runway (Figure 16); note there was little or no crosswind present when the FedEx accident occurred.

It is viewed as significant that the lower surfaces of these flaps suffered no significant damage. The inboard flap would have been directly in the path of the main landing gear had the gear separated before the flap and would have been badly damaged. It is clear then, that the main landing gear did *not* "knock" the inboard flap off the aircraft.

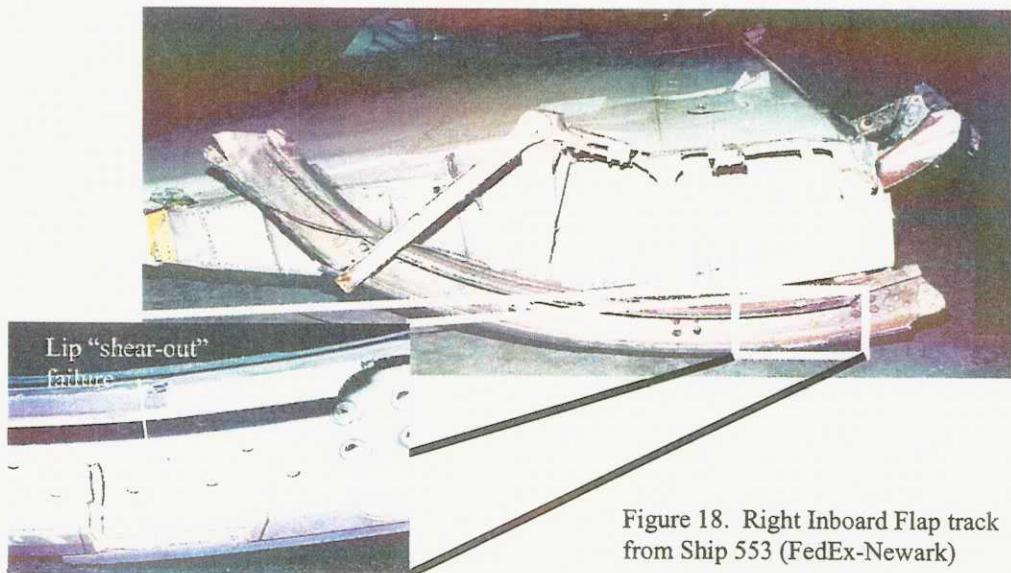
Figure 18. Right Inboard Flap track from Ship 553 (FedEx-Newark)

The local shear-out failure of the flap track is evident in a photograph taken at the accident site (Figure 17). The location of this failure is consistent with the position of the side rollers for the reported flap setting of 35 degrees. The same type of failure is observed in the photograph of the inboard flap from the FedEx-Newark aircraft (Figure 18); in this case the failure location is consistent with the reported flap setting of 50 degrees.

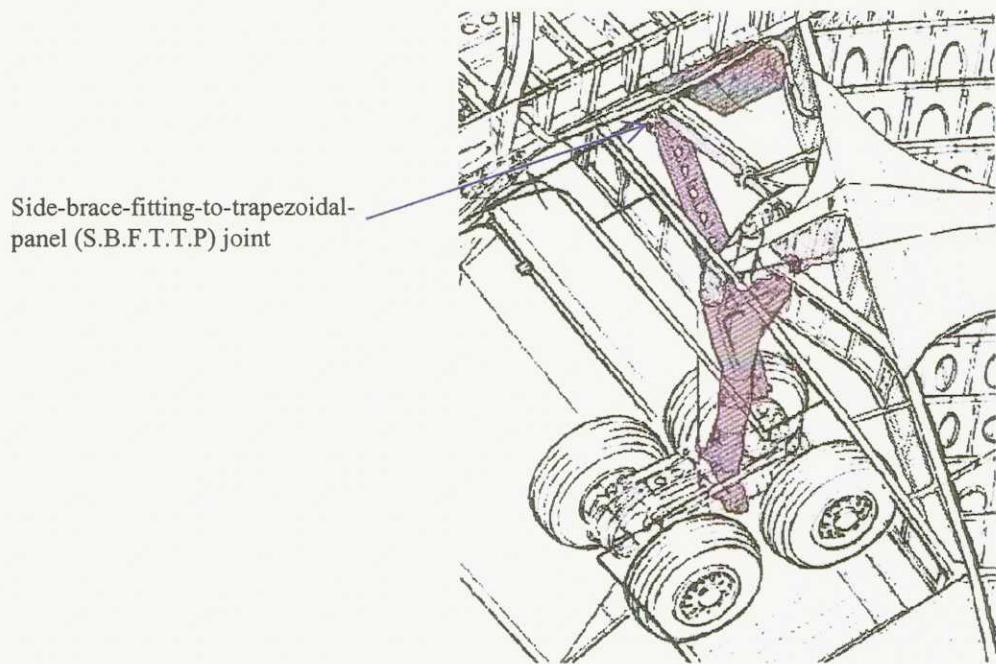
Figure 19. Location of the side-brace-fitting-to-trap-panel joint

The location of the side-brace-fitting-to-trap-panel (S-B-F-T-T-P) joint is highlighted in Figure 19. A photograph of this area (taken from inside the landing gear wheel well) is included as Figure 20 along with a sketch of the joint (with the fixed and folding side braces removed).

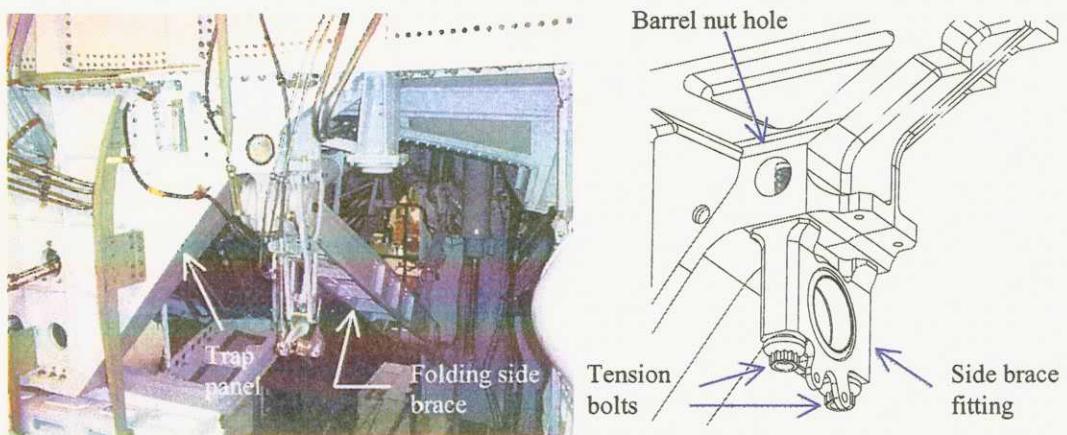
Figure 20. Side-brace-fitting-to-trap-panel joint (from inside the right wheel well)

As was the case for the inboard flap's departure, the damage to the S-B-F-T-T-P joint was the result of large relative displacements between attach points on the wing and on the fuselage. After the right wing rear spar failed, the MLG-to-wing attach fitting moved up (relative to the fuselage) and the outboard wing twisted severely nose-down. This motion effectively tilted the truss formed by the MLG strut, and the fixed and folding side braces, and applied a nose-down twist to the S-B-F-T-T-P joint. This applied twist rocked the side brace fitting (bottom-end-aft) and resulted in "impressions" on the lower surface of the trap panel (Figure 21). Similar impressions were observed on the underside of the trap panel from the FedEx-Newark accident aircraft.

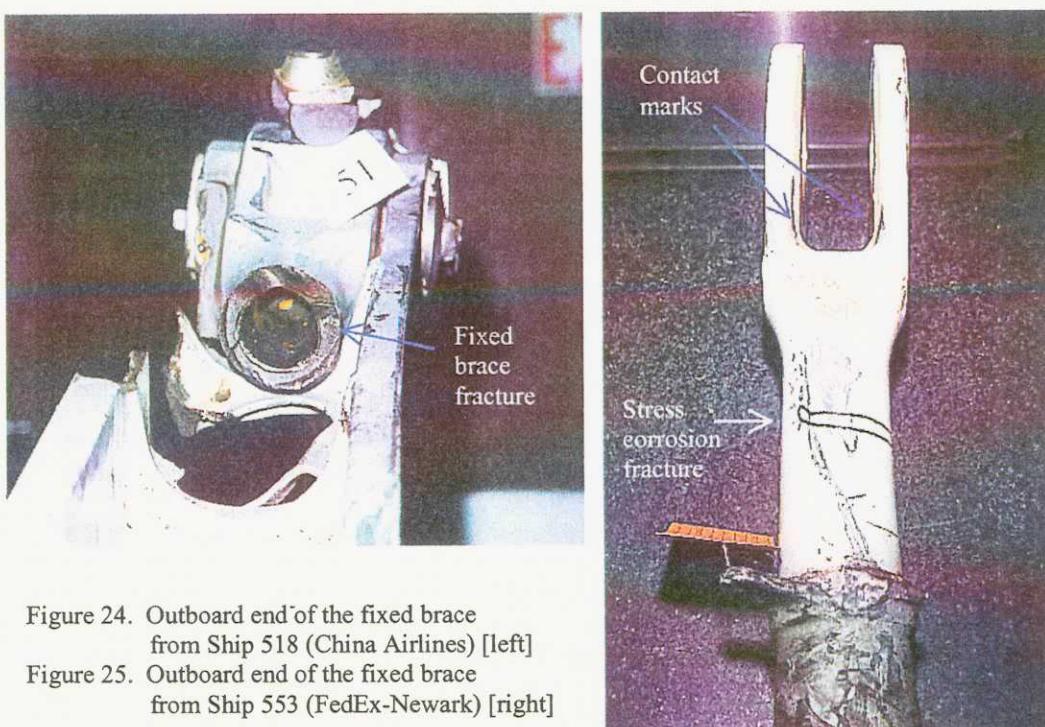
The presence of a large prying load at the S-B-F-T-T-P joint results in severe distress to this joint. This manifests itself as localized high bending (flexure) at the outboard end of the fixed brace, and a large tension load on the inboard of the two tension bolts attaching the side brace fitting to the trap panel. Evidence of flexural distress of the fixed brace was observed in parts taken from both the China Airlines and FedEx-Newark accident aircraft. The fixed brace from the China Airlines aircraft failed completely (Figure 24). The fixed brace from the FedEx-Newark aircraft was bent and suffered a stress corrosion fracture (Figure 25). The stress corrosion fracture is attributed to residual stress resulting from a high flexural load. Note also in Figure 25 the evidence of local contact with the side brace fitting.

Figure 24 also shows damage to the upper folding side brace. The upper folding side brace is an I-section "laid on its side" with lightening holes in the web (Figure 19). The fixed brace after it failed in flexure, appears to have dropped down into the upward facing "channel" of the I. Relative motion between the outboard wing and the fuselage then appears to have "punched" the inboard end of the fixed brace through the web and aft cap of the upper folding side brace.

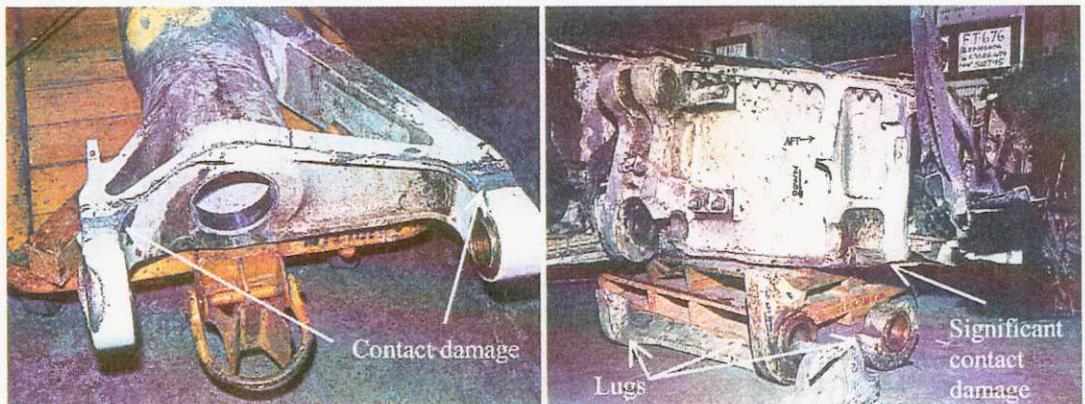
Figure 27. Right main landing gear strut from Ship 553 (FedEx-Newark) [left]
 Figure 28. Right MLG-to-wing attach fitting from Ship 553 (FedEx-Newark) [right]

There is clear evidence that the right main landing gear strut, once released at the S-B-F-T-T-P joint, rotated outboard and contacted its wing attach fitting. Similar observations were made for the parts from the FedEx-Newark accident aircraft (see Figures 27 and 28). This type of contact creates a "short couple" prying action that easily breaks the gear loose from the fitting.

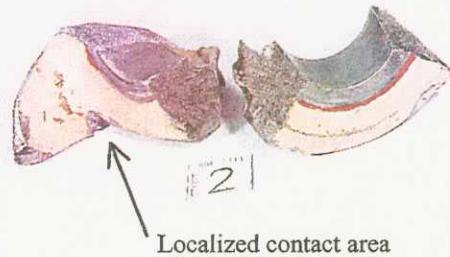
In the case of the China Airlines accident the markings indicating contact between the right main landing gear strut and the wing attach fitting are slightly different (and not quite as clear). This is primarily due to the fact that the forward trunnion connection was partially failed (See Section 5.0) before the strut rotated outboard. The contact area for the forward trunnion was therefore very localized, and quickly resulted in the fracture of the remaining connection (the aft lug). See Figures 29 and 30. The two lugs that support the *aft* trunnion, the forwardmost still connected to a large piece of the wing fitting, also

Figure 29. Wing fitting lugs that support the MLG forward trunnion [left]

Figure 30. Separated pieces of the aft wing fitting lugs that support the MLG forward trunnion [right]

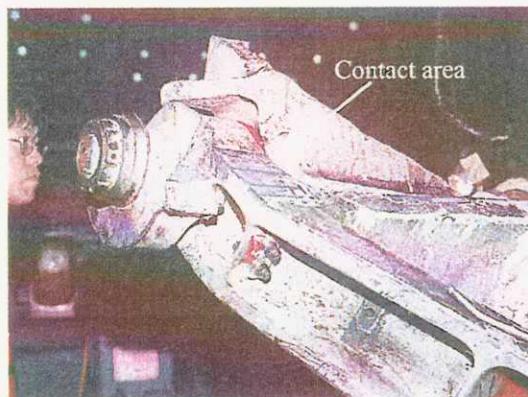
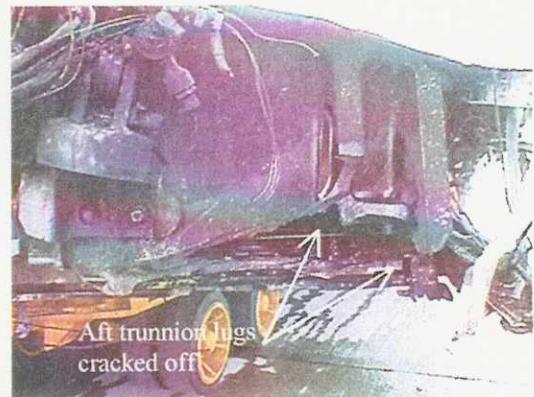
Figure 32. Aft trunnion arm of the right main landing gear strut [left]
 Figure 33. Right MLG-to-wing attach fitting from Ship 518 (China Airlines) [right]

cracked off as a result of the gear rotating outboard (Figure 31). This separated the right main landing gear from the aircraft. The contact area on the aft trunnion arm is shown in Figure 32. A photograph of the wing fitting, showing the mating area for the two aft trunnion support lugs, is included as Figure 33.

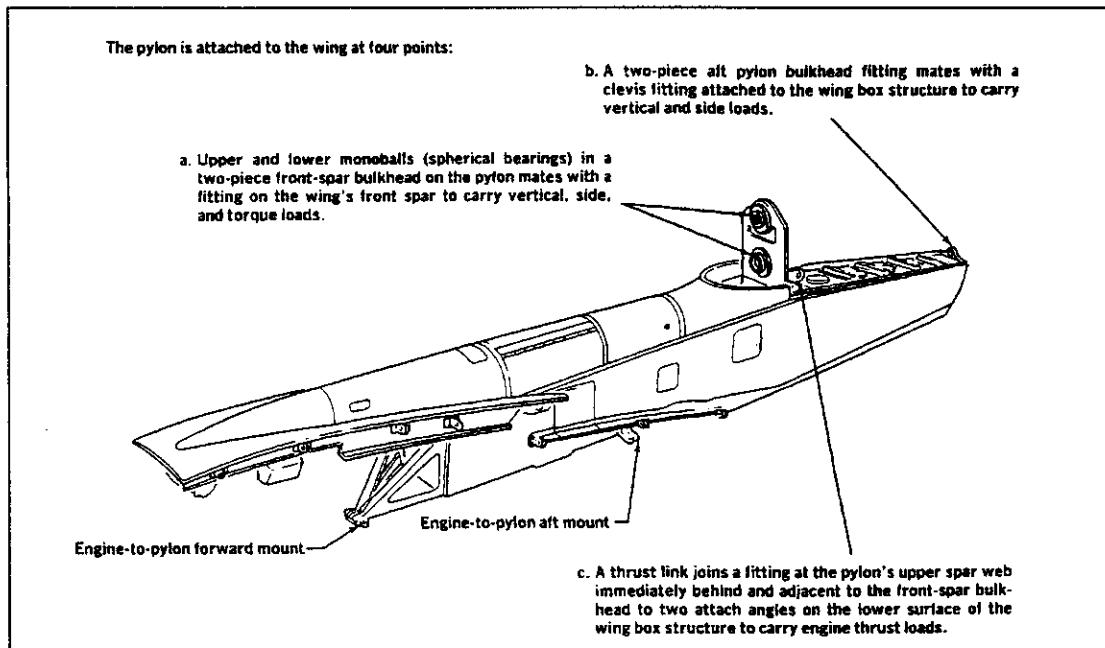
Figure 35. Pylon-to-wing attachment details

Figure 35 illustrates and describes the key elements of the attachment of the engine pylon to the wing. Figure 36 shows how the wing engine pylons are designed to “fuse” in the event of a wheels up landing to protect against rupture of the wing fuel tanks.

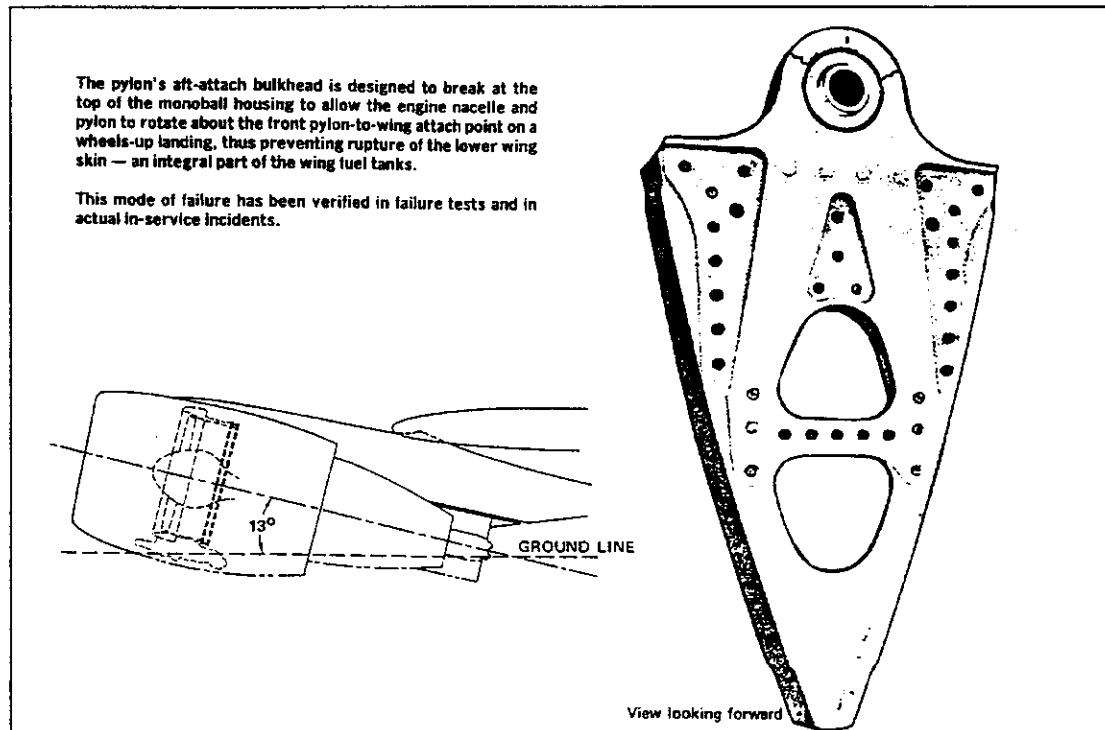
Figure 36. Wing pylon "fusing" mechanism

If the loads acting on the nacelle are primarily upwards, the engine pylon’s aft attach bulkhead is designed to break at the top of the monoball housing, freeing the back end of the pylon and allowing the engine/nacelle to tilt up and act as a “ski”. This failure mode has been verified by testing and validated in a number of in-service incidents. (As a point of reference, this *was* the observed failure mode for the right engine pylon from the FedEx-Newark accident).

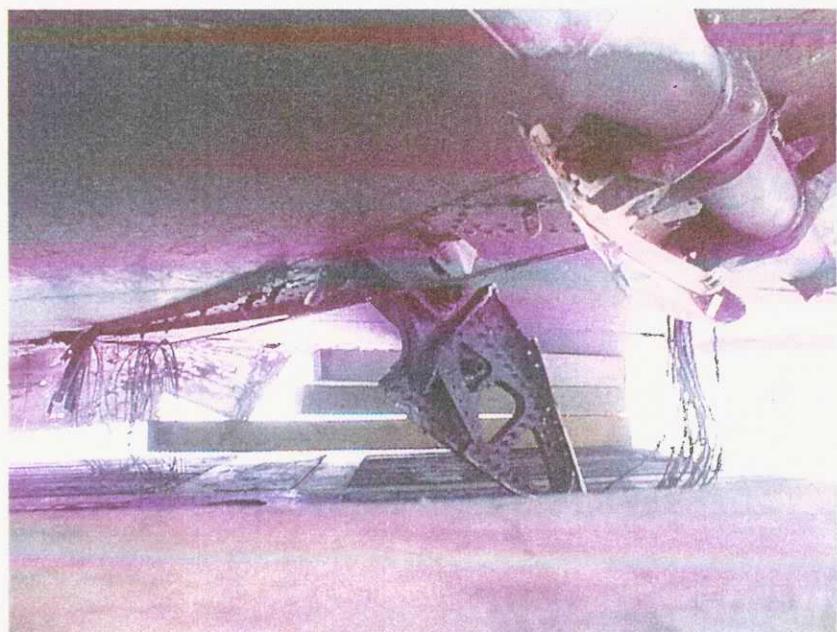
Figure 37. Right engine pylon aft-attach bulkhead still attached to the right wing

Figure 37 shows that the right pylon failure mode was different for the China Airlines accident aircraft; the right engine pylon aft-attach bulkhead is still attached to the right wing. Figure 38 shows the right engine pylon. The observed failures suggest that the loads on the nacelle included a significant sideways

component. This is thought to have occurred because the outboard wing, as the failure progressed, began to sweep further and further aft.

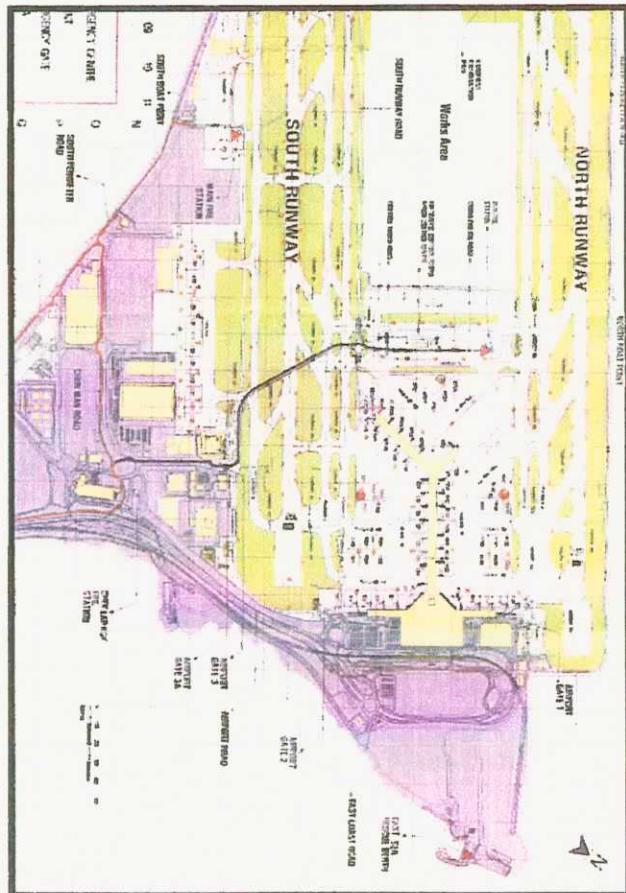
Figure 1. Runway 25L approach area in the lee of the Passenger Terminal Building

- a) The Hong Kong draft Final Report minimizes the significance of the absence of high capability wind shear warning detection system at Chap-Lap-Kok Airport. The improvement of wind shear detecting system is a major challenge confronting the world aviation industry.
- b) The Hong Kong draft Final Report also minimizes the finding of the three very valuable simulator lessons tested at Boeing facility, Long Beach, California.
- c) The Hong Kong draft Final Report does not adequately address the RWY 25L and 25R wind difference analysis attributed from passenger terminal building. It should be considered in that context. See Figure 1 below.

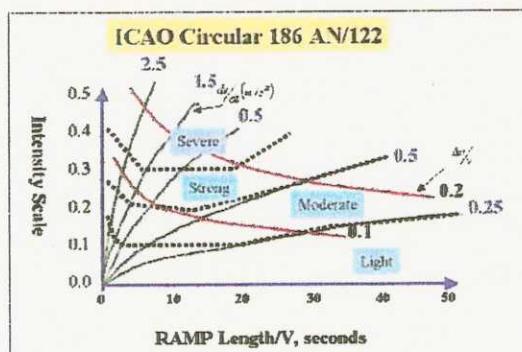
Figure 3: Wind Shear Intensity classification

In 1987, ICAO proposed a method to measure the wind shear hazard (ICAO, 1987). This method categorizes the wind shear into four levels: light, moderate, strong and severe. The wind shear identification depends on two parameters, i.e. the air speed change and the proportion of air speed, as shown in Figure 3.

Based on table 3 data for calculating wind shear intensity, the result showed CI642 encountered a strong to severe wind shear below 200 feet. The intensity of wind shear varied with radio altitude is plotted in figure 3.

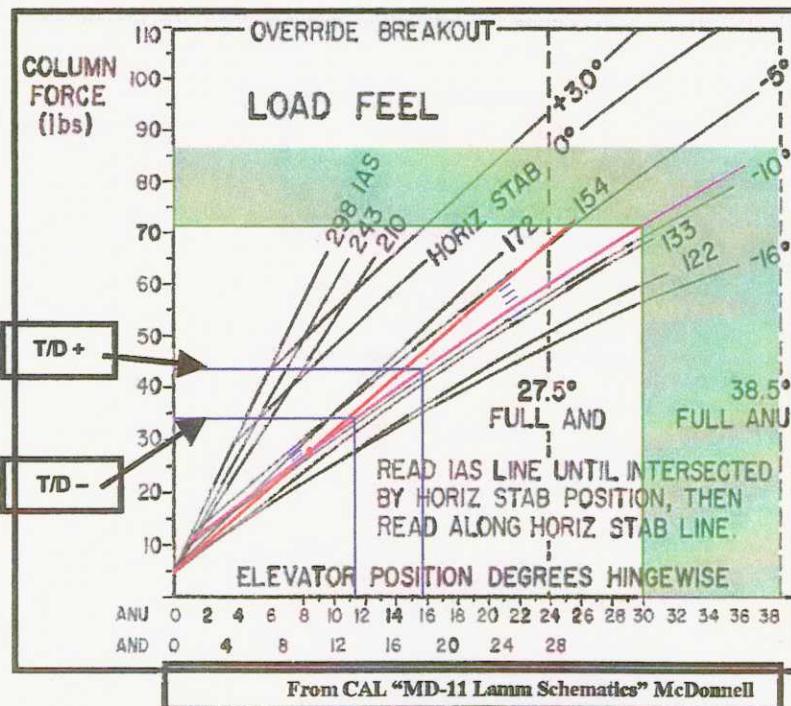
Figure 4. MD-11 Elevator Load Feel force Gradient

3.2.3.1 Elevator control forces required achieving the large deflections necessary to arrest the descent rate in time, which were well in need of large input from the pilot (with one hand on the control wheel, See Figure.4 below).
