Aircraft Incident Report

Wing-Tip Strike with Building while Taxiing

China Eastern Airlines Flight 5054

A321-211, B2290

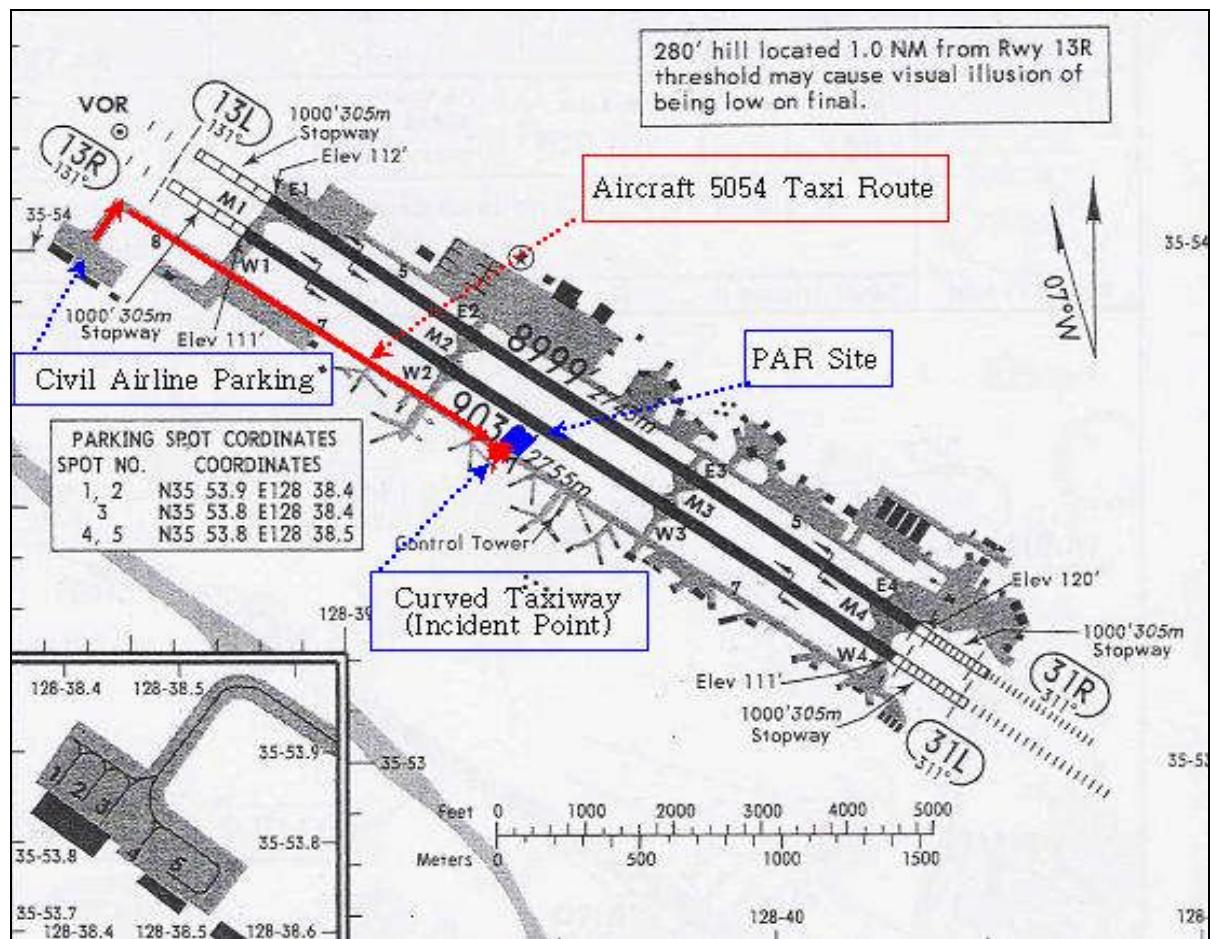
[Figure 1] Aerodrome Chart of Daegu Airport

After Aircraft 5054 was given taxi clearance from Daegu Control Tower at 12:47, the Aircraft started taxiing along the west parallel taxiway in order to move to runway 31R for take-off.

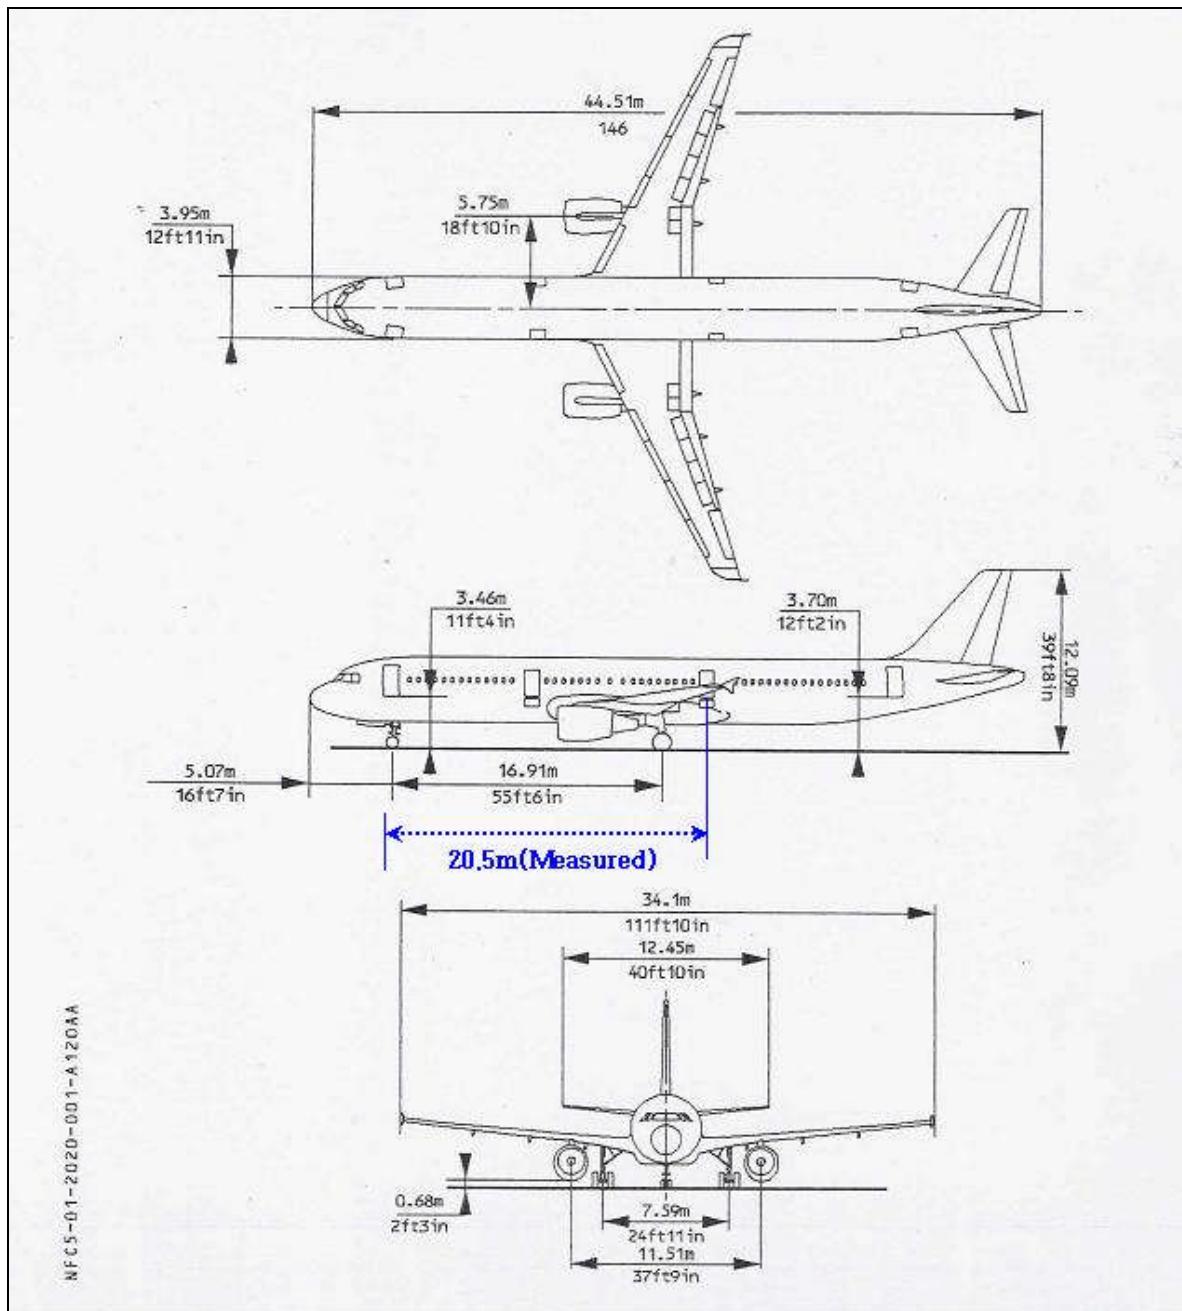
[Figure 2] The Principal Dimension of Aircraft A321

According to A321 FCOM (Flight Crew Operating Manual) and actual measurement data, principal dimension is as shown in the [Figure 2].

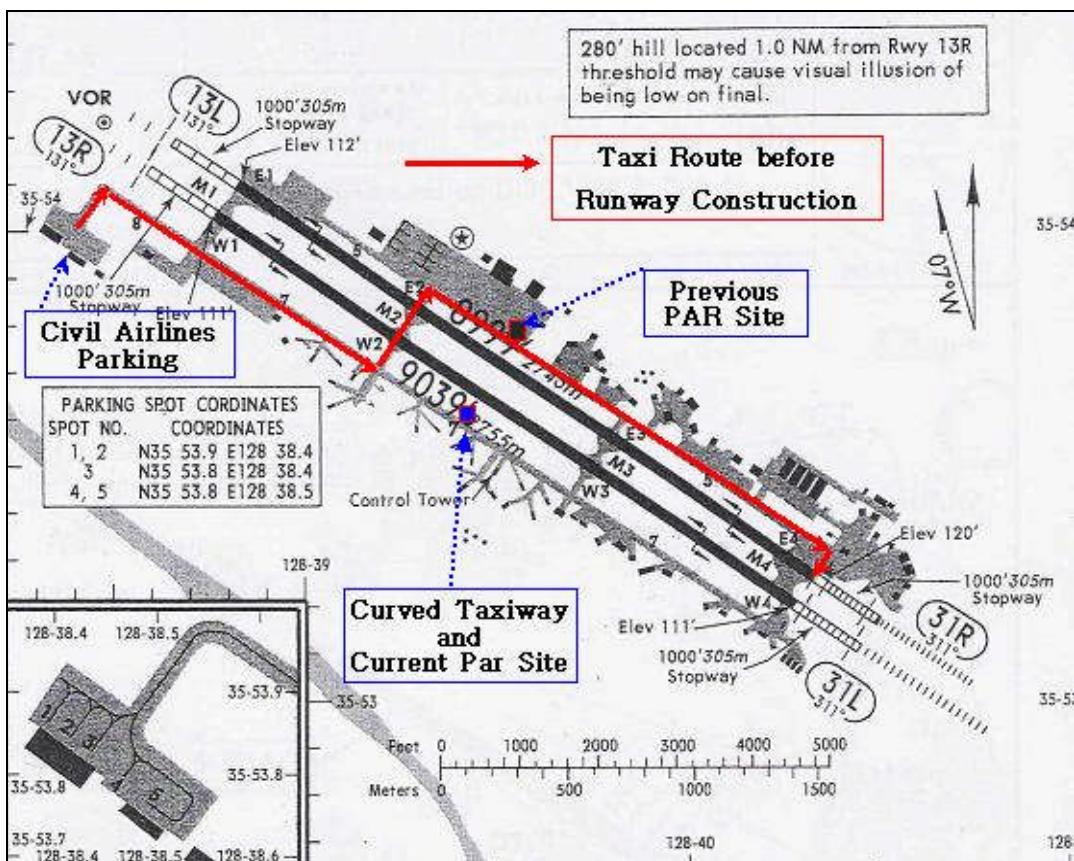
[Figure 3] Aerodrome Chart of Daegu Airport

For the implementation of re-pavement work for main runway (RWY 31L-13R), Daegu Aerodrome Authority had to use preliminary runway (RWY 31R-13L) and for this the Authority moved and installed the PAR Site which used to be located near the preliminary runway to current location¹⁶.

However, the moved and installed site was also located near west parallel taxiway and became an obstacle for civil flights. Therefore all civil aircrafts were required to cross the runway through the taxiway W2, M2 and E2 as shown in the [Figure 3] and then to use east parallel taxiway (TWY 5).

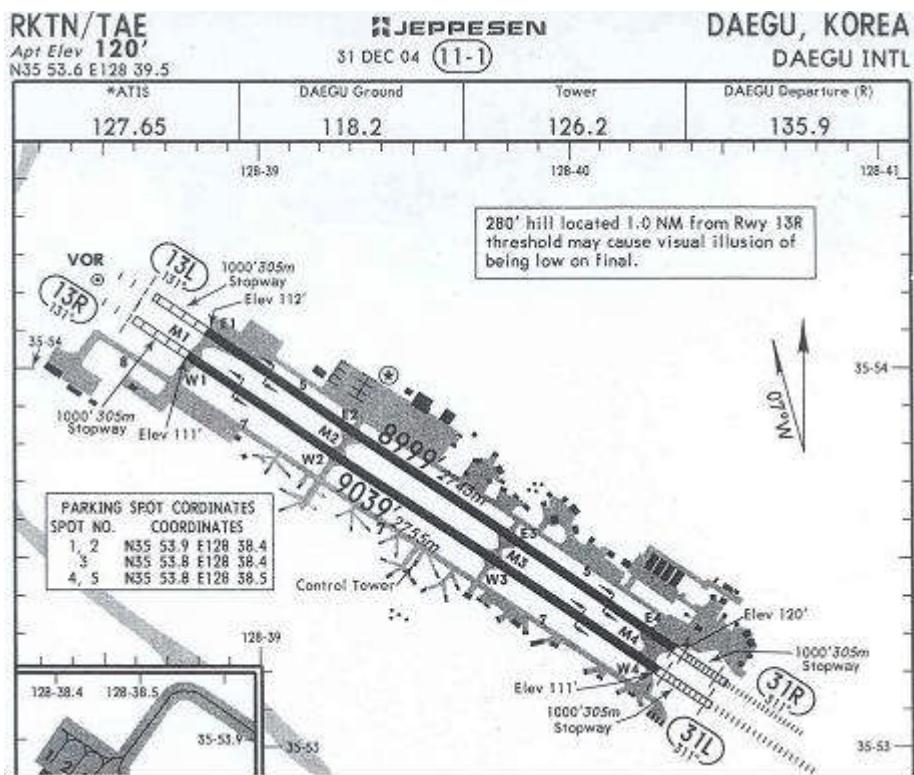
[Figure 5] Jeppesen's Daegu Aerodrome Chart used by the flight crew of Aircraft 5054

The change of west parallel taxiway of Daegu Airport to curved taxiway was not published in the supplement of Aeronautical Information Publications, and Jeppesen's Aerodrome Chart of Daegu Airport which the Flight crew of Aircraft 5054 possessed and used at the time of occurrence of incident is as per [Figure 5] and the Aerodrome Chart of Daegu Airport in the Aeronautical Information Publication which was valid at that time is as per [Figure 6].

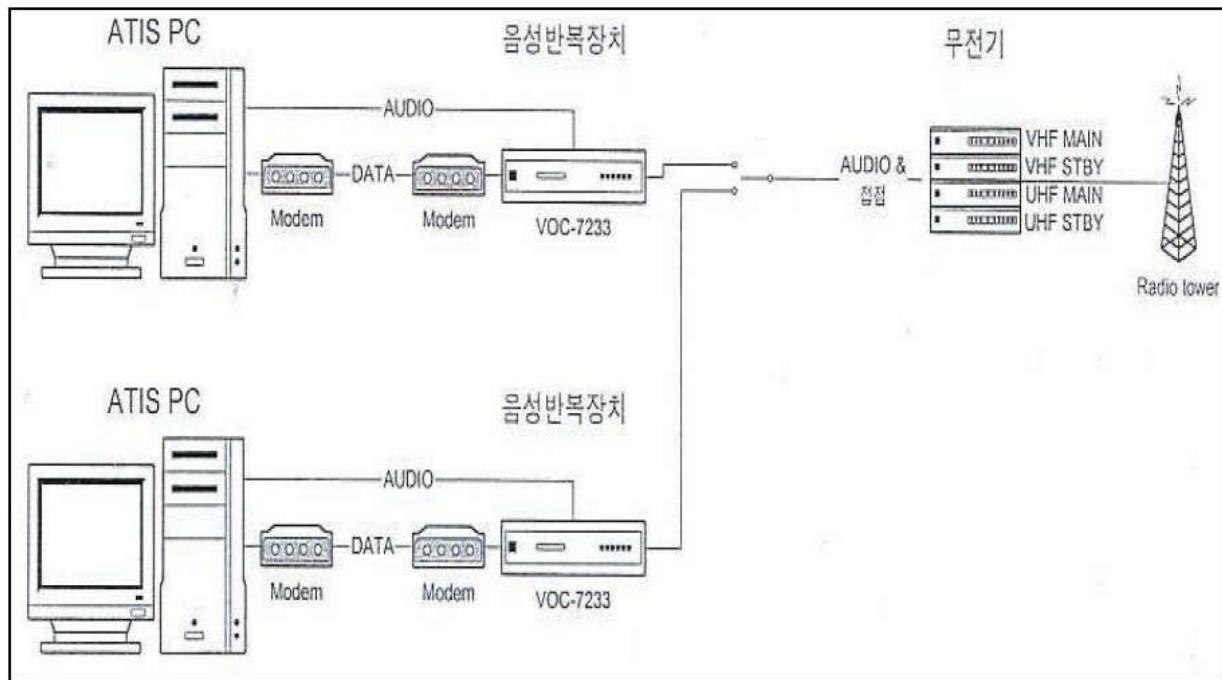
[Figure 7] Block Diagram of ATIS System of Daegu Airport

At the time of the incident, information on the curved part of west parallel Taxiway and PAR was not input to ATIS²⁸ of Daegu Airport and therefore information in that regard was not broadcasted.

Block diagram of ATIS System of Daegu Airport is as per [Figure 7]. When the Controller selects certain information which was already stored in computer as voice information, the information is edited in the form of ATIS broadcasting format and the System automatically repeats the broadcasting of the information. For this reason, only the information stored in the computer can be broadcasted and under this System, the contents of broadcasting could not be changed at any time depending on the judgment of the Controller.
