Tail strike during take-off

Boeing 737-800, registration PH-HZB,
Rotterdam Airport, January 12th 2003

The Hague, November 2006, project number 2003004

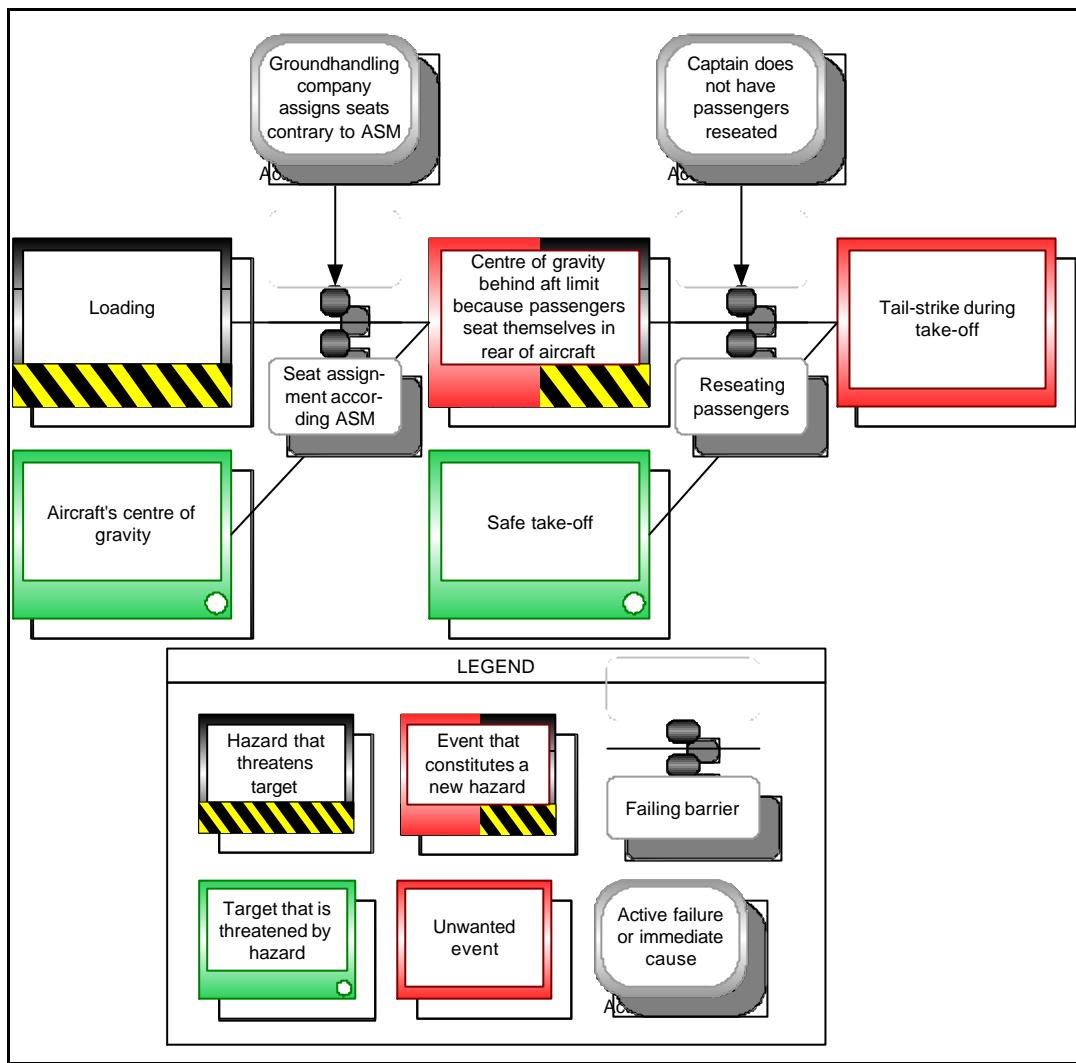
Figure 1 depicts the results of the Tripod analyses in a simplified diagram. More specifically, the sequence of events and corresponding hazards and targets (HET-trio's) that, eventually, resulted in the top event (i.e., tail strike) is presented. Furthermore, figure 1 indicates for each HET-trio (1) which barrier could have prevented the unwanted event and (2) which active failure formed the immediate cause for the barrier to fail. Inspection of figure 1 reveals that:

- Aviapartner did not assign the seats to the passengers in accordance with the passenger distribution table in ASM. As a result, passengers seated themselves in the rear of the cabin;
- Consequently, the aircraft's centre of gravity was situated behind the applicable aft limit. This deviation was not rectified by reseating the passengers;
- Because of this, the aircraft pitched nose-up just after take-off thrust had been selected. Subsequently, this movement stopped when the aft fuselage and the tailskid assembly contacted the runway (i.e., tail strike during take-off).

Figure 1: Simplified diagram of the Tripod analysis of the "Tail strike" of the Boeing 737-800 during take-off at Rotterdam airport on January 12th 2003
