Air Accidents Investigation Branch

**Report on the accident to
Cessna 550 Citation II, G-JETB
at Southampton (Eastleigh) Airport
on 26 May 1993**

This investigation was carried out in accordance with
The Civil Aviation (Investigation of Air Accidents) Regulations 1989

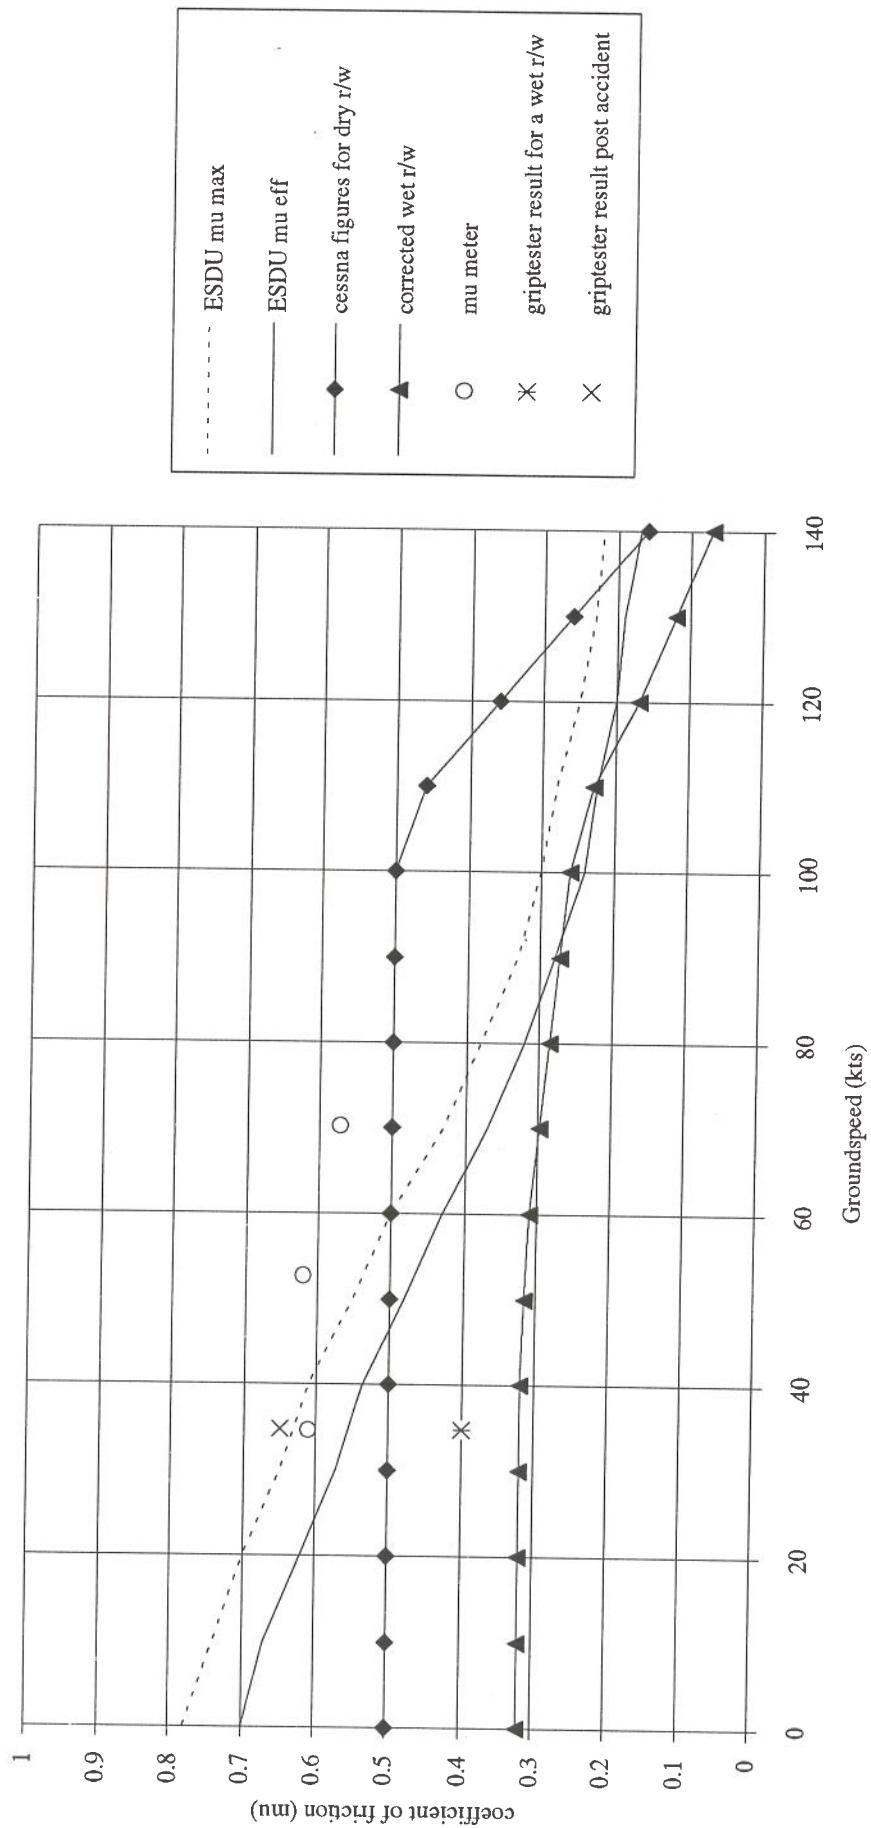
Figure C-1

- (ix) Braking performance analysis indicates that, in the conditions existing at the time of the accident, the aircraft probably could not have stopped in the runway available.

G-JETB COMPARISON OF THEORETICAL AND MEASURED RUNWAY FRICTION
