ATSB TRANSPORT SAFETY REPORT
Aviation Occurrence Investigation AO-2008-007
Final

Hard landing
Darwin Airport, Northern Territory
7 February 2008
VH-NXE
Boeing Company 717 – 200

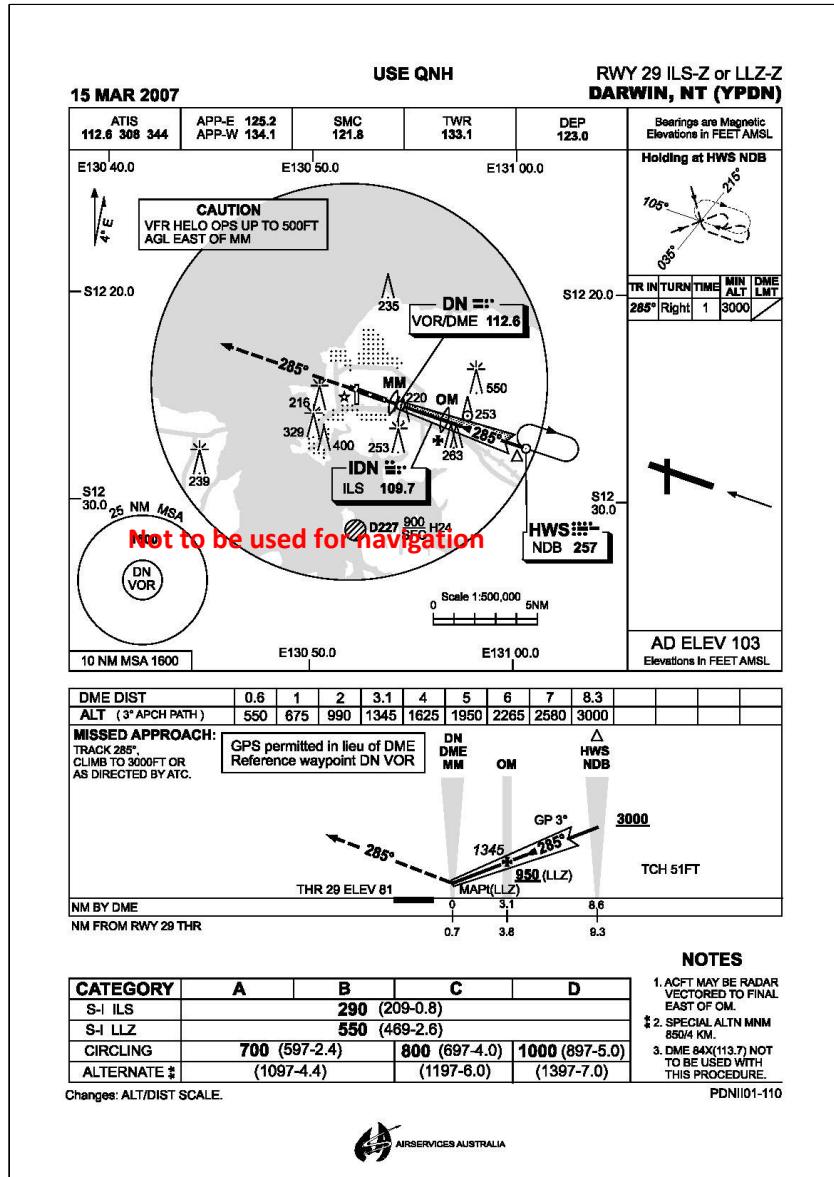
Figure 1: Aeronautical Information Publication (AIP) Darwin Runway 29 ILS approach chart

The PIC recalled that the runway was in sight before the aircraft passed over the Howard Springs non-directional beacon (NDB), which was 9.3 NM (17 km) from the runway threshold (Figure 1). The crew of a preceding aircraft that was conducting visual circuits to runway 29, advised ATC that there was a rain shower on the approach and that the runway threshold was wet. That report was passed by ATC to the flight crew of NXE.

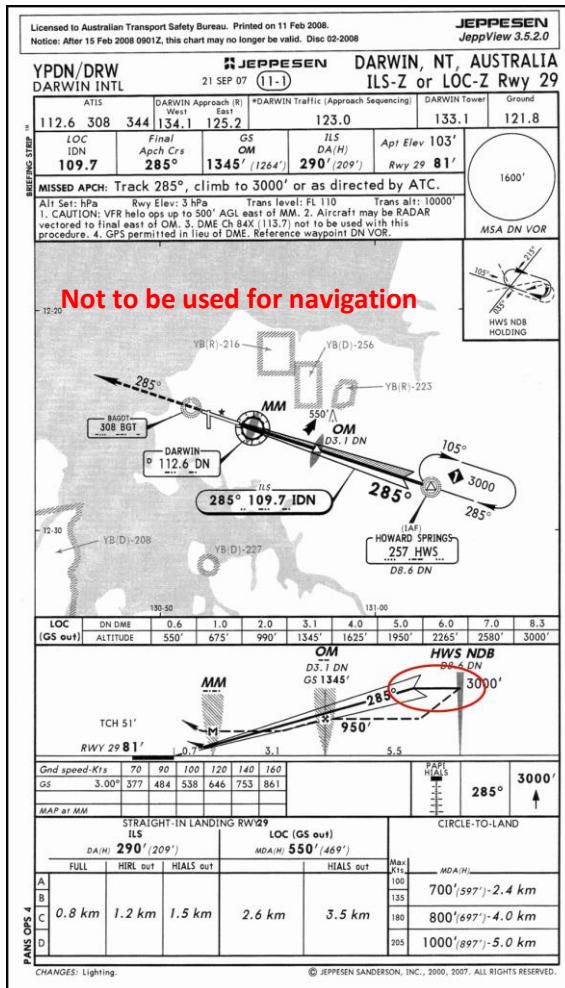
Figure 4: Jeppesen-Sanderson Darwin Runway 29 ILS approach chart dated 21 SEP 07 (level segment highlighted within red ellipse)

During the approach, the flight crew was using the Jeppesen-Sanderson Inc. chart *Darwin ILS-Z or LOC-Z Rwy 29*. The profile diagram on that chart depicted a level segment after the Howard Springs NDB (Figure 4). That depiction was inconsistent with the Aeronautical Information Publication Australia (AIP) chart *ILS-Z or LOC-Z RWY 29 Darwin, NT (YPDN)* that was current at the time of the occurrence, which showed the descent commencing overhead the Howard Springs NDB.
