Statens haverikommission
Swedish Accident Investigation Board

Report RL 2008:06e

**Collision between aircraft B-HIH and a tow
vehicle at Stockholm/Arlanda airport,
AB county, Sweden on 25 June 2007**

Case L-12/07

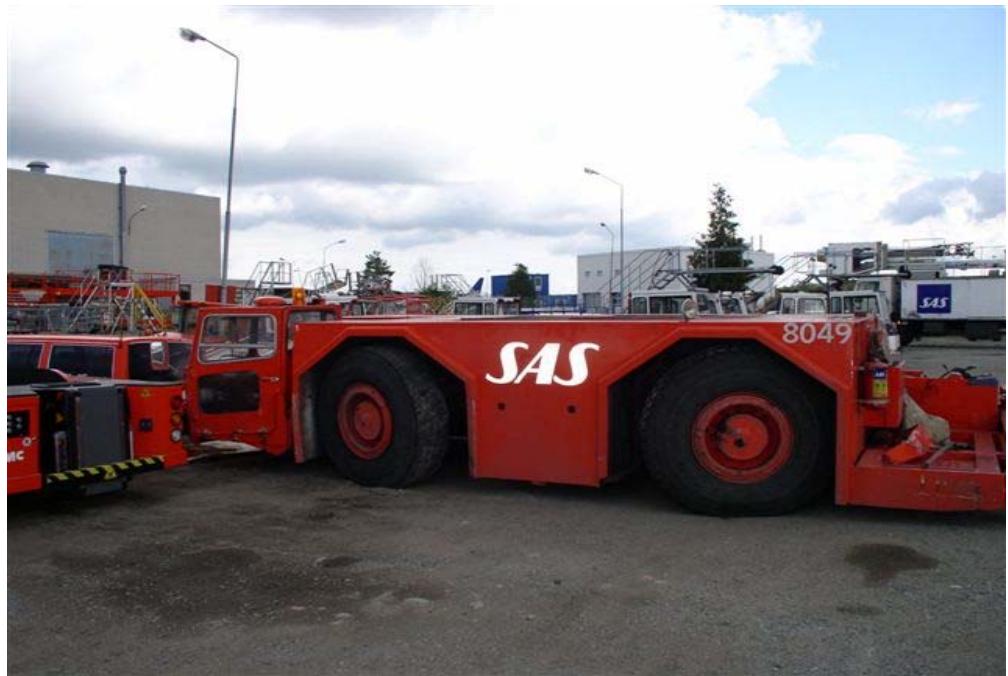
Fig 4. The vehicle

The vehicle	
Manufacturer	Schopf 356
Engine	Deutz F12L, 413 303H
Weight	43,000 kg
Length	7.60 m
Width	2.98 m
Height	1.60 m (2.50 m with elevated driver's cab)

The tow vehicle is one of the larger model used at Arlanda airport and is used during the pushback of larger aircraft. The vehicle has driver's positions at both ends, of which one is adjustable in height. The particular tow bar is specially intended for the pushback/towing of the B747 and has a length of 3.3 metres.

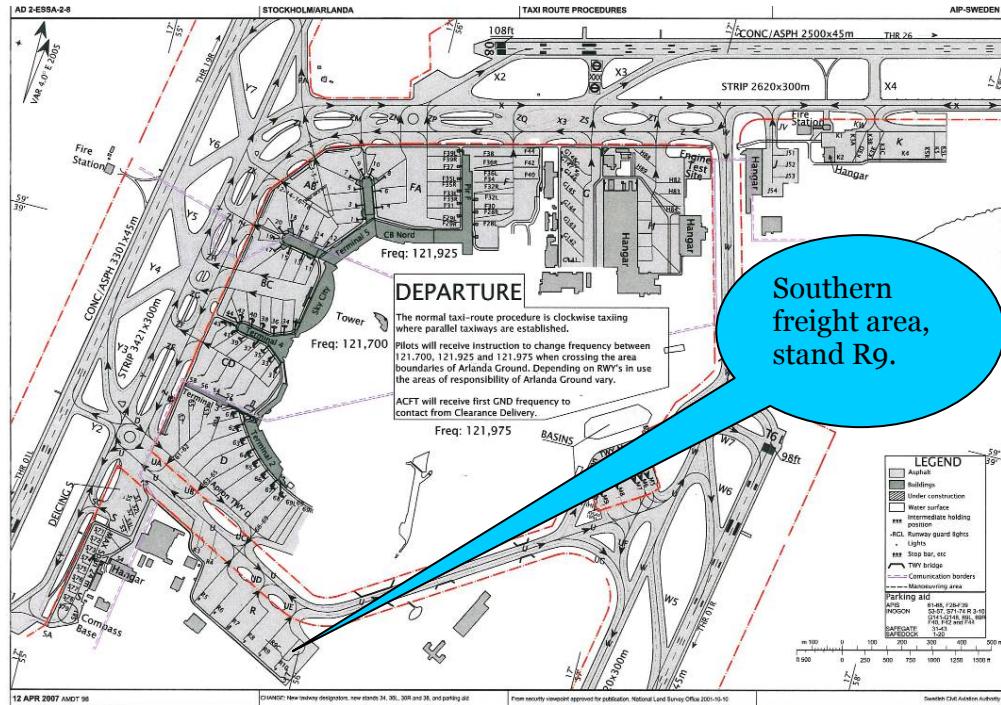
Fig 7. Location of R9 in the southern freight area, at Arlanda airport.
