ATSB TRANSPORT SAFETY REPORT
Aviation Occurrence Investigation – AO-2008-003
Final

Electrical system event
25 km NNW of Bangkok International
Airport, Thailand
7 January 2008
VH-OJM
Boeing 747-438

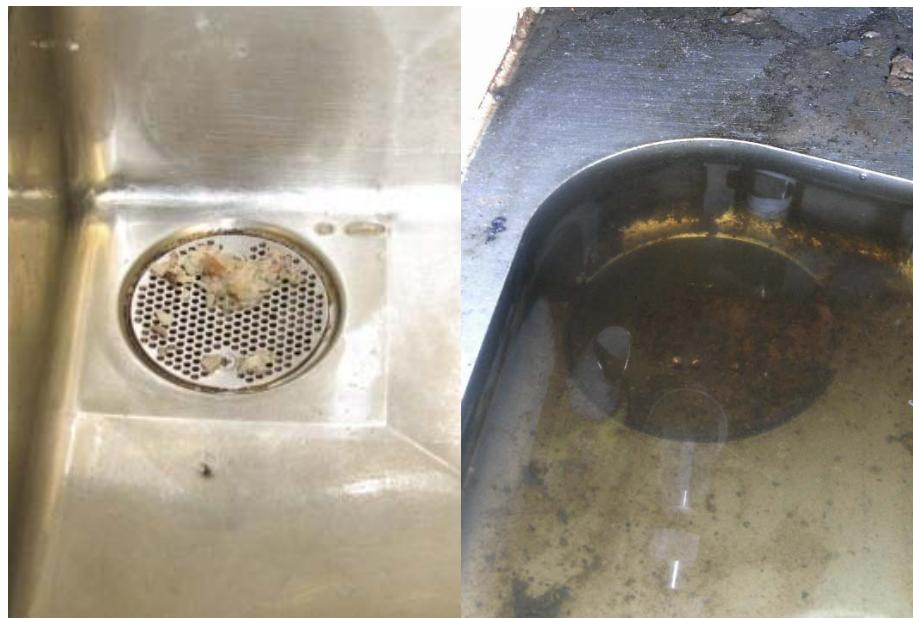
Figure 24: Galley sinks and solid waste

Inspection of the galley drains showed remnants of solid waste in the forward and mid galley sinks. The mid galley sink drain was completely blocked (Figure 24).

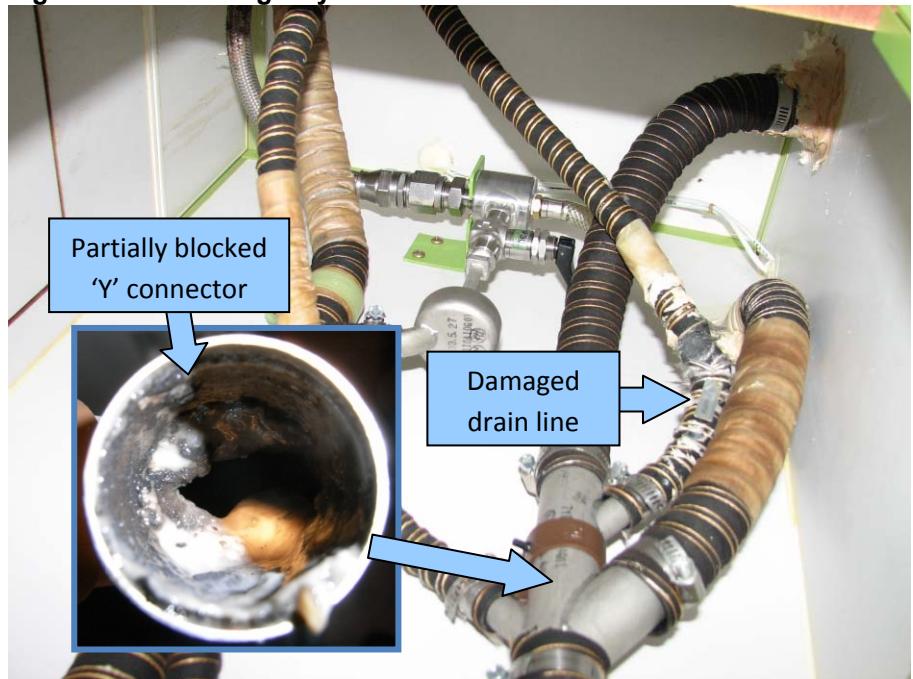
Figure 25: Forward galley sink drain lines

A damaged drain line beneath the forward galley sink did not leak when tested in place (Figure 25). A metal drain line 'Y' connector in the forward galley was removed and found to be partially blocked by solid waste (Figure 25).

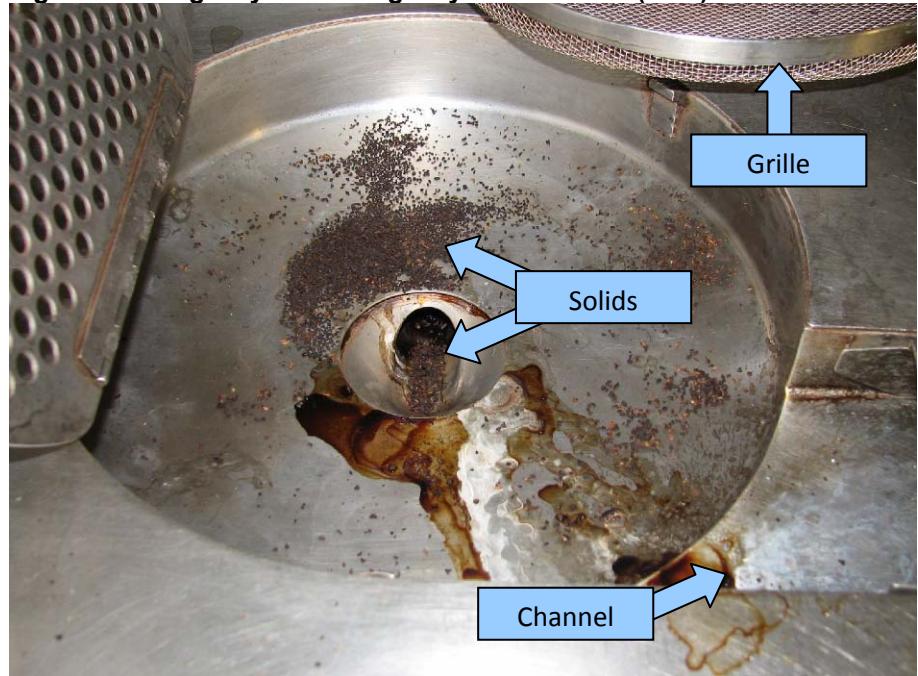
Figure 28: Aft galley sink and galley waste solids (OJK)

Inspections of the galley sinks revealed solid waste, which appeared to be coffee grounds, in one of the sinks in the aft galley (Figure 28).

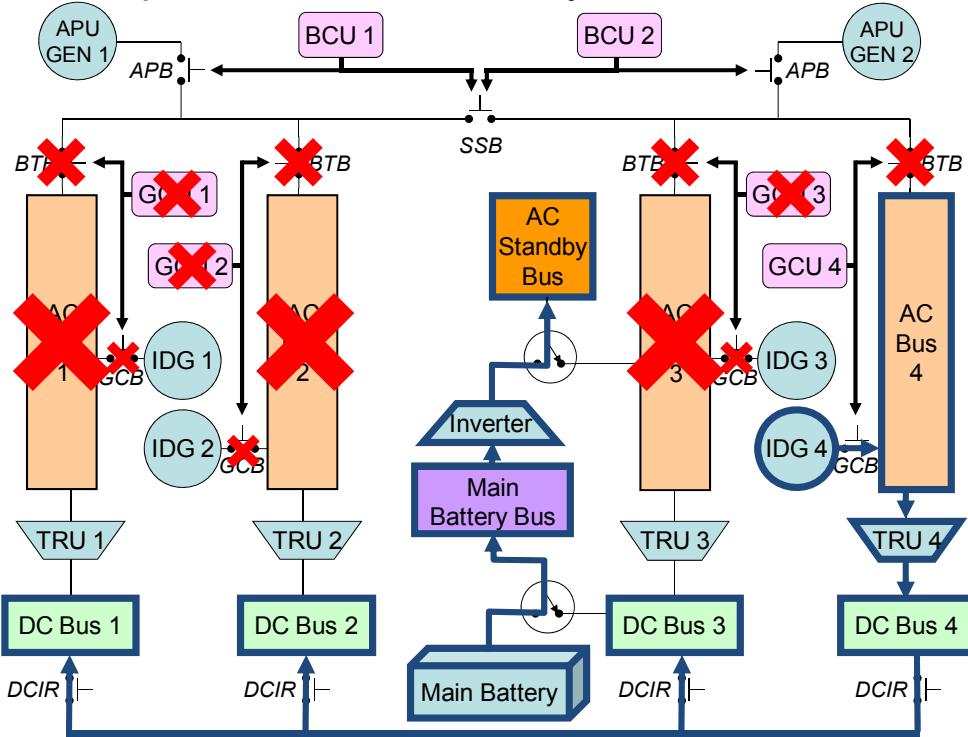
Figure 33: Simplified overview of the aircraft's electrical system configuration at landing. Blue border: active systems; red: inactive systems and open circuit breakers/isolation relays.

Of the aircraft's four primary AC buses and four primary DC buses, only AC bus 4 and the four DC buses remained powered during the aircraft's final approach and landing (Figure 33). In addition, the aircraft's batteries provided power to the two battery buses and to the AC standby bus via the aircraft's static inverter.

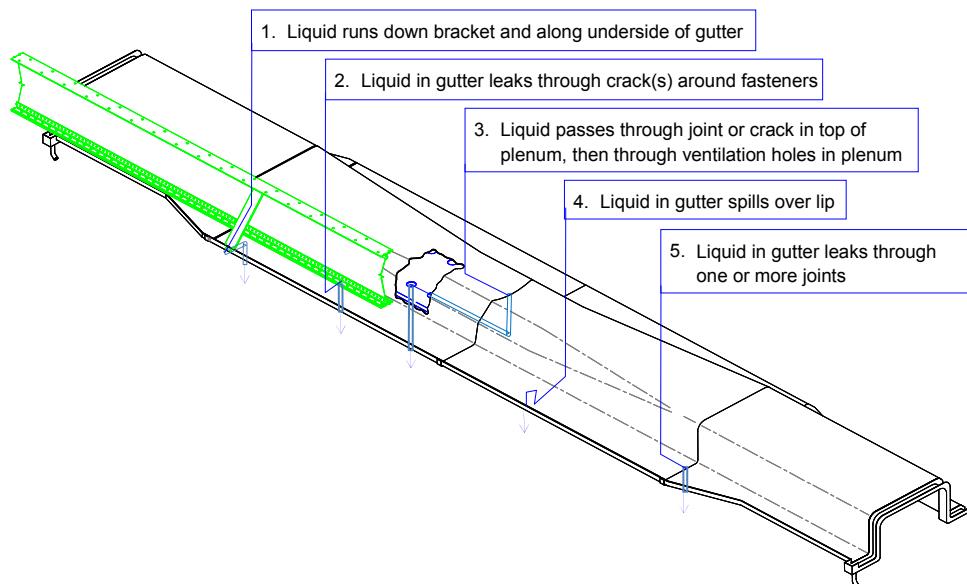
Figure 35: Potential water ingress paths

During inspections of two 747-400 aircraft, including the incident aircraft, the investigation identified five potential paths by which liquid from above could reach the equipment in the E1 and E2 racks. The investigation concluded that although the drip gutter joints were the most likely path for water to have bypassed the dripshield, all five potential liquid paths posed a substantial risk to the electrical equipment in the E1 and E2 racks (Figure 35).

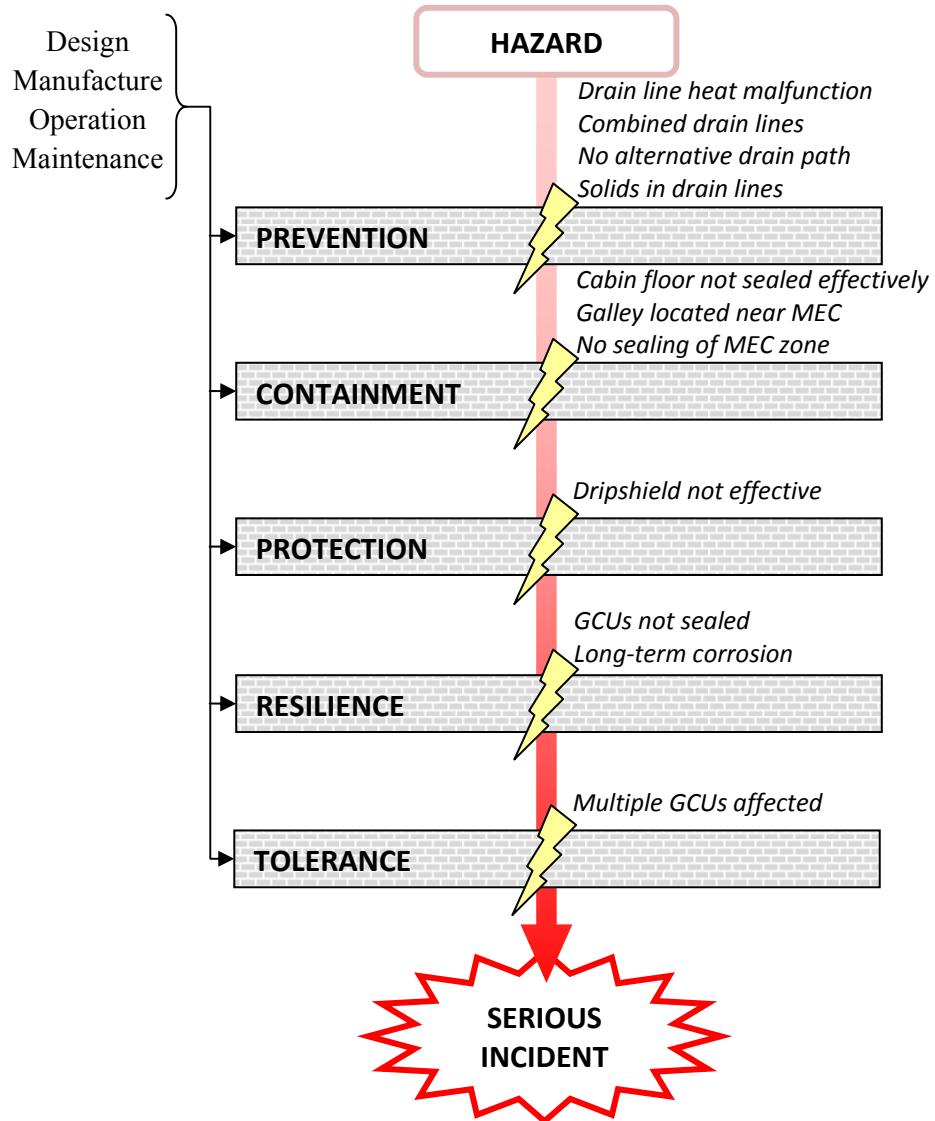
Figure 37: Breaches of defence

In this incident, each of those defences was breached by a different failure or design characteristic (Figure 37).

A breach in any single defence could be considered low-risk in view of the other defences that were in place, but the circumstances that allowed that breach to occur could also affect the other defences. As a result, the overall integrity of the system is compromised. Such circumstances could involve a weakness in the principles and policies that drive the design, operation, and/or maintenance of the defences, or a weakness in the implementation of those principles and policies.
