# Report

Incident on **2 June 2010**

**Bordeaux FIR, OLRAK Point**

between the **A318** registered **F-GUGJ** operated by **Air France**  
and the **PC 12** registered **EC-ISH**

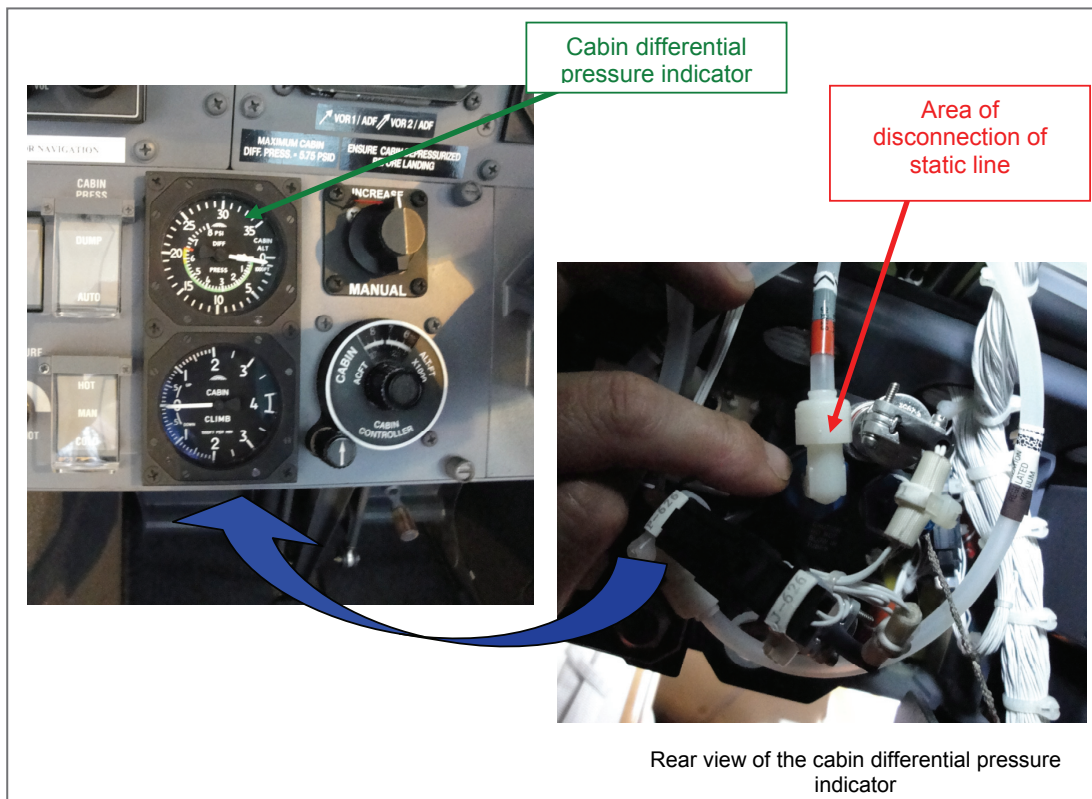
Figure 6

On the PC 12, before performing this test, it is necessary to disconnect the N°1 static line at the level of the cabin differential pressure indicator in order to protect it from the high pressures used during the test. This disconnection is done by unscrewing the connector located on the rear panel of the differential pressure indicator (see figure 6). At the end of the test, the connector is screwed back on. This manipulation is made tricky due to the limited space and the presence of an electrical plug near the pipes.

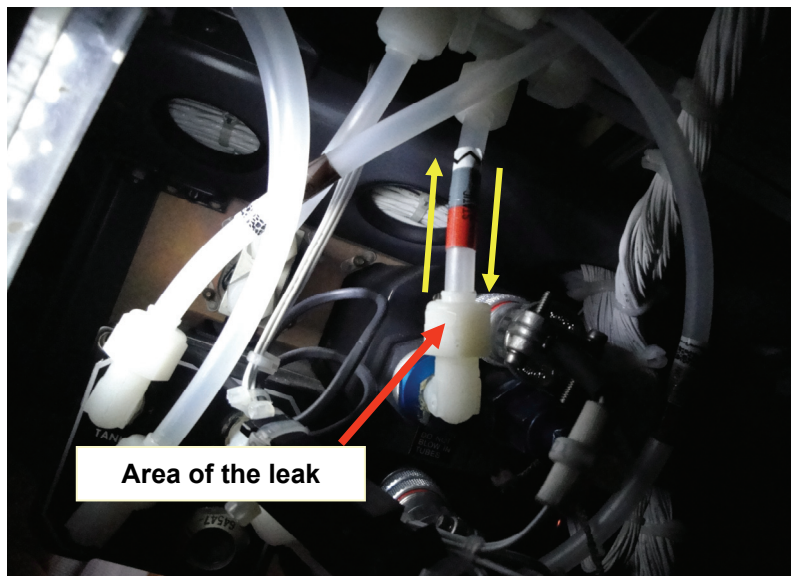
Figure 9: Location on airplane

It was possible to establish, during these tests, that the deformation observed on the connector made a perfectly impermeable joint impossible between the pipe and the cabin differential pressure indicator. Due to this, the tube (see "A" figure 8) could be moved in the longitudinal direction though it is, normally, immobilised by the tightening. Without manipulating this tube, no notable leak occurred. As soon as it was displaced in a longitudinal direction (see "B" figure 8), a leak appeared.

Thus, during the impermeability tests performed by Pilatus, on the airplane on the ground, no leak was detected. During departure of the PC 12, the vibrations in flight, as well as the stresses created by the climb with pressurisation of the cabin, very likely led the tube to move, thus causing the leak at the level of the connector.
