REPORT QUITO-1/2007

Date and time	Friday, 31 August 2007; 21:05 h UTC
Site	Mariscal Sucre International Airport in Quito (Ecuador)

Registration	EC-JFX
Type and model	AIRBUS A-340-600
Operator	Iberia, L.A.E.

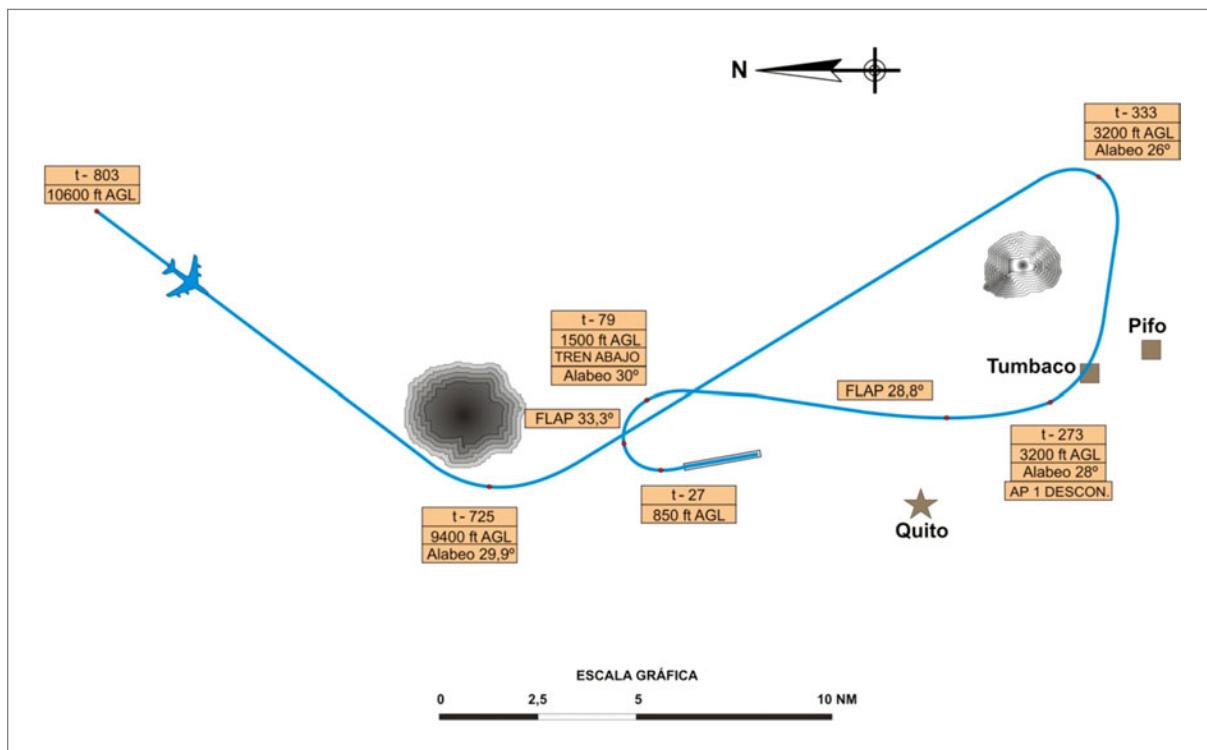
Figure 1. General diagram of the path taken by the aircraft according to the FDR

The performance of this maneuver is subject to certain restrictions due to the relief of the area where the airport is located. The existence of a mountain in the extension of the downwind leg (see Figure 1) prevents prolonging this leg excessively. There is no indication that the operator had planned this maneuver in any detail.

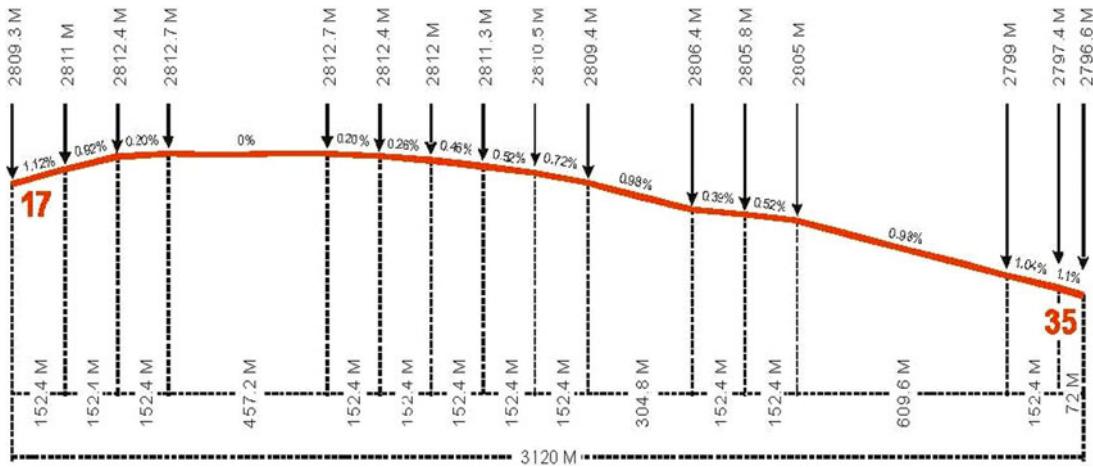
Figure 5(a). Runway longitudinal profile

Figure 5(a) shows the runway longitudinal profile. It can be observed that runway 17 starts with an upward slope of approx. 1%.

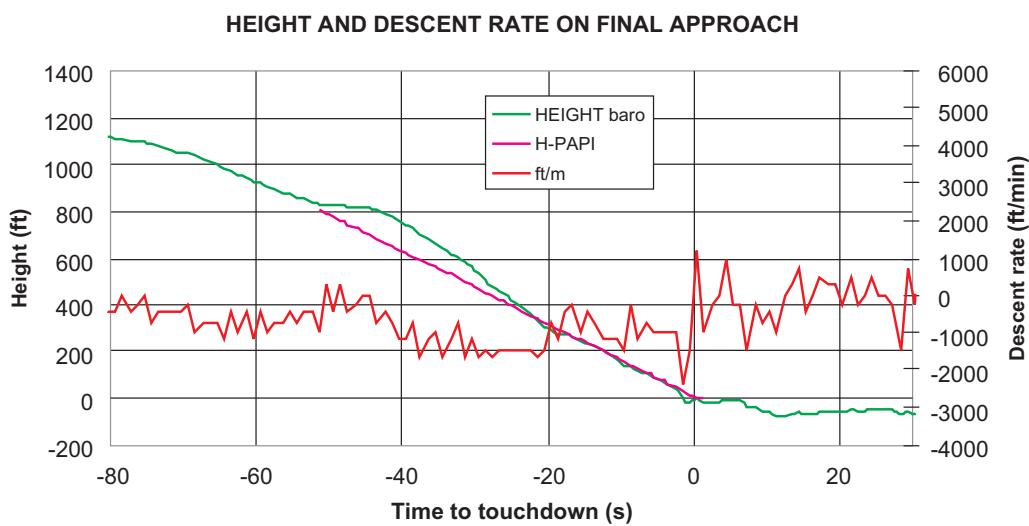
Figure 6. Descent rate and glide slope

The data most relevant to the investigation are shown in the following graphs. The descent rate shown is the value recorded in the FDR (parameter IVV). The indicated airspeed and groundspeed differ significantly due to the altitude at which the airport is located.

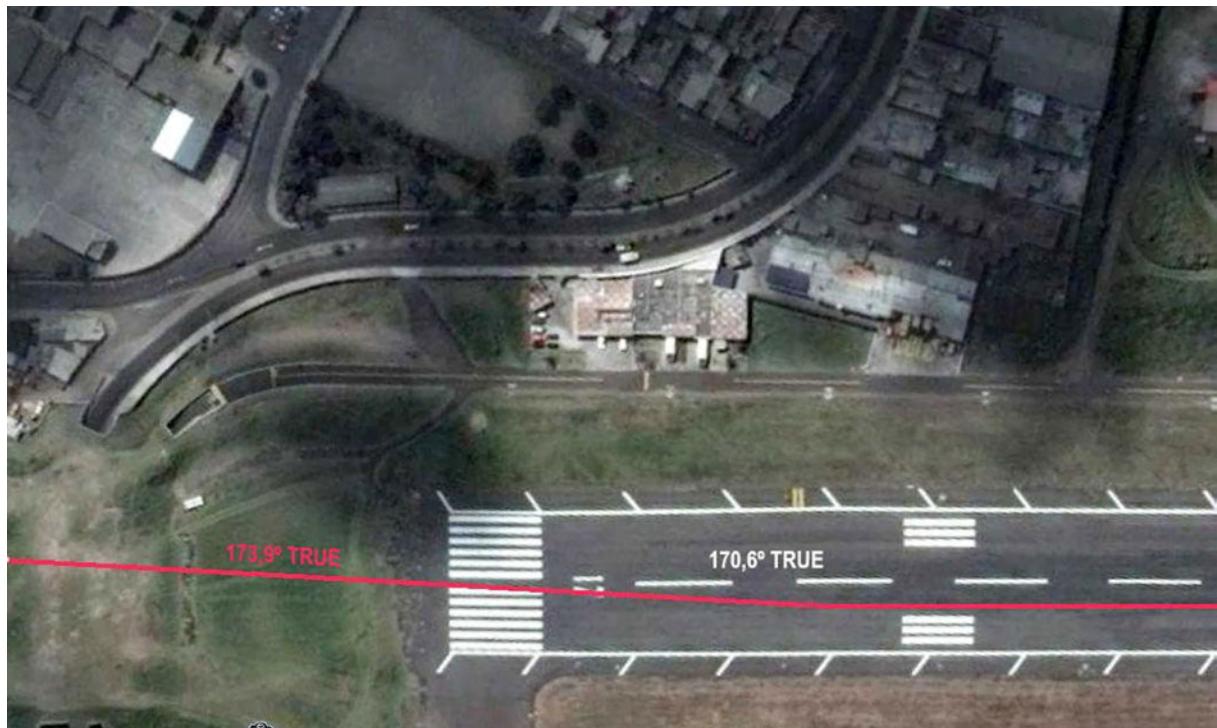
Figure 14. Final part of the aircraft's path obtained from FDR coordinate data adjusted to the point on the runway where the aircraft came to a stop. Photo property of Google Earth

Large left roll angles are present until second -25, as the turn from base to final is completed. After the turn, the aircraft's heading varied from 160-165°. The graph of lateral acceleration shows the aircraft deviating right (producing acceleration to the left).

Of significant importance to the event were the consecutive changes in the crosswind directions during the last 20 seconds before touchdown.

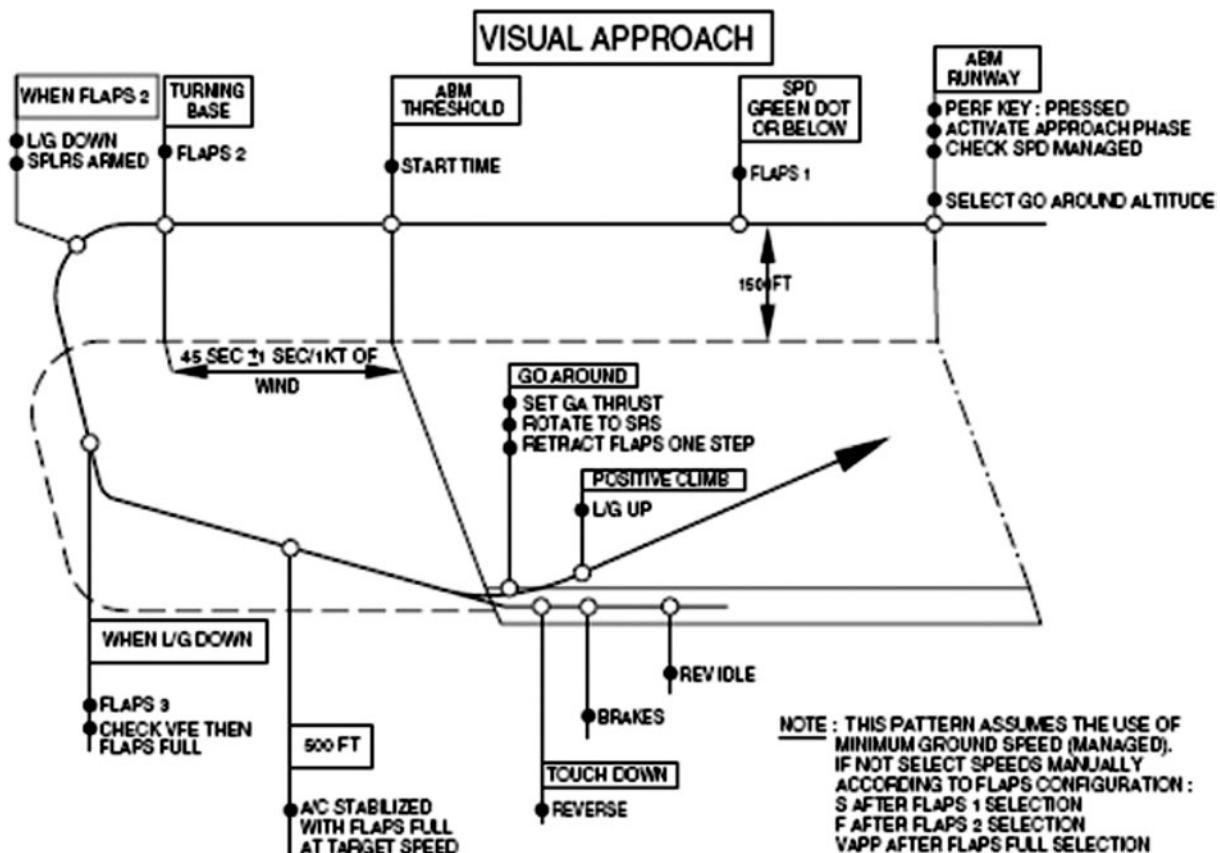
Figure 16. Standard visual pattern, taken from Airbus FCOM

- Given the mountainous terrain, published maximum maneuvering speeds must be strictly observed.
- The main approach is the 35 ILS-VOR, with a permissible tailwind of 10 kt.
- Only a circling approach to the E (east) of runway 17/35 is possible for runway 17.
- The low visibility circling maneuver is described in the Flight Crew Operating Manual (FCOM) issued by the aircraft manufacturer, Section 3.03.19 (see Figure 15), which states the need to be stable at an altitude of 400 ft at the conclusion of the base leg. The standard pattern visual approach is performed at 1,500 ft AGL (see Figure 16).
