**Rejected takeoff after the takeoff
decision speed ' V_1 ', Boeing B737-800,
at Eindhoven Airport**

4 June 2010

The Hague (project number 2010040)

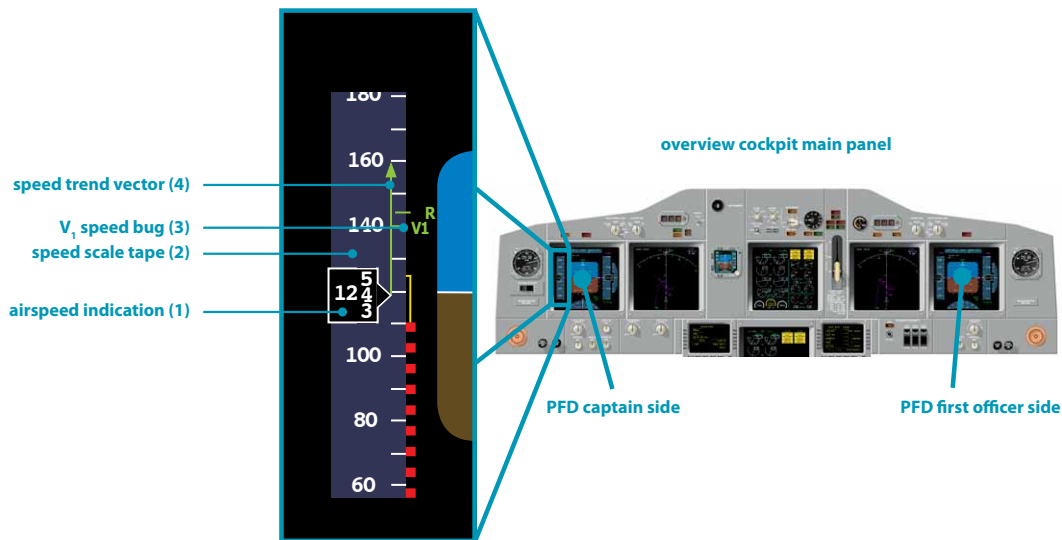
Figure 3: Overview B737-800 cockpit with detailed schematic of the speed indications of the primary flight display.

The (computed) airspeed information is displayed in numerical format on the left side of each primary flight display (Figure 3 – (1)). A dynamic moving speed scale tape (Figure 3 – (2)) displays additional speed information depending on the airspeed and phase of flight. For takeoff V-speeds are determined and input into the Flight Management Computer. Subsequently the V_1 (Figure 3 – (3)) and V_R speed are displayed on the speed tape. Superimposed onto the speed scale tape is a green arrow (Figure 3 – (4)) which is the speed trend vector. The tip of the speed trend vector shows the predicted airspeed after 10 seconds. The prediction is based on the concept that change in airspeed and longitudinal acceleration stay the same. The speed trend vector points upward when the aircraft speed increases (acceleration) or down in case the speed decreases (deceleration). When the calculated speed trend vector is below a threshold it will not be displayed. The speed trend vector is designed as a helpful in-flight tool to set appropriate thrust setting and fly the desired speed. This reduces pilot workload when changing or maintaining an airspeed or altitude.
