ATSB TRANSPORT SAFETY REPORT
Aviation Occurrence Investigation – AO-2006-154
(previously 200601076)
Final

**Warning device event
232 km south of Paraburdoo, WA
28 February 2006**

**VH-NXH
Boeing Co 717-200**

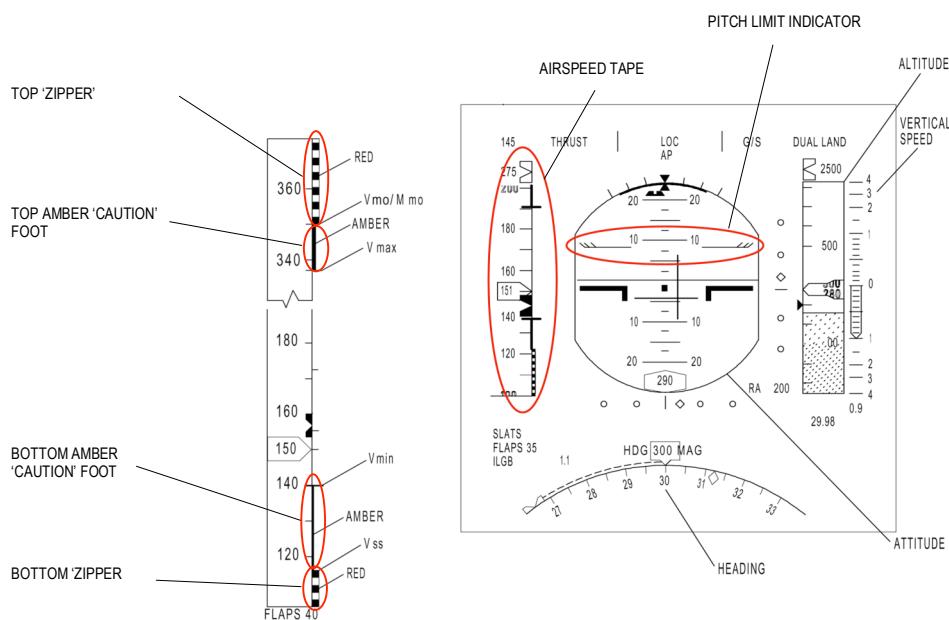
Figure 1: Primary flight display and airspeed tape

The auto flight system levelled the aircraft at FL340. The flight crew recalled that the aircraft accelerated normally to cruise speed and that the pitch attitude and engine power settings were normal for that stage of flight. During the acceleration, the flight crew detected that, over a period of several seconds, the speed displayed on their primary flight displays (PFD) for stick shaker activation (V_{ss}) began converging towards the indicated airspeed, overtaking the amber caution speed range associated with the flight management computer-calculated minimum operating speed (V_{min}). The relevant indications on the aircraft's PFDs are annotated at Figure 1.

The flight crew stated that the stick shaker⁸ activated as V_{ss} merged with the current airspeed. The speed indicated for V_{ss} continued to increase and merged with the maximum operating speed (V_{mo}/M_{mo}), such that the right edge of the airspeed tape gave the appearance of being one continuous red and white 'zipper'⁹. Similar indications were observed on both the pilot's and the copilot's PFDs. The flight crew reported that they did not receive any other cautions, alerts or warnings on the aircraft's engine and alert display (EAD).

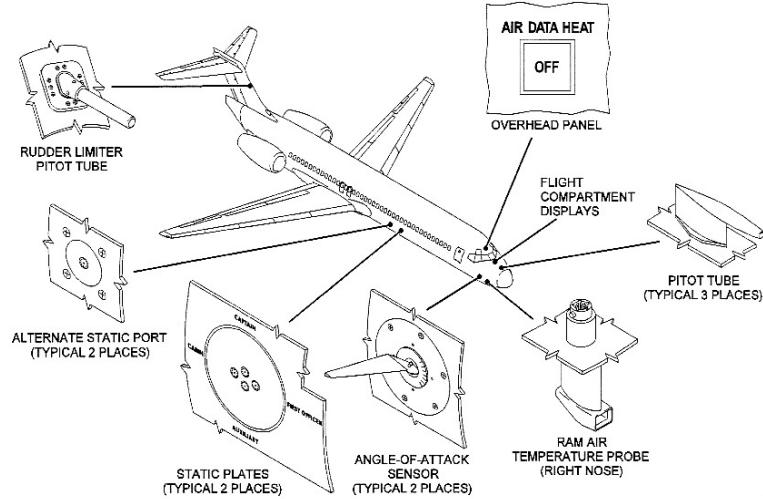
Figure 2: Flight environment data sensors

affecting the aircraft (Figure 2). Data modules converted the pitot-static information into digital signals and supplied those signals to the aircraft's air data inertial reference units which, in turn, sent parameters computed from that data to the aircraft's flight computers and navigation systems. Flight environment data was displayed to the flight crew on the aircraft's electronic instrument system displays, including information on its altitude, airspeed, Mach number, vertical speed and air temperature.

Sensor S/N 215 (installed on the right forward fuselage – Figure 2)

Sensor S/N 263 (installed on left forward fuselage – Figure 2)

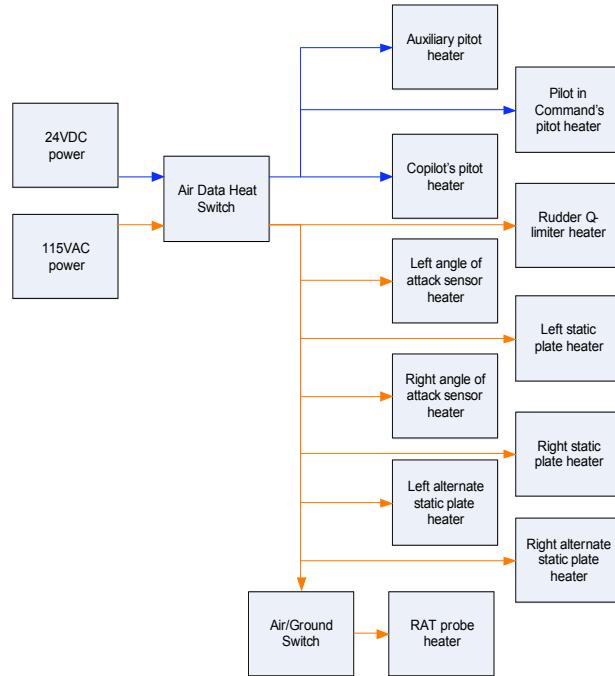
Figure 3: Air data heating system

Each of the flight environment data sensors (Figure 3) was able to be electrically heated in order to ensure the continued availability of data during flight, including when operating in icing conditions. Sensor heating was controlled by the AIR DATA HEAT switch, an illuminated, four-pole, double-throw (alternate action) latching switch that was located on the cockpit forward overhead panel. The crew were required to select the switch ON as part of the pre-flight checklist.

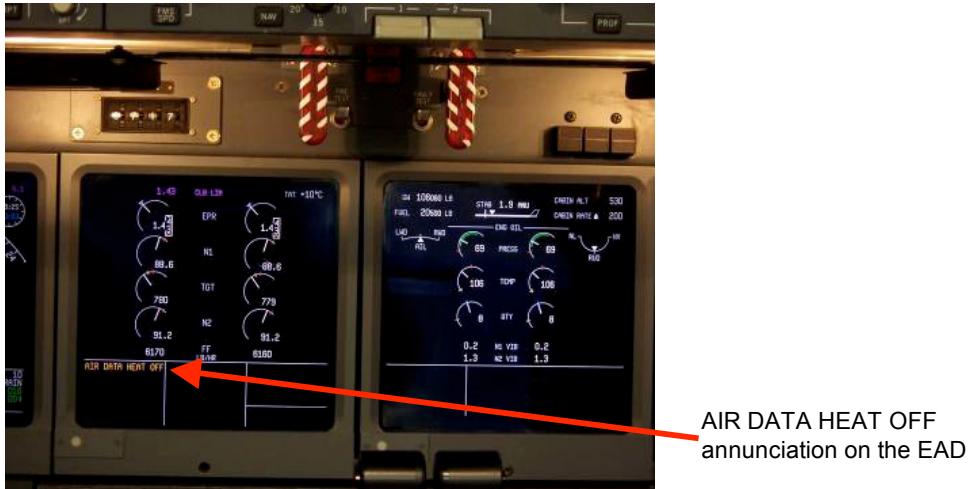
Figure 5: AIR DATA HEAT OFF annunciation

ON during flight, its status was only enunciated to the flight crew when it was selected to the OFF position. That annunciation was displayed as an OFF illumination of the switch button and by a system status message ‘AIR DATA HEAT OFF’, which was displayed on the lower left corner of the EAD on the centre console (Figure 5). That system design was certified under the indicating system requirements of FAR 25.1419.

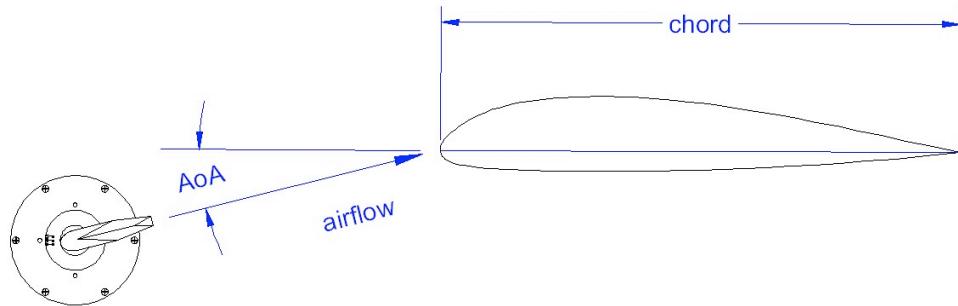
Figure 7: Angle-of-attack sensor schematic

The sensors were calibrated to determine the direction of the airflow relative to the chord of the wing, enabling a measure of the aircraft’s angle-of-attack (Figure 7). The FCCs performed a test of the angle-of-attack sensor data immediately after takeoff and before the stall warning system changed to the flight mode. After that check, the output of the angle-of-attack sensors was not monitored to detect and alert flight crews of an immobilised sensor. There was no comparison of the angle-of-attack data between the sensors during a flight.

Heating for each angle-of-attack sensor was operated from a separate pole of the air data heat switch. Embedded in each sensor’s vane was a solid state ceramic heater that self-regulated its surface output temperature to a nominal 125° C. To minimise condensation inside the sensor case, one small-capacity, fixed-resistance heater was situated at the rear of the case assembly. The slinger, central shaft and faceplate were not directly heated.
