Accident  
Investigation Board  
Norway

# REPORT

SL 2012/04

REPORT ON AIRCRAFT ACCIDENT ON  
10 OCTOBER 2006 AT STORD AIRPORT,  
SØRSTOKKEN (ENSO) NORWAY INVOLVING A  
BAE 146-200, OY-CRG, OPERATED BY ATLANTIC  
AIRWAYS

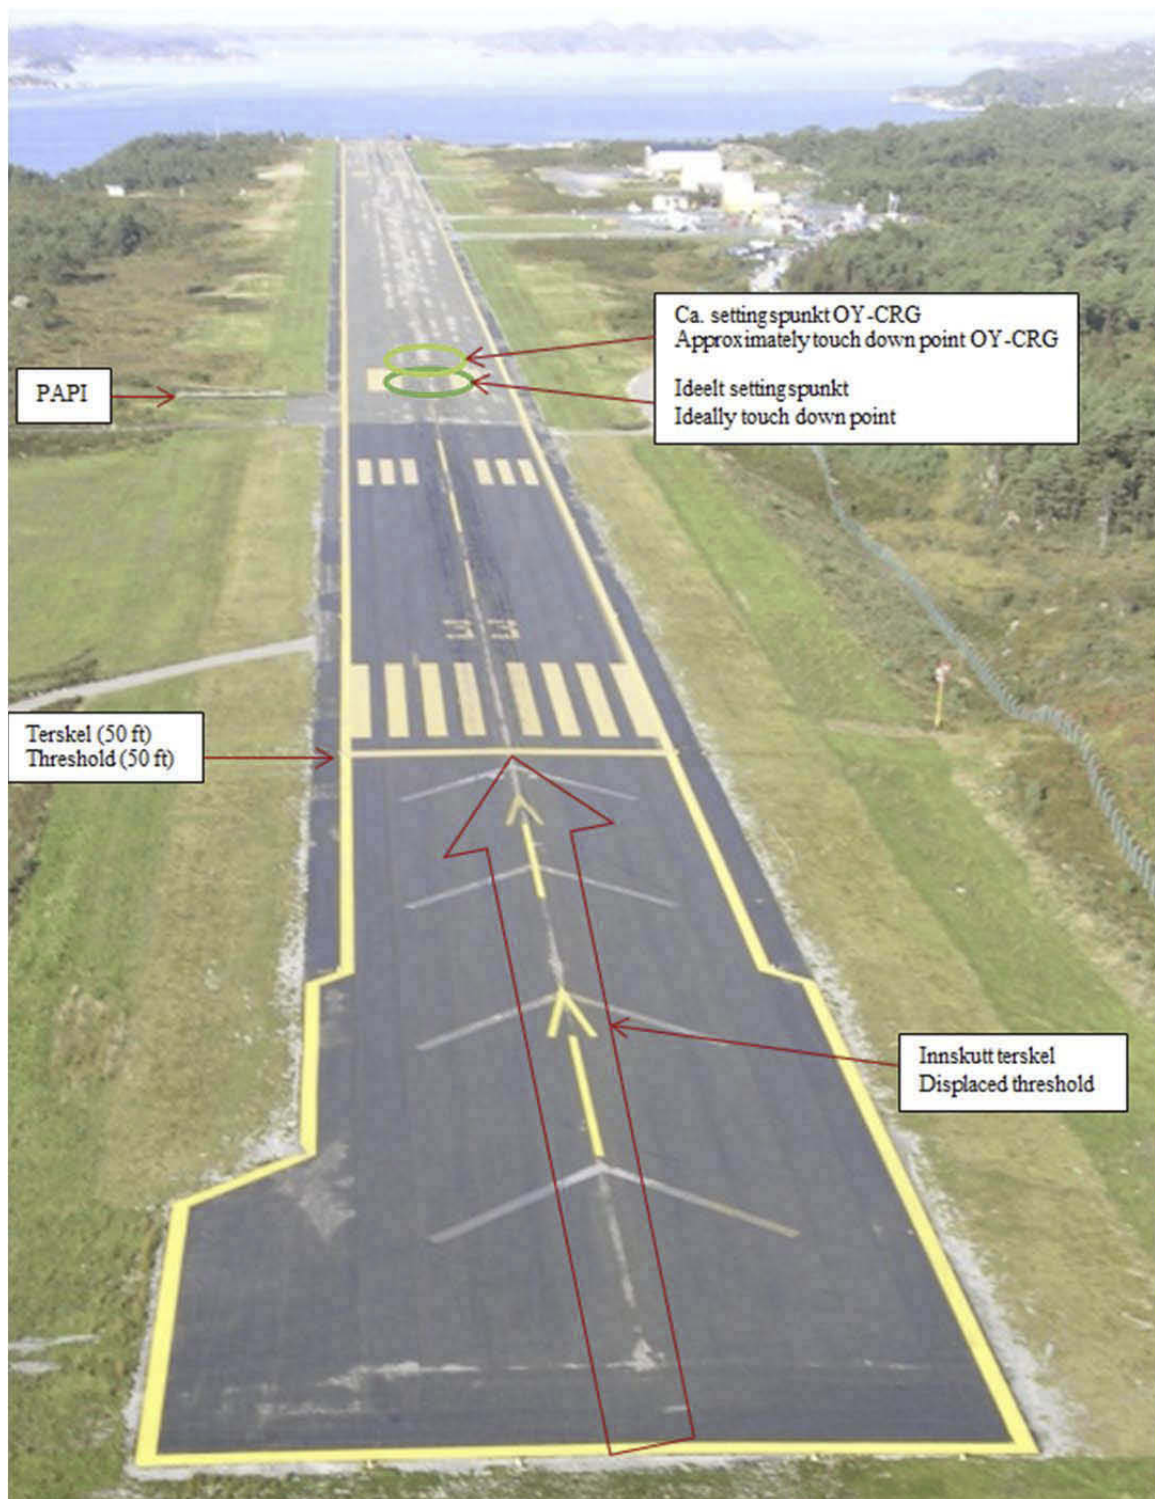
Figure 1: Runway 33 seen in the landing direction (the photo is from an higher altitude than the pilots see the runway during a normal approach)

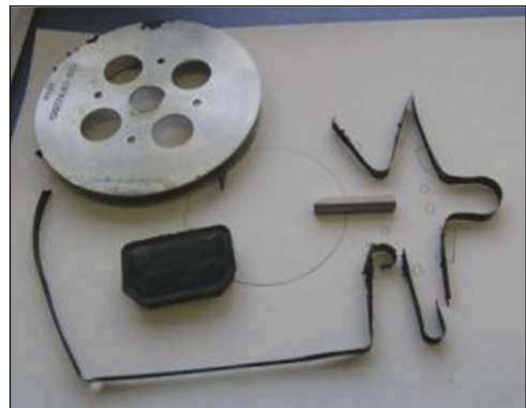
- 1.11.1.2 Data from the FDR was recovered by the Air Accidents Investigation Branch (AAIB-UK) at Farnborough. When the FDR was opened, it showed clear signs of having been exposed to higher temperatures and for a longer time than it was designed to withstand pursuant to the certification criteria. After having made every possible effort, the specialists at the laboratory had to acknowledge that most of the FDR data was lost as a result of heat damage (see Figure 16 and Figure 17).

Figure 17: Magnetic tape sections from which data could be recovered.

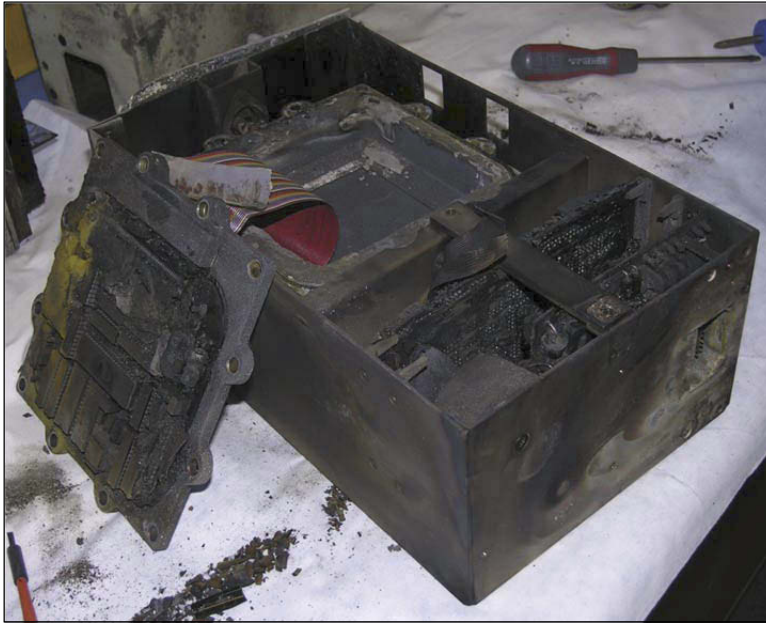
- 1.11.2.1 Pursuant to current regulatory requirements, the aircraft type shall have a cockpit voice recorder that stores data from the last 30 minutes. OY-CRG was fitted out with a cockpit voice recorder (CVR) of the type Fairchild A100S, with part number S10008000 and serial number 00654. The CVR was a solid-state recording device.
- 1.11.2.2 The Air Accident Investigation Branch (AAIB-UK) tried to recover the CVR data. Despite considerable effort by highly skilled personnel, they did not succeed in recovering any of the CVR data. This was mainly because the connections on the storage unit's circuit board had been destroyed due to heat damage (see Figure 18).

- 1.11.2.3 The AIBN therefore brought the storage unit on to the manufacturer L3 Communications in Sarasota, Florida, USA, where they were able to repair the circuit board and recover the data stored on it.
- 1.11.2.4 The quality of the CVR recording was good. The recording was of the pilots' communication amongst themselves, their two-way communication with the various Air Traffic Control units and cockpit sounds. The recording was of 30 minutes duration as expected, and covered everything from starting the plane at Sola until the power supply failed as a result of the accident.

Figure 18: Cockpit voice recorder.

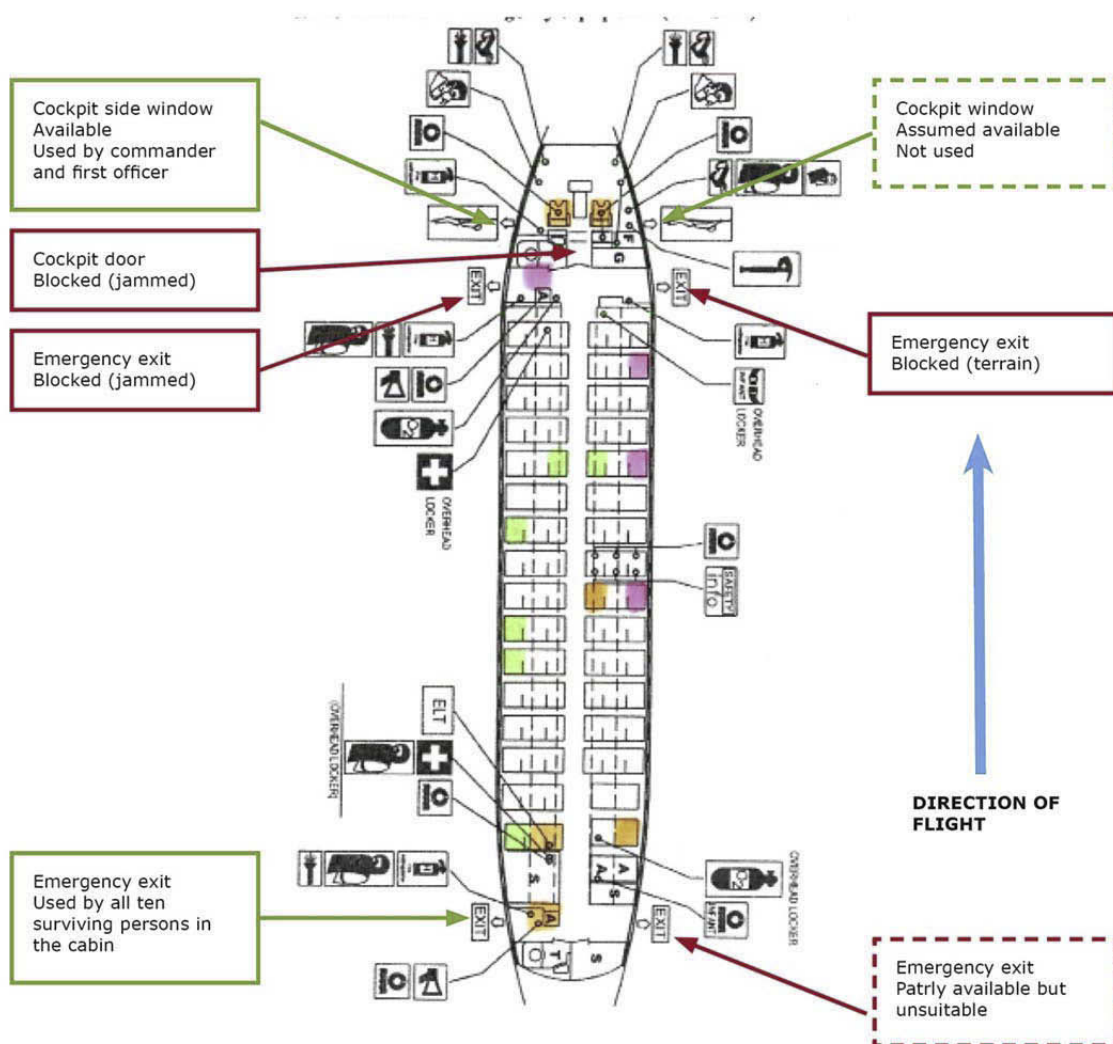
Based on the statements of those involved, it took some time before the fire spread to the interior of the cabin. Hence those in the forwardmost part of the cabin had some time to

escape through the cockpit or forward emergency exits (provided that these had been accessible/were not blocked). Cabin crew member no 1 and one of the passengers were found dead just behind the cockpit door.

Figure 32: Position<sup>26</sup> in the aircraft, degree of injury and accessible emergency exits

- 2.3.3.4 Information from the survivors indicates that the evacuation of the aircraft started immediately. The position of the door handle on the right forward door shows that someone had tried to open the door. This was unsuccessful because the door was blocked by the terrain outside. The left forward door could not be opened either, when the commander tried it. There are grounds for supposing that problems with opening the cabin doors, in combination with the early outbreak of fire at the forward end of the cabin, explains why all those who died were sitting in the forward half of the cabin (see Figure 32).

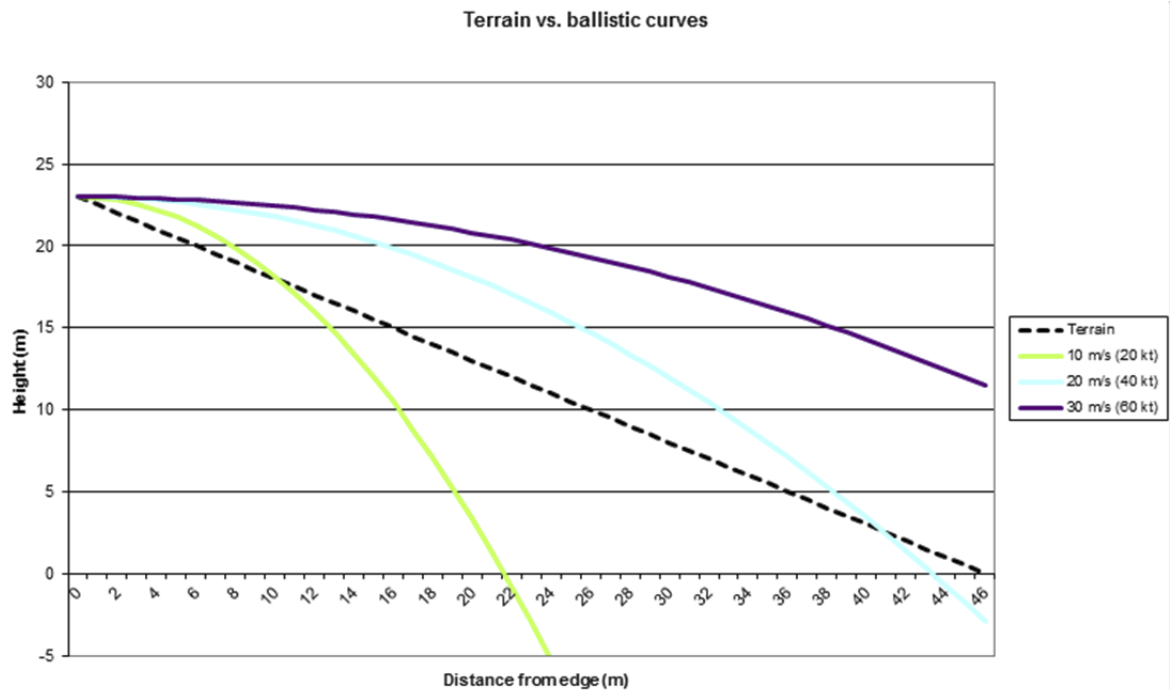
Figure 37: Graphical portrayal of the slope seen in relation to the aircraft's ballistic curve at different speeds.

- 2.2.2.2 On the way down the slope the wheel doors and later the outer starboard engine (engine no 4) were ripped off. The starboard wing sustained several cuts as it pulled down trees and the approach lighting. It is probable that the aircraft maintained its speed down the slope and that it was still travelling at a relatively high speed when its nose encountered rising ground. The collision deformed the nose section and distortions arose that jammed the door between the cabin and the cockpit.

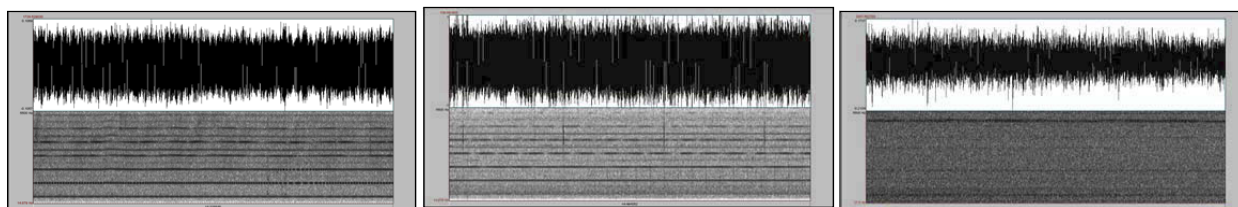
**Figure 1** From left to right: 2 x BAe 146 and Avro RJ85

In general, the BAe 146 aircraft type was found to be noisier than Avro RJ85. This may be because of differences in gyro- or inverter systems etc. In Figure 1 there are oscillograms and spectrograms of two BAe 146 and one Avro RJ85. Figure 2 presents the differences in FFT-spectra.

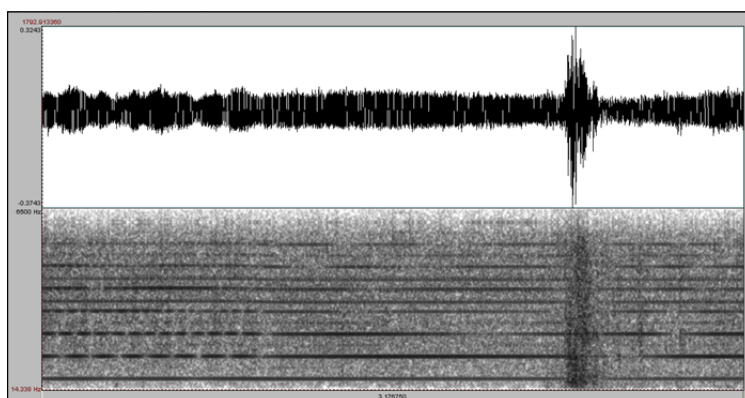
The sounds of OY-CRG landing gears were compared to one BAe 146 landing and four landings performed by two different Avro RJ85. The landing sounds of OY-CRG (Figure 3) had similar features as the sounds of Avro RJ85 (best match) performing a hard landing (Figure 4). In general, the touchdown of a nose landing gear is the most prominent sound. This sound masks the other sounds coming from the main landing gear when touching down at the same time or right after the nose landing gear.

**Figure 3** The landing of OY-CRG

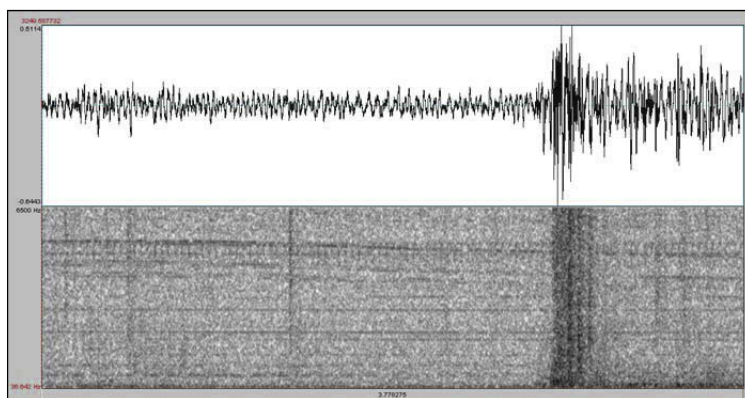
**Figure 4** The landing of Avro RJ85

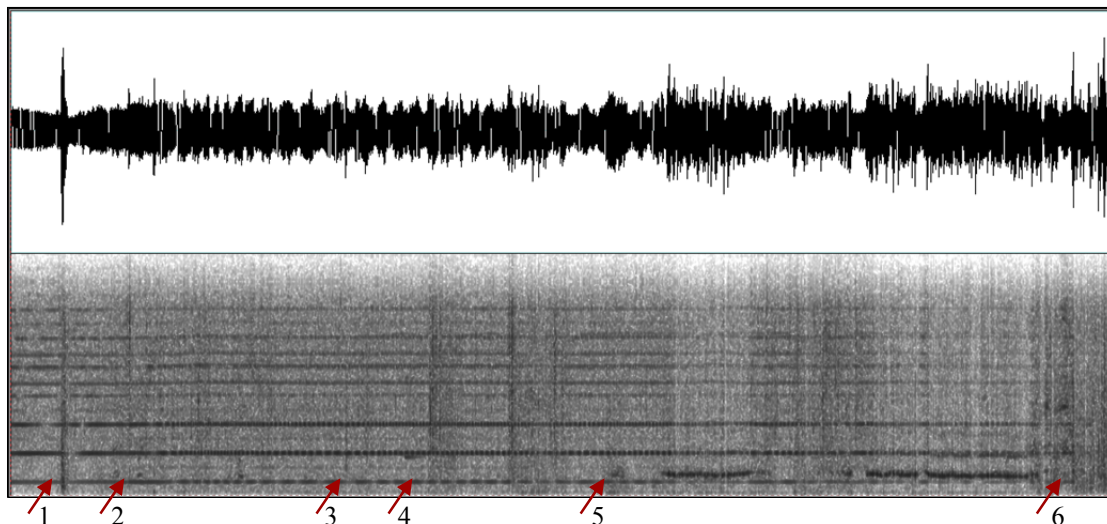
**Figure 5** See table 2 for explanations

The times and durations of following events were analyzed from the CVR material. The number correspondent to each event presented in Table 2 is marked into oscillogram and spectrogram in Figure 5. Detailed description of analysis, references and comparisons are presented further.

An attempt was made to correlate the squawking sounds to the variations of the runway surfaces. No clear correlation was found.

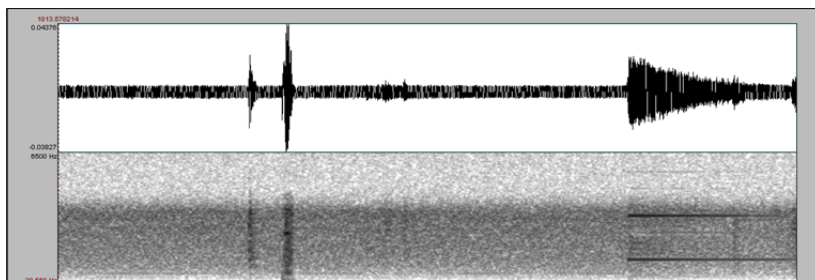
The brake system was selected 6,6 seconds after the touchdown. The sound of the selection is audible and visible in the oscillograms and spectrograms in all three occupied channels (Figures 6a, b and c). However the sound of selection is accompanied with a snap in captain's and co-pilot's channels. This snap is not present in Area channel recording. It is probable that the snap on Captain's and First Officer's recordings is electrically induced.

**Figure 6a** Brake system selection accompanied with a snap in Captain's channel recording

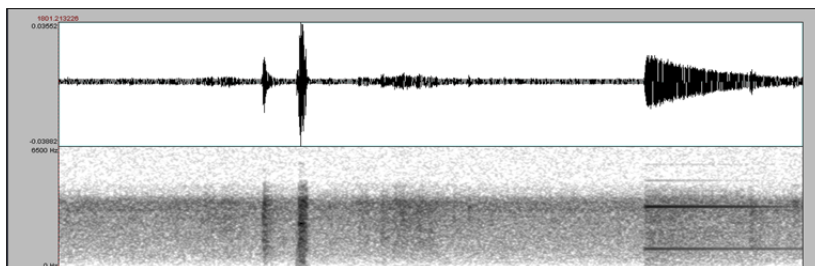
**Figure 6b** Brake system selection accompanied with a snap in Co-pilot's channel recording

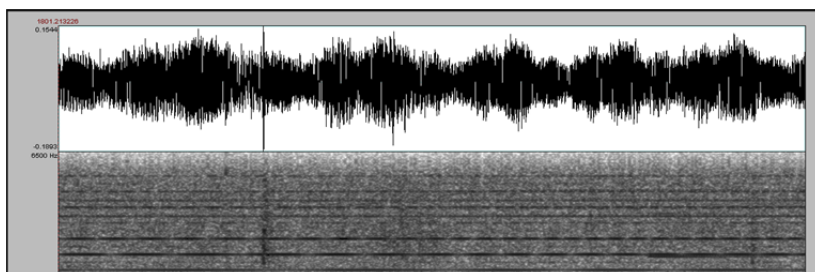
**Figure 6c** Brake system selection in Area channel recording

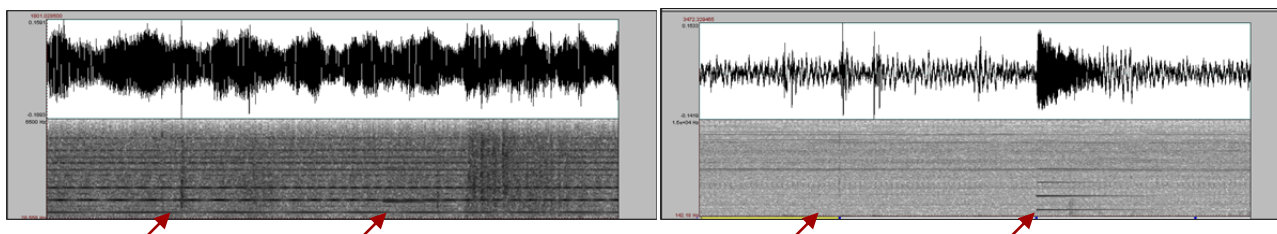
A comparison was made to identify and specify the time from the selection of brake system to the appearance of a single chime. In the Figure 7 the sound of selection and chime of OY-CRG (left) and brake system selection and chime of Avro RJ85 (right) are marked with red arrows. According the times presented in Table 4, the selector sound found in the OY-CRG Area channel recording can be identified as a sound of brake system selection. The chime after brake system selection is followed by a chime to warn about the consequences of this selection to the anti-skid system.

**Figure 7** Brake system selection and chime of OY-CRG (left) and Avro RJ85 (right)

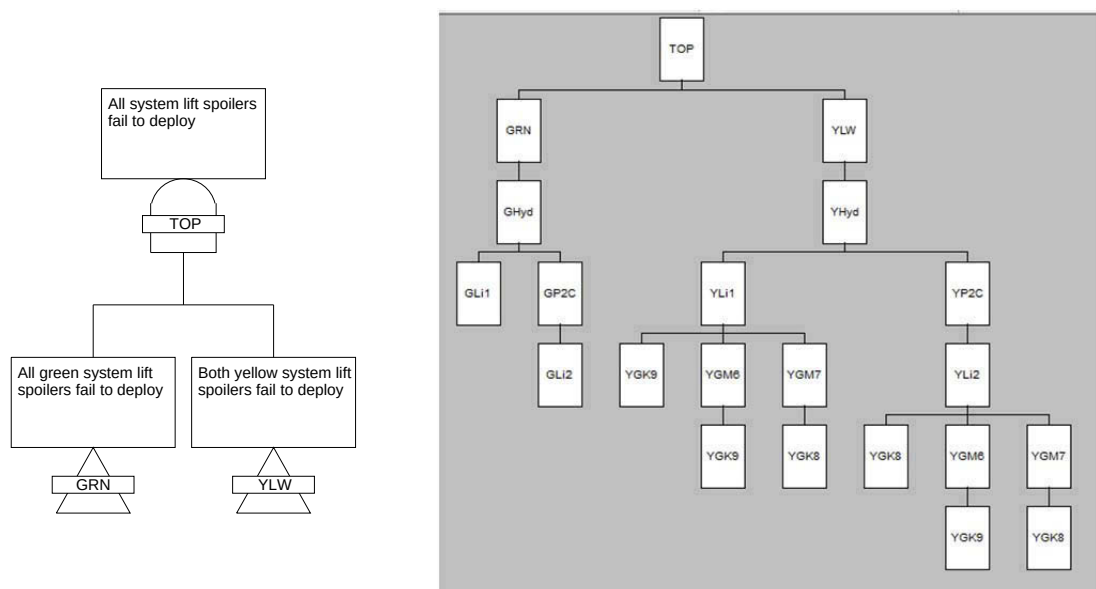
The fault tree consists of 81 basic events (see Appendix C) linked together. The top-event at system level is the failure of all lift spoilers. The fault tree has two distinct sub-systems: green and yellow. The fault tree indicates that the yellow spoiler system is more complicated than the green spoiler system.

Minimal cut sets of order 1 at system level were identified by the CARA-FaultTree program. Only one minimal cut set of order 1 was found: *Mechanical (linkage) failure of air brake/lift spoiler lever*. Thus, this basic event constitutes a common single failure of both green and yellow systems.
