Final report RL 2012: 07e

**Serious incident on 5 February 2011 with
the aircraft D-ABGQ at Arlanda airport,
Stockholm County.**

Case L-08/11
2012-03-05

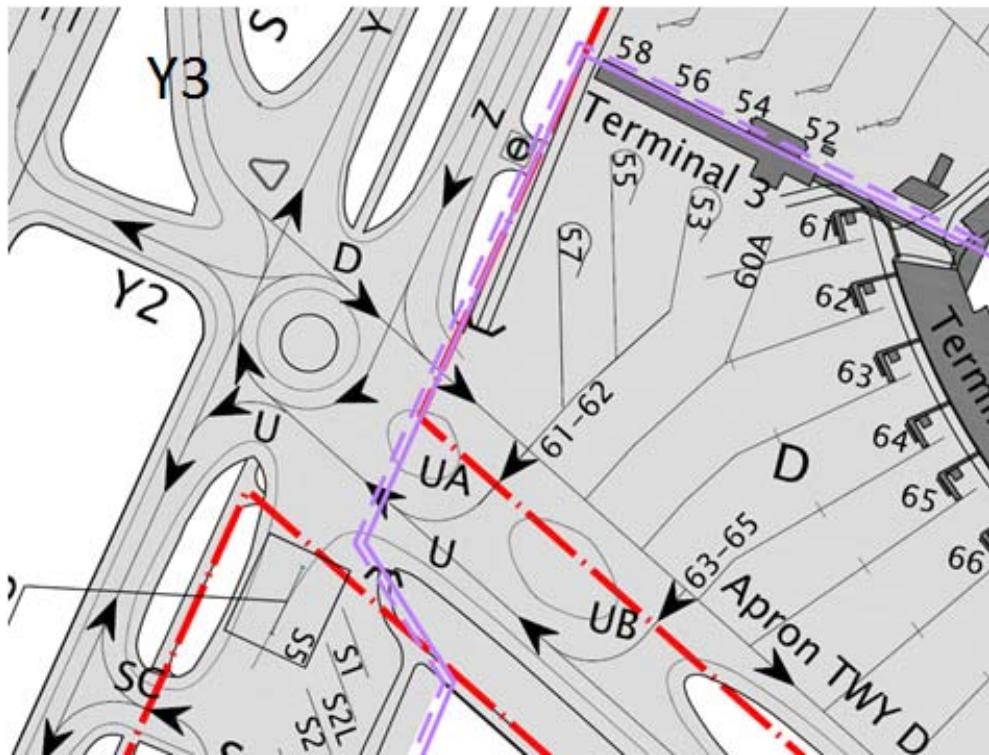
Fig. 2 Excerpts from AIP Sweden/Sweden with published taxi routes (black arrows) for outbound aircraft.

Taxi routes for outbound aircraft are published in AIP Sweden/Sweden on page AD 2-ESSA-2-8 (see fig. 2). The published taxiway out from stand 66 is UC, which is followed by a right turn out onto U and later a right onto Y. Taxiway Y then continues parallel to runway 01L/19R to the holding position 19R.

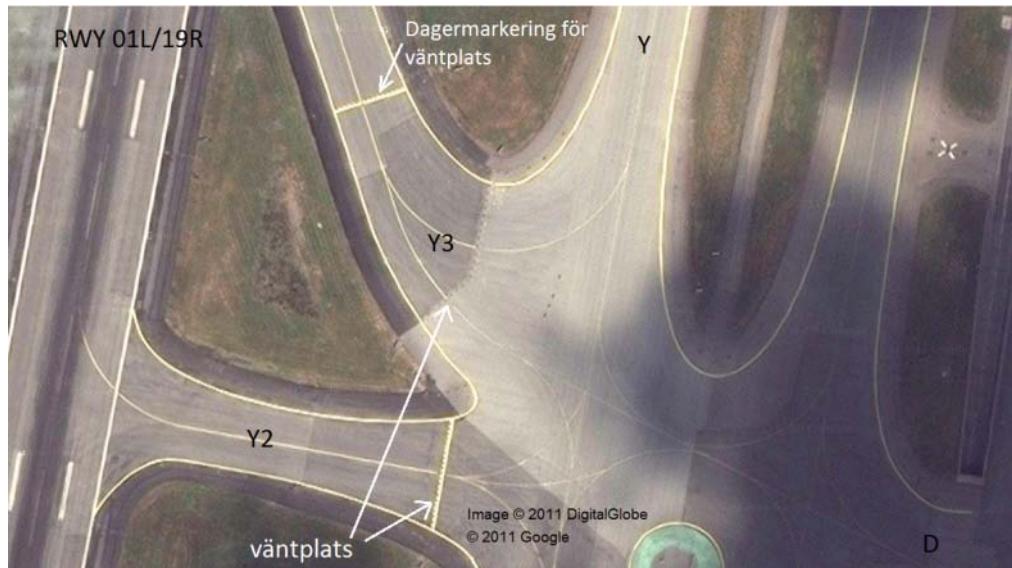
Fig. 3 Google Earth 07/10/2011. The photograph was taken on 06/06/2010.
