Transportation Safety Board
of Canada

AVIATION INVESTIGATION REPORT
A10A0032

RUNWAY EXCURSION

**CARGOJET AIRWAYS LTD.
BOEING 727-225, C-GCJZ
MONCTON, NEW BRUNSWICK
24 MARCH 2010**

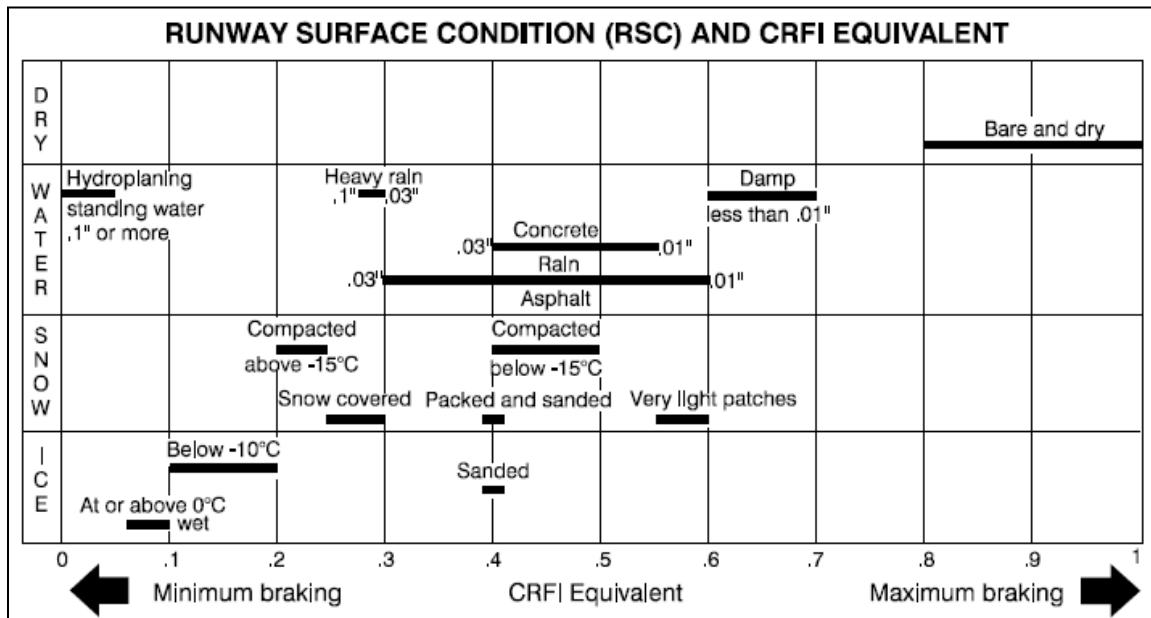
Figure 1. RSC and CRFI Equivalent Chart - prior to 27 October 2005 (values for water)

On 27 October 2005, the AIM replaced the *Aeronautical Information Publication* (AIP). Prior to the issue of the AIM, the AIP included CRFI equivalents for wet runways, and various intensities of rain (See Appendix H, figure 1). In the 27 October 2005 issue of the AIM, reference to CRFI equivalents for water-related conditions was removed (see Appendix H, figure 2). The ‘explanation of changes’ record in the AIM issued 25 October 2005 provided no reason for the removal of these water-related CRFI values. Instead, the ‘explanation of changes’ indicated that additional information had been added to the RSC and CRFI section, and that Tables 4 a) and 4 b) replaced table 4. TC has indicated that the removal of rain from this table came about as a result of a 2004 TC document entitled *TP 14498E – Friction Coefficients for Various Winter Surfaces*. TP14498E questioned the accuracy of CRFI values for water, and recommended that “no CRFIs should be given for wet as this is speed-dependent.”⁶⁰ Despite the removal of wet runway friction values from the CRFI equivalent table, the AIM states that “the wet condition associated with rain may produce friction values on the order of a CRFI of 0.3 on a poorly maintained or
