Investigation Report

Type of Occurrence:	Serious incident
Date:	5 January 2009
Location:	Stuttgart Airport
Aircraft:	Transport aircraft
Manufacturer / Model:	Embraer EMB-145
Injuries to Persons:	No injuries
Damage to Aircraft:	Minor damage to airplane
Other Damage:	Minor damage to the airfield lighting
Source of Information:	Investigation by BFU staff
State File Number:	BFU EX001-09

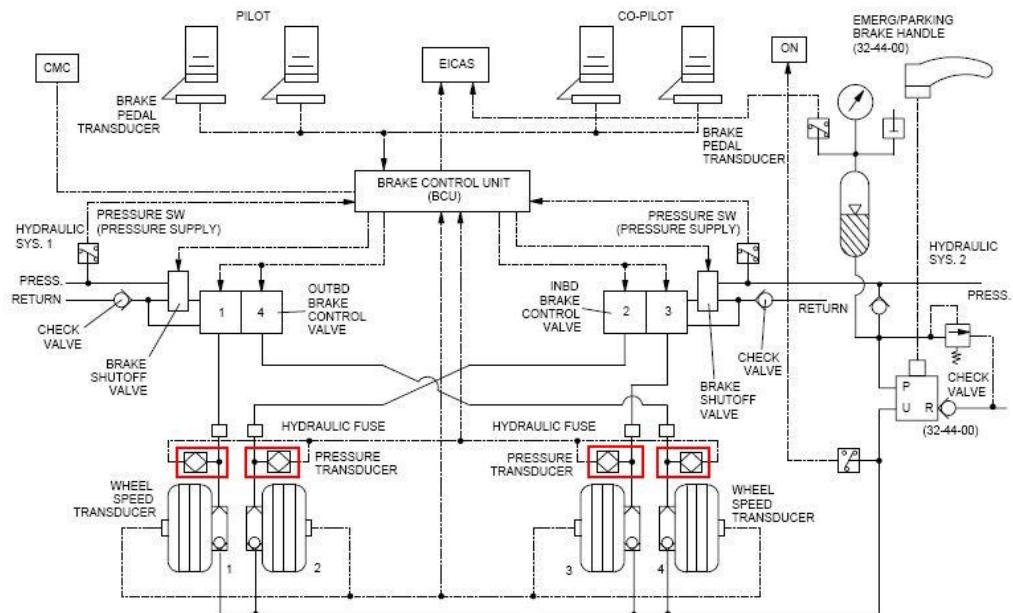
Brake system diagram

- The braking action information in the ATIS did not correspond any longer to the prevailing conditions on the runway at the time of the incident.
- The copilot actuated the emergency brake at the end of the rollout distance. Thus the anti-skid system was deactivated.
