AAIS Case Reference: 06/2012

SERIOUS INCIDENT INVESTIGATION REPORT

Runway Incursion

Dubai International Airport
United Arab Emirates
20th March 2012

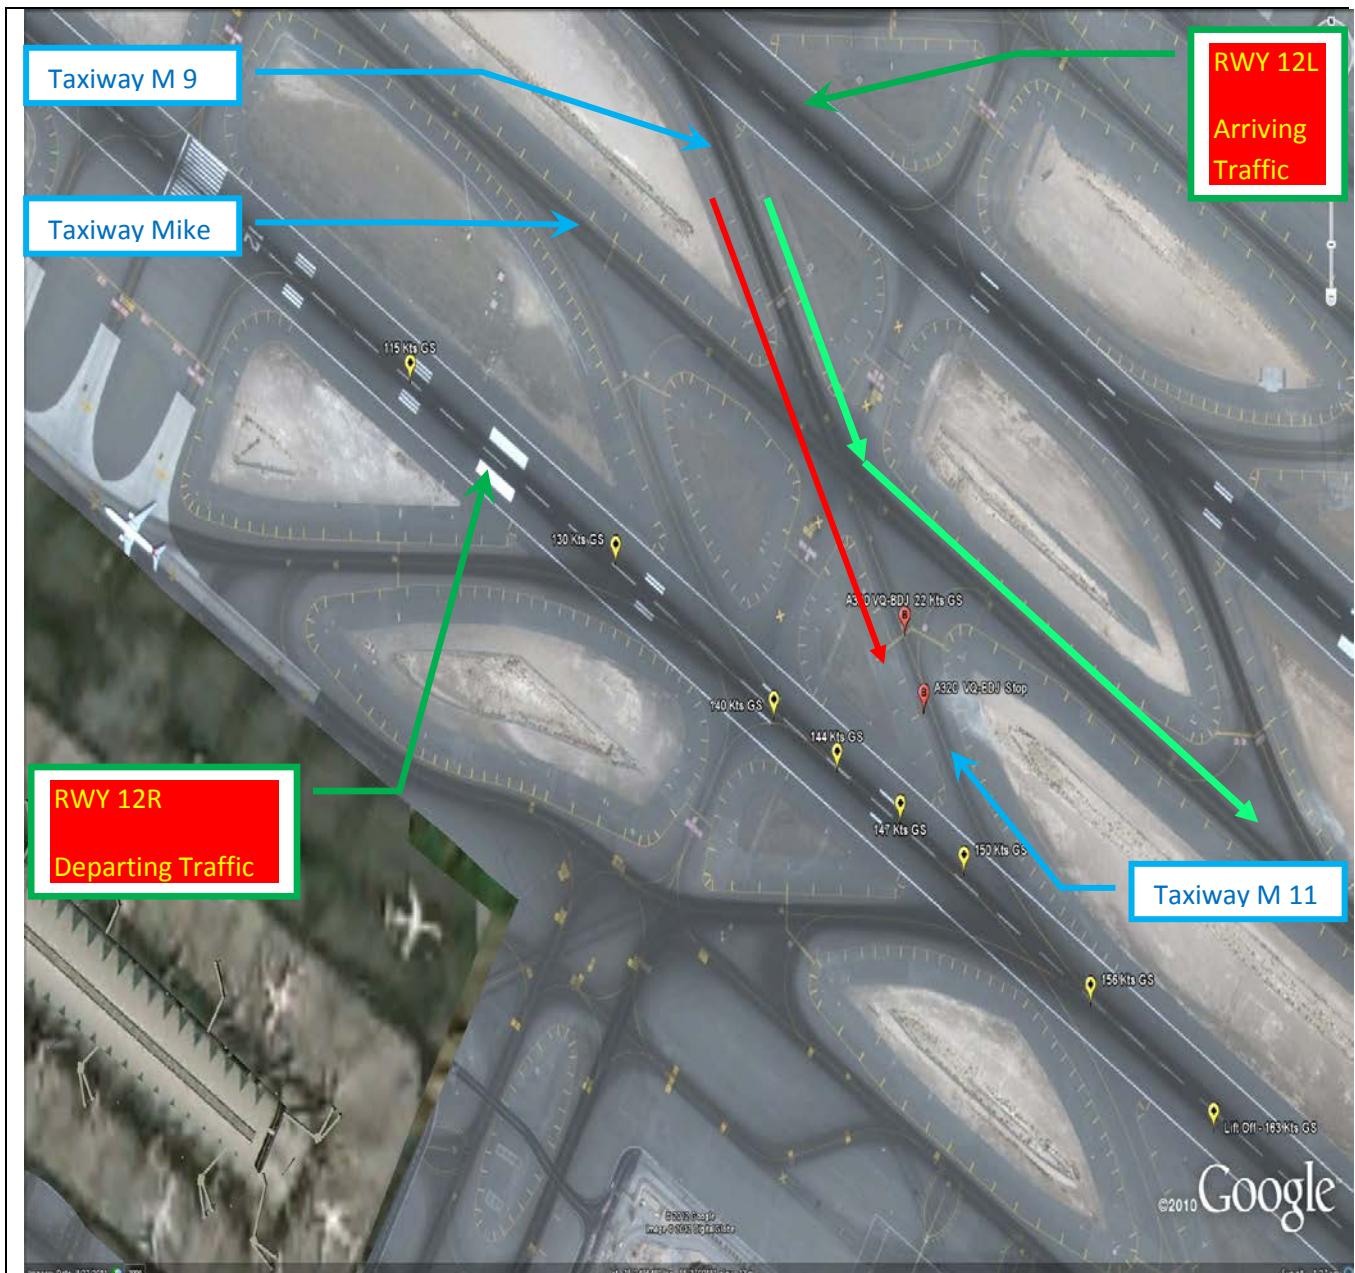
Image 1

Dubai International Airport

Dubai International Airport (see image 1) has two parallel runways and taxiways have respective signs. (see photos 1, 2 and 3 which were taken a day after the occurrence. At the time the photographs were taken the visibility was reported as 3000m).
