Approach above glide path, interception of ILS sidelobe signal, increase in pitch angle commanded by autopilot

Aircraft	Airbus A340-300 registered F-GLZU
Date and time	13 March 2012 at 04 h 50 ⁽¹⁾
Operator	Air France
Place	On approach to Paris Charles de Gaulle Airport (95)
Type of flight	International public transport of passengers
Persons on board	Captain (PF) Co-pilot (PNF)
Consequences and damage	None

This is a courtesy translation by the BEA of the Final Report on the Safety Investigation. As accurate as the translation may be, the original text in French is the work of reference.

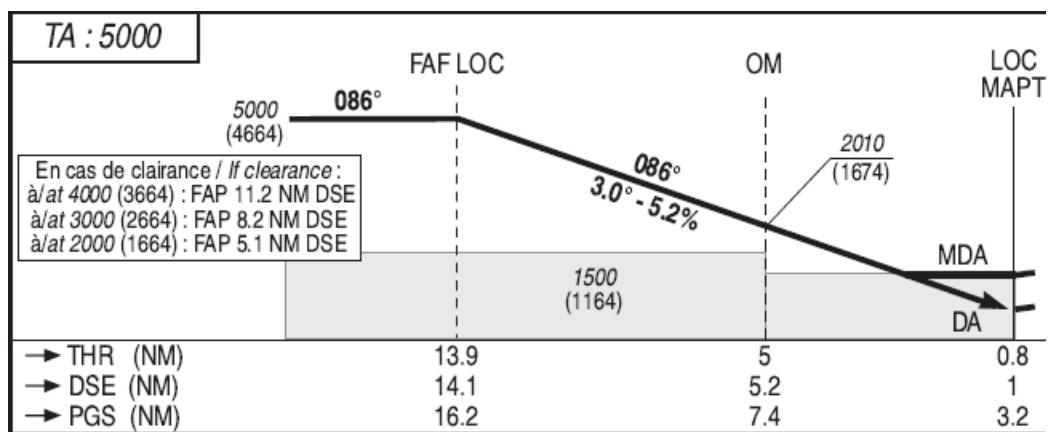
Figure 2: Extract from the AIP approach chart

The ILS CATIII RWY 08R AIP approach chart for 8 March 2012 defined the FAP position according to the clearance altitude given by the controller in the following way:

- At 5,000 ft, the FAP is about 14 NM from the runway threshold;
- At 4,000 ft, the FAP is about 11 NM from the runway threshold;
- At 3,000 ft, the FAP is about 8 NM from the runway threshold;
- At 2,000 ft, the FAP is about 5 NM from the runway threshold.

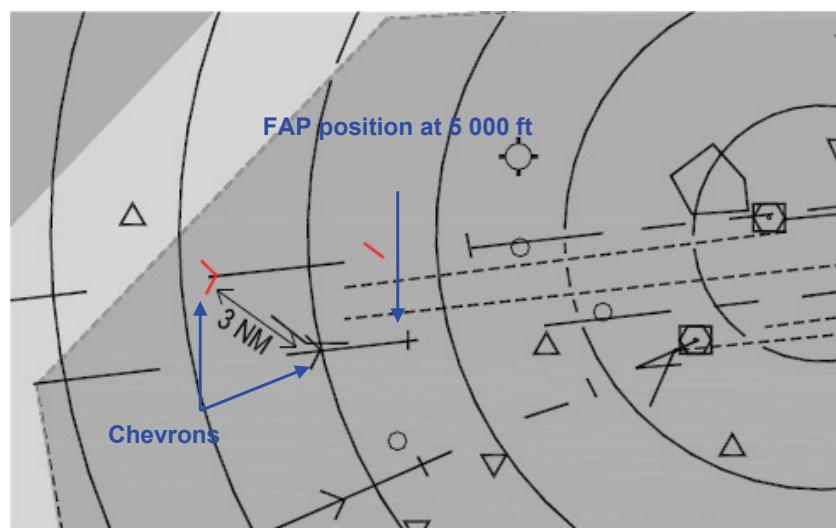
Figure 3: Visual reference points on the radar screen

The aeroplane should intercept the LOC signal at the chevrons and at the FAP altitude indicated on the diagram below (from the operations manual) so that interception is correct.

The visual reference points are to allow levelling off before final descent (standard approach) and to ensure aircraft separation in the event of simultaneous approaches.

In order to favour a stabilised approach, the controller has visual reference points on the radar screen. These reference points are placed at the recommended altitude for glide path interception on the approach chart. If the controller gives an interception clearance at a lower altitude, he no longer has these reference points and can no longer estimate the deviation of the aeroplane vertically in relation to the published trajectory.

- **DGAC study the implementation of a system enabling controllers to determine the vertical position of an aircraft in relation to the published glide path. [Recommendation FRAN-2013-007]**
