Final Report

HCLJ510-2012-172

Serious incident to Airbus A319-131
Registration OY-KBR
At Copenhagen Airport, Kastrup (Denmark)
On 21 November 2012

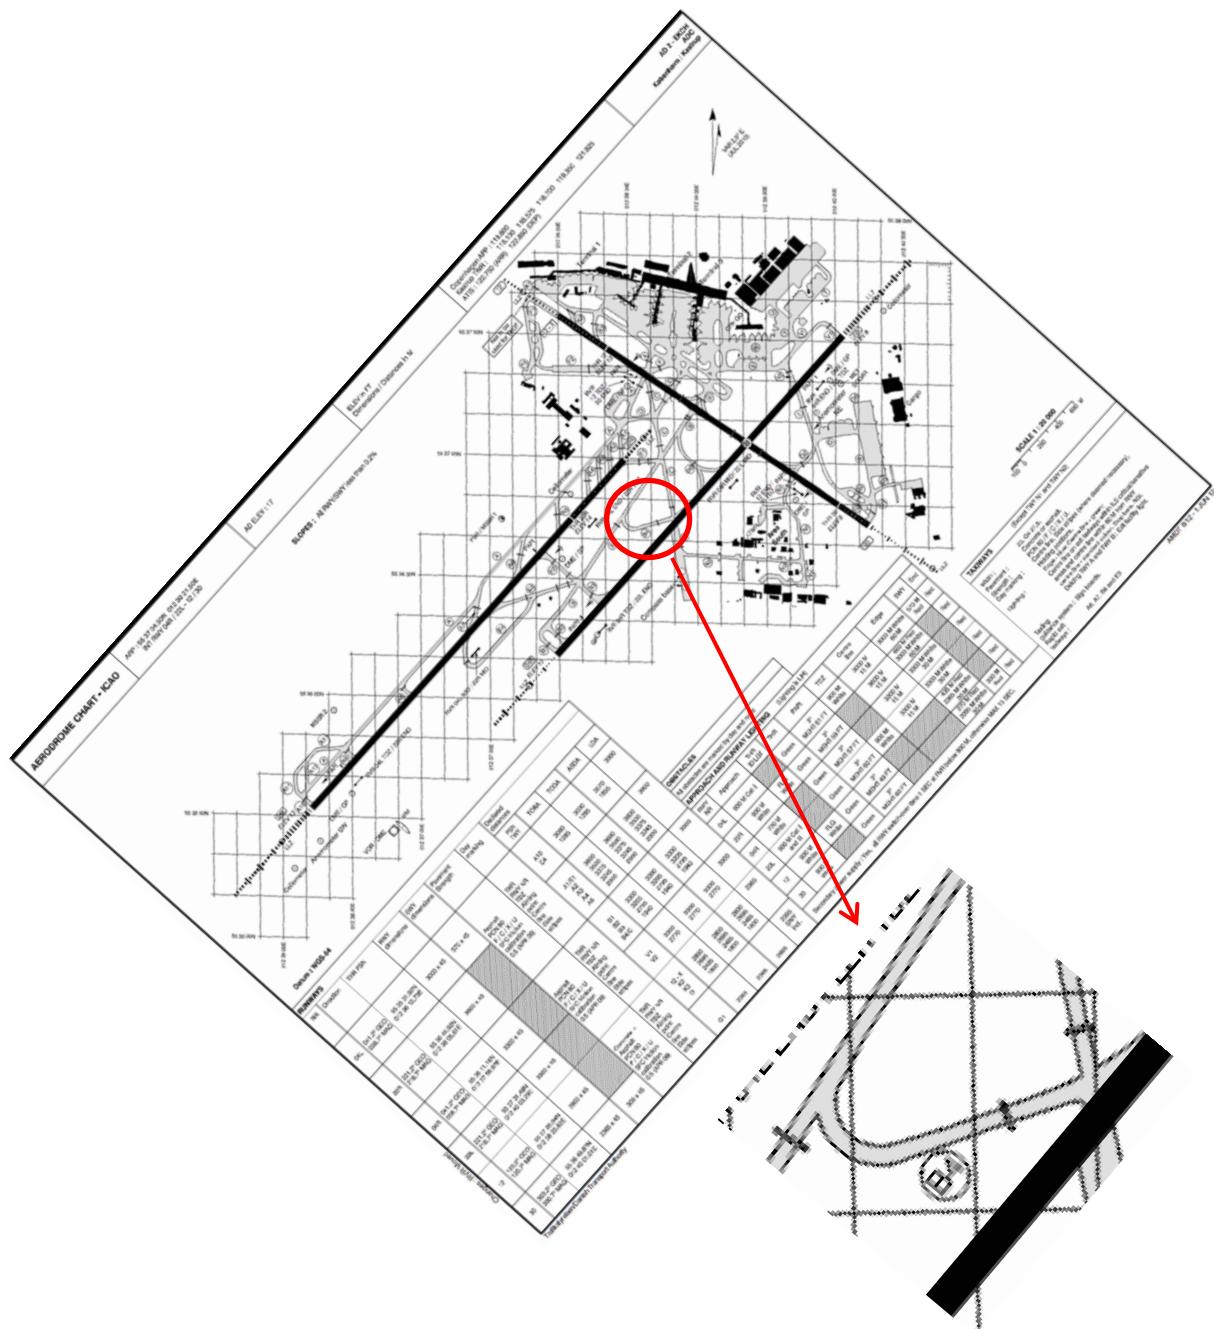
TWY B4 (shown in the red circle) is located 1940 meters from the threshold of RWY 22L.

TWY B4 geometry:

Angle of the turn-off curve:	30°
Radius of the turn-off curve (R):	543 meter
Straight part:	226 meter
Angle of the curved end:	142°
Radius of the curved end (R):	76 meters

"RWY 22L leaving rapid exit TWY B4, the curved end of TWY B4 is designed for a max 15 knots in dry conditions only. Hotspot chart will be issued SAP in AIP Denmark, AD2-EKCH-ADC".
