**Air Accidents Investigation Branch**

**Report on the accident to  
Eurocopter EC225 LP Super Puma, G-REDU  
near the Eastern Trough Area Project (ETAP)  
Central Production Facility Platform  
in the North Sea  
on 18 February 2009**

Published 14 September 2011

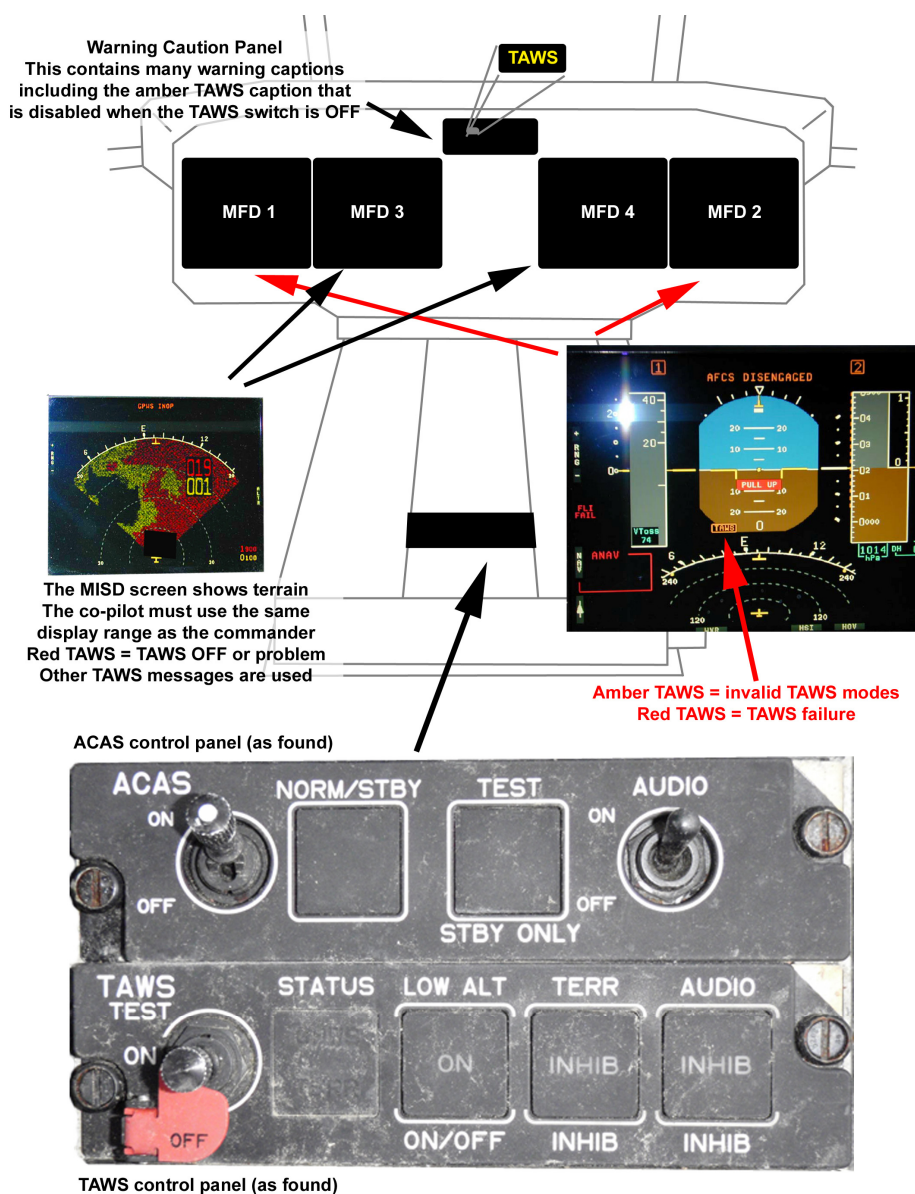
**Figure 4**

TAWS and ACAS control panels and TAWS indications

Figure 4 in Section 1.6.8.1 includes a photograph of the TAWS and ACAS control panels as they were found when the helicopter was recovered from the sea. The control panel switches for both systems were found in the ON position; the TAWS switch guard was in place.

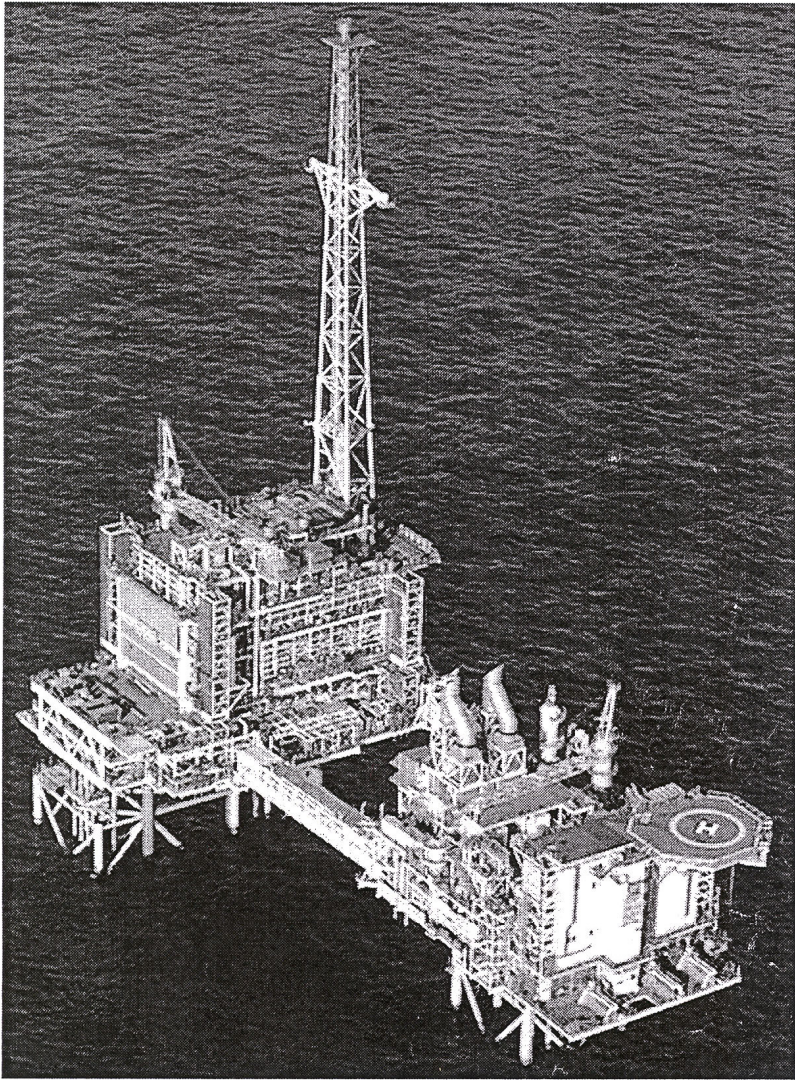
**Figure 5**  
The ETAP platform

The information chart at Figure 5, as used by the crew, did not provide the height of the installation ie the top of the flare stack. Nor did it provide any orientation. The position given is not that of the helideck.

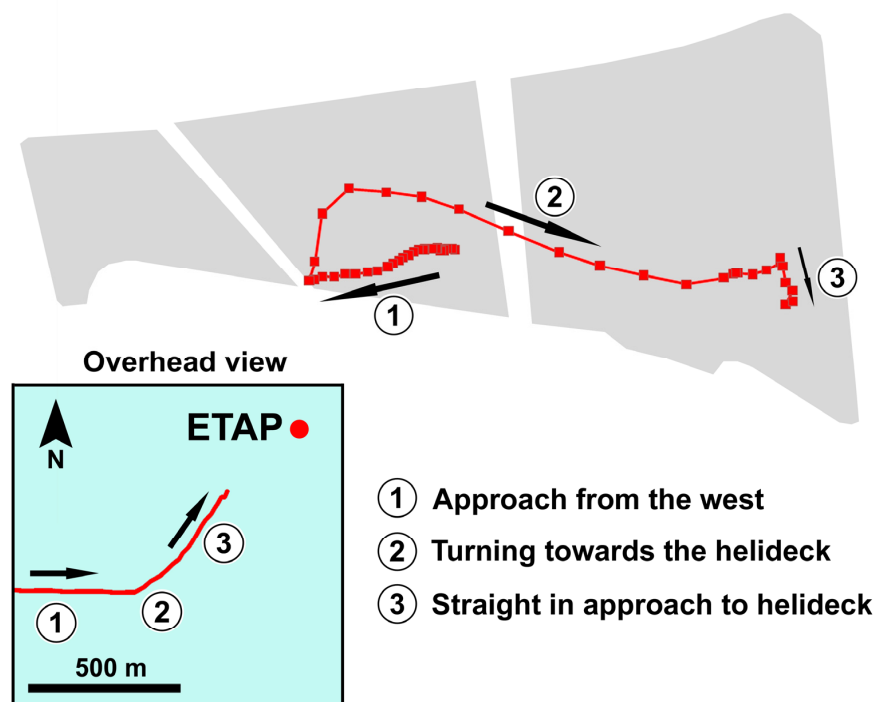
**Figure 6**

The geometric position of the helideck in the cockpit window, as seen from the nominal commander's position, was calculated for the final part (approximately 30 seconds) of the accident flight (see Figure 6). This did not address the issues of compromised visibility due to visual conditions.

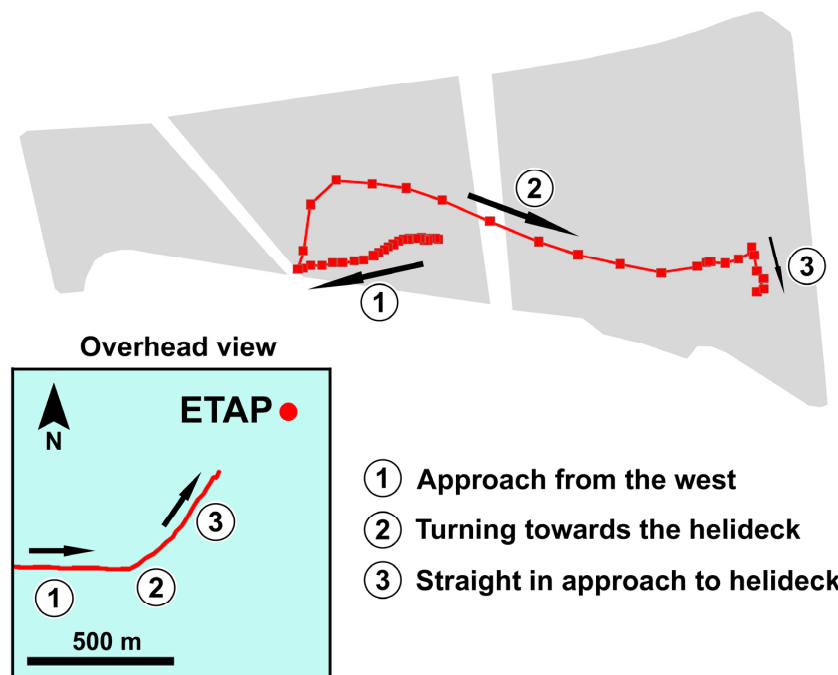
**Figure 16**

Without a visible horizon or good surface texture cues, the apparent position of the platform would have led to the perception that the approach was normal but becoming high and fast in the final 5 seconds before impact. This accords with the commander's impressions. See Figure 16.

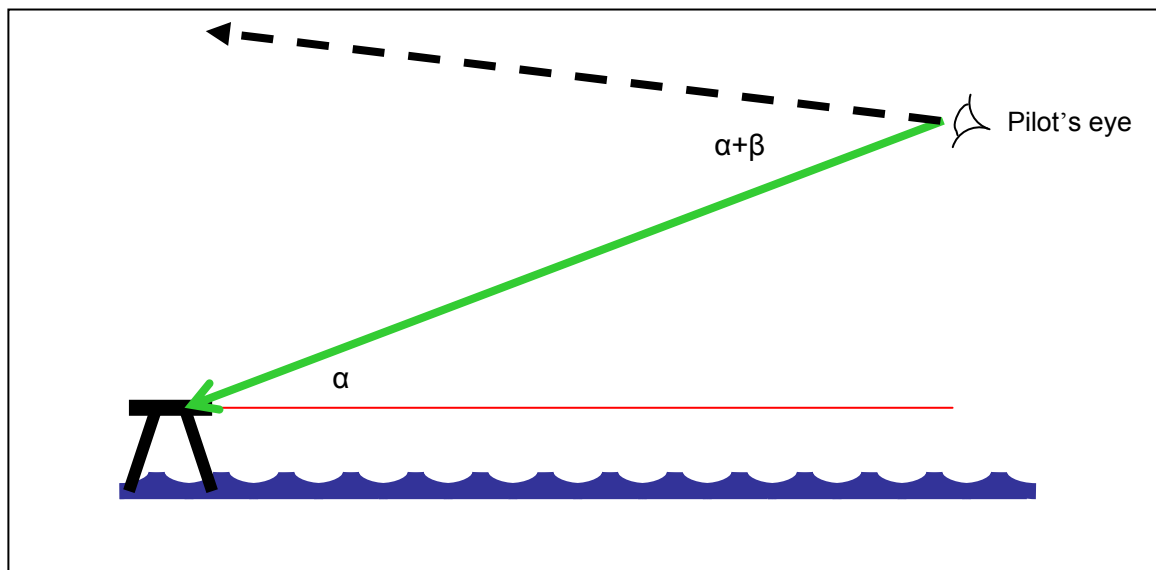
Figure 3

If there is no visible or texturally implied horizon, the possibility arises of a pitch change being misinterpreted as a change in approach angle. In the case represented in Appendix A Figure 3, the perceived approach angle is steeper than the actual approach angle. In addition to the absence of external visual cues defining orientation with respect to the horizontal, this case also requires that the change in pitch angle be undetected by reference to instruments or by non-visual senses.

Misperceived approach geometry

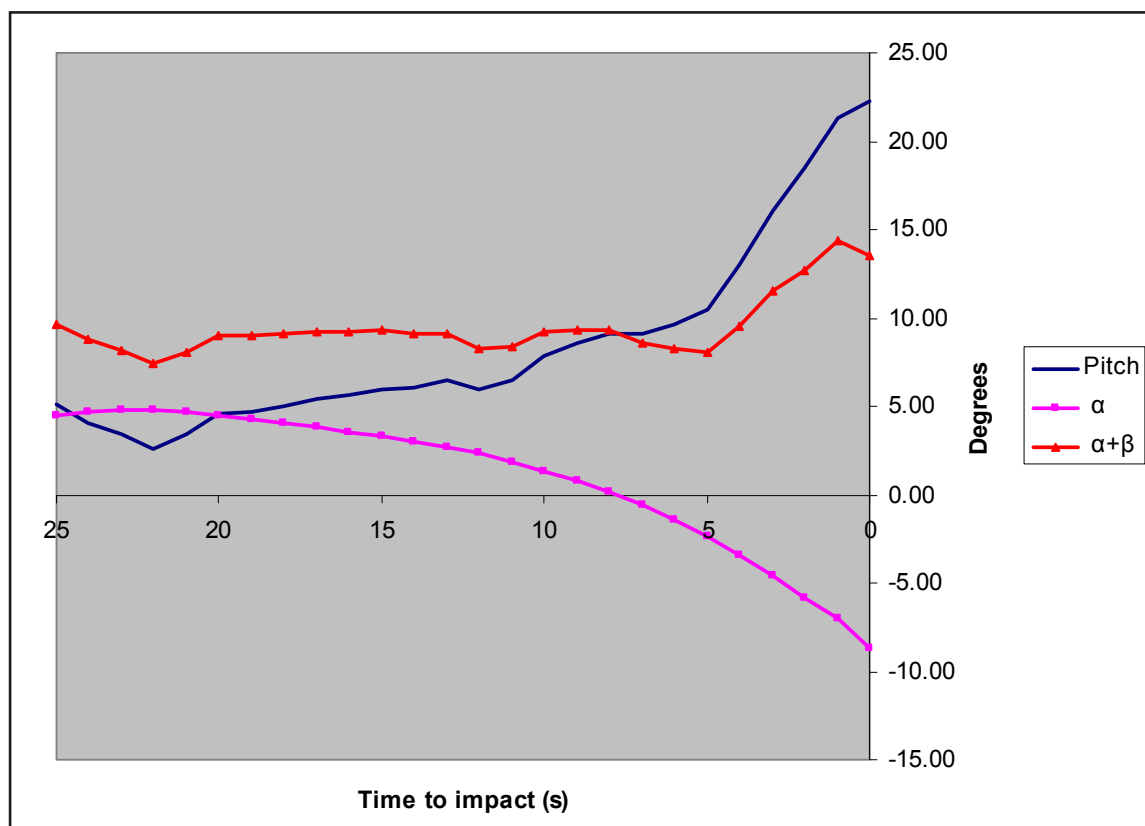
The final approach was conducted in darkness and poor visibility. The possibility of a misperception of this sort warrants consideration. Appendix A Figure 4 is derived from data from the airborne data recorder. It shows that the approach angle to the helideck declined from about I-22s, passing zero at about I-7s, i.e. the helicopter passed below the

The final approach

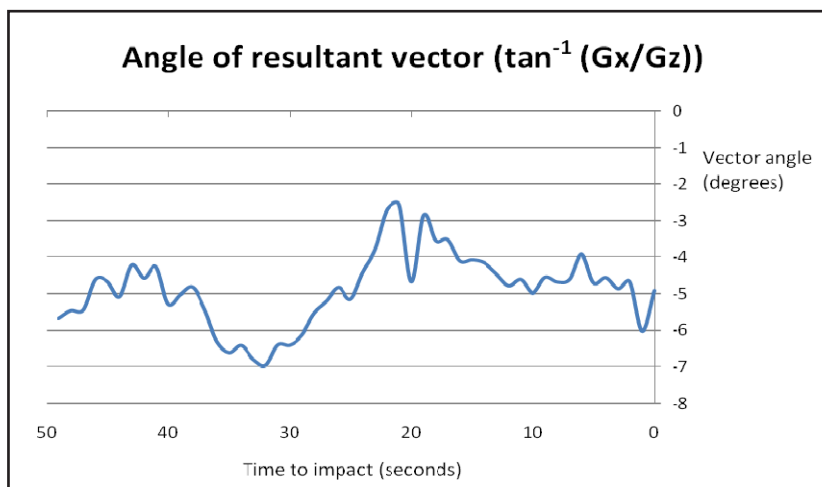
**Figure 4**

It can be observed from the graph of Appendix B Figure 4 that the angle of the resultant force vector varies by little more than  $\pm 2$  degrees from its mean value of -5 degrees. (This mean value of -5 degrees is the same as the offset that it was found necessary to subtract from the recorded pitch attitude of the aircraft.) It is important to note that, despite the increasing pitch up of the aircraft in the final 10s of the record, the direction of the force vector relative to the aircraft is unchanged from that obtained in the first 10s of the record when the aircraft was in level flight. This implies that, from the perceptions derived from the force environment of the aircraft, the aircrew had no reason to think that in the final seconds before impact the aircraft was not in level flight.

Direction of resultant force vector by summation of longitudinal ( $G_x$ ) and aircraft-vertical ( $G_z$ ) accelerations. Small scale fluctuations are probably the result of rounding errors in the flight data records.

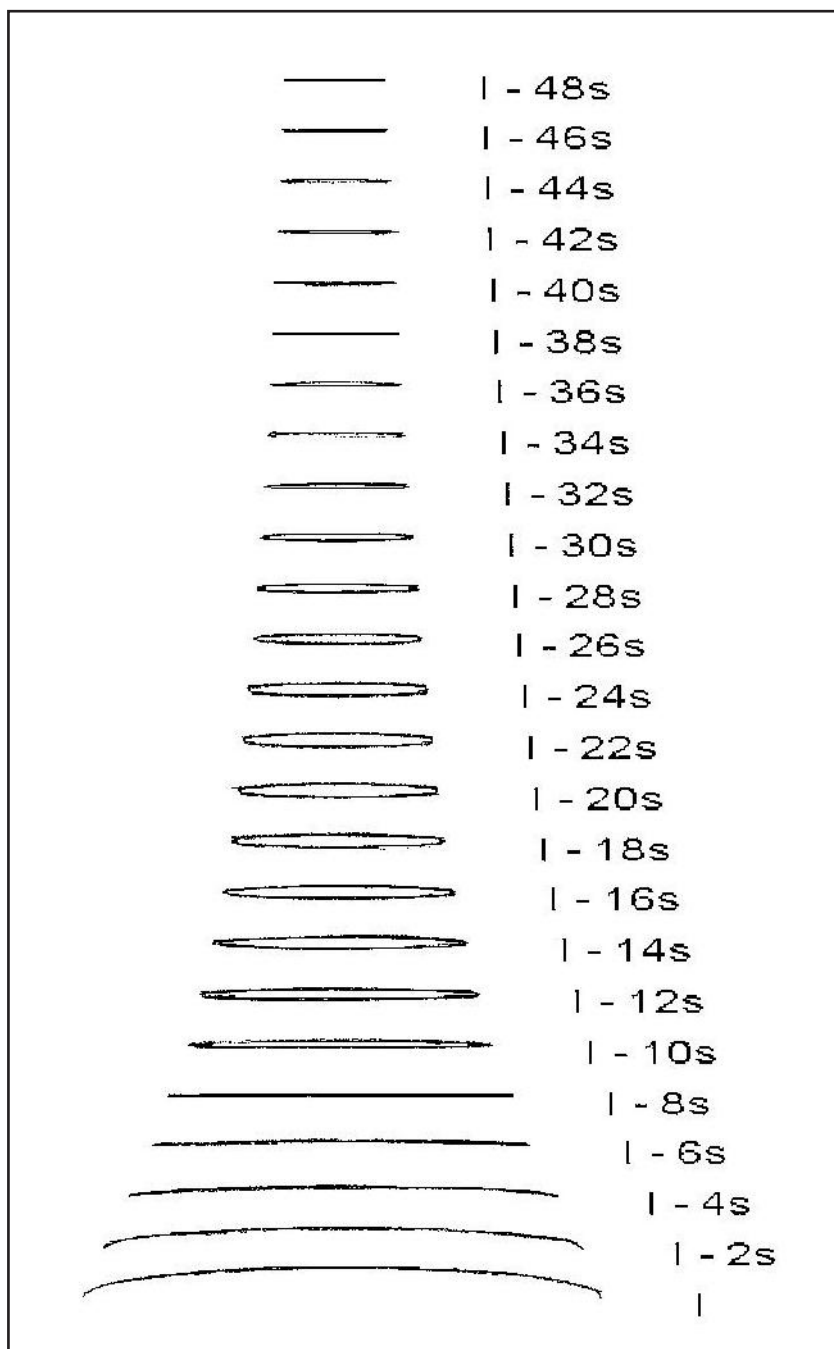
**Figure 5**

A knowledge of the aircraft height above the sea and distance from the platform allows calculation of the glideslope to the helideck. It also enables a calculation of what the crew might have been able to see of the green lights around the periphery of the helideck on the approach to the platform. A sequence at 2s intervals from I-48s of the helideck appearance is shown in Appendix B Figure 5. This shows that the ellipse of lights on the periphery of the helideck would have appeared most 'open' at 20s before impact when the aircraft was turning on to the final approach, some 820m from the platform. From 8s before impact the aircraft was below the height of the helideck and the lights of the further edge of the helideck would no longer have been visible.

The likely appearance of the helideck at 2s intervals from 48s before impact. The side-to-side subtended angle of the helideck is as it would have been seen by the pilots if this figure is viewed at a distance of 70cm from the eye.

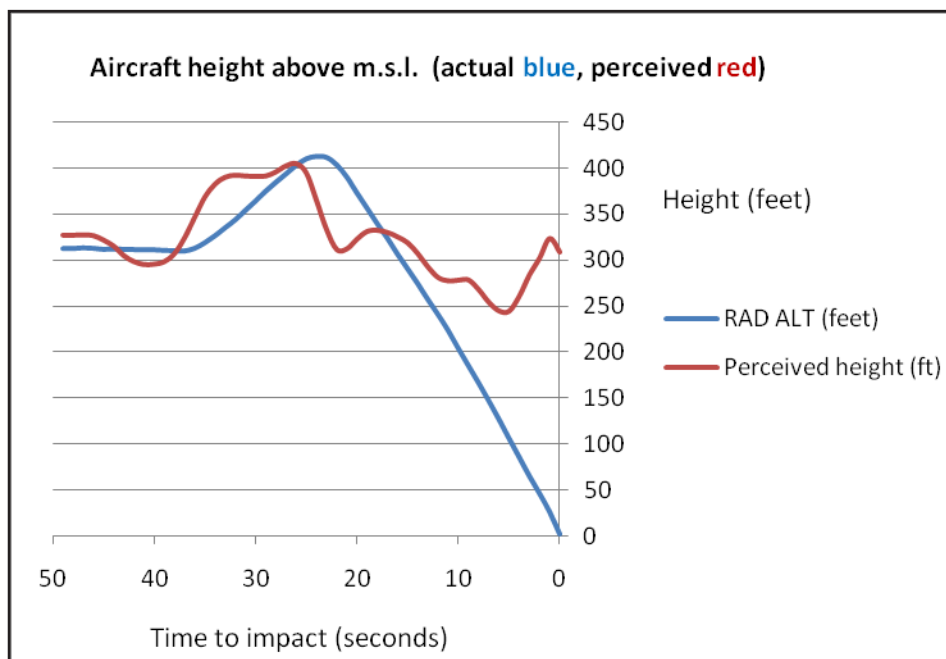
Figure 8

Actual and visually perceived height above sea level.
