## Introduction

# Aircraft Protection, during Washing and Painting

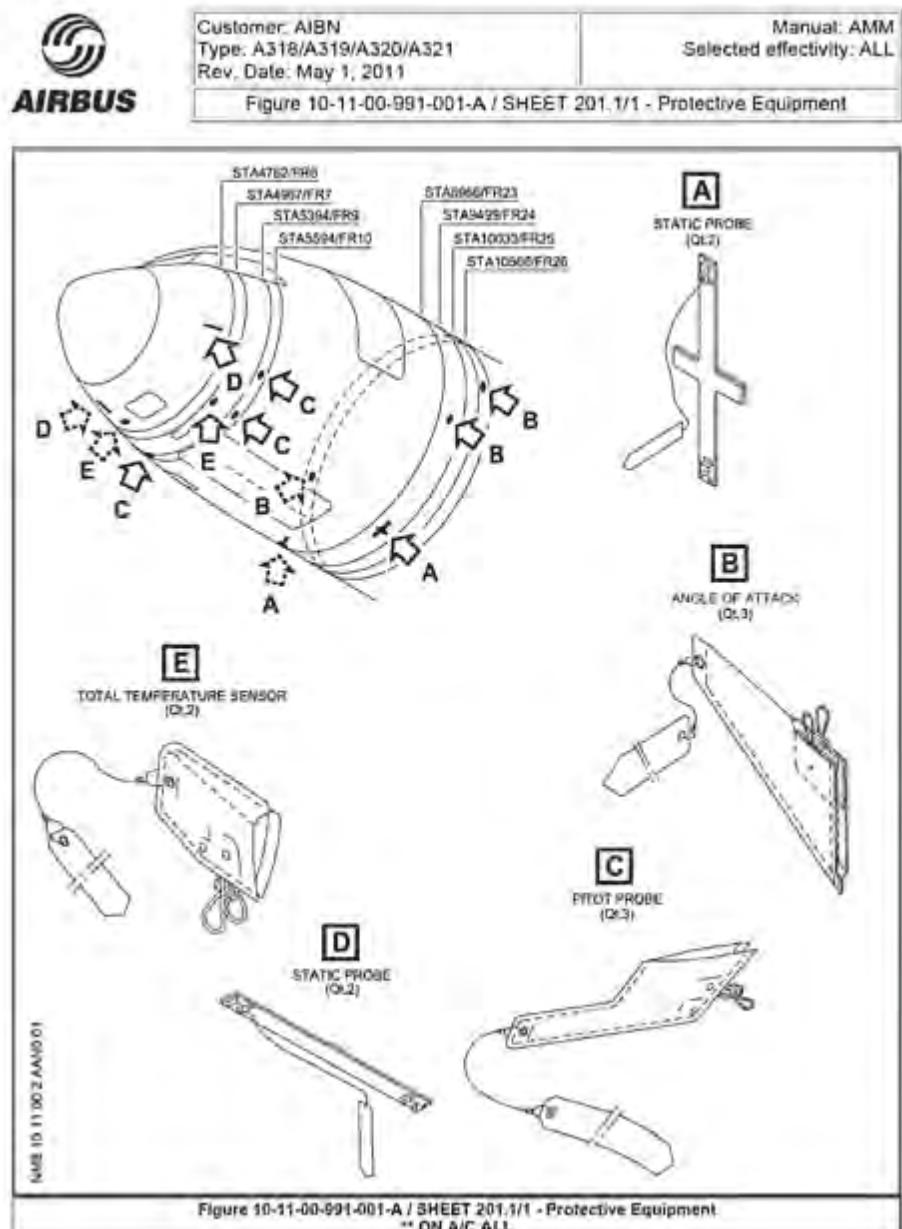
**Figure 4**  
Fig 4: TEM description of the static probe cover

Inadequate protections were applied during aircraft painting in such a way that they were difficult to see from the ground. As a result, they were not removed after the painting job was done.

The transparent plastic was only noticed because of the presence of air bubbles under the film.

Part No.	98D10103500001( FAPE3)
Designation	COVER-STATIC PROBE
Description	This tool is used to blank the static probes. Note: this tool is in the flight kit.
See drawings	98D10103500 COVER STATIC PROBE
References	AMM 10-11-00 AMM 12-21-11 AMM 34-21-00

Chapter 51-75-11 contains recommendations for stripping and paint removal. The SRM provides also cautions in chapter 51-75-12, Repair of Paint Coatings, about the materials, areas and parts affected by the painting activities, which must be properly protected. A caution includes instructions to remove all masking materials upon work completion, with a special attention to pitot heads and static ports.
