LEVEL BUST

Japanese Near Miss

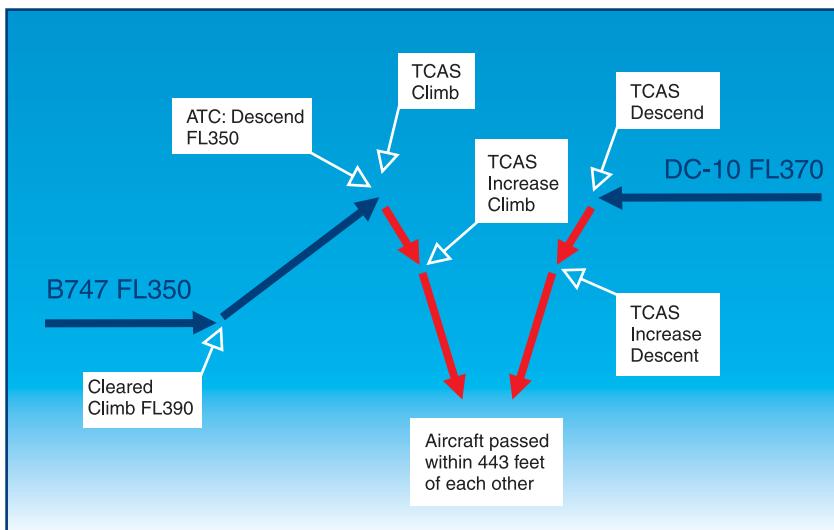
The decision of the B747 captain to follow ATC instructions instead of the TCAS RA was a major cause of this incident. ATC were not informed by either crew that they had received an RA, nor did the DC-10 crew inform ATC that they were following their

the fact that the ATCO and supervisor were in discussion may have distracted their attention from the approaching conflict, which should have been evident from the indications on the radar screen.

RA. This omission increased the uncertainty on the part of the controllers, and the ATCO continued to issue instructions which contradicted the TCAS (although they could not have known that).

Subsequently, ICAO ruled⁸ that pilots must follow TCAS RAs regardless of contrary ATC instructions; if for any reason it is not possible to follow the RA, aircraft must remain level rather than take action in the opposite direction to that indicated by the RA. ICAO also requires pilots to notify ATC as soon as possible.
