**PART 1.1 – COVERING NOTE**

3 Oct 14

**SERVICE INQUIRY INVESTIGATION INTO AN INCIDENT INVOLVING VOYAGER ZZ333  
ON 9 FEB 14**

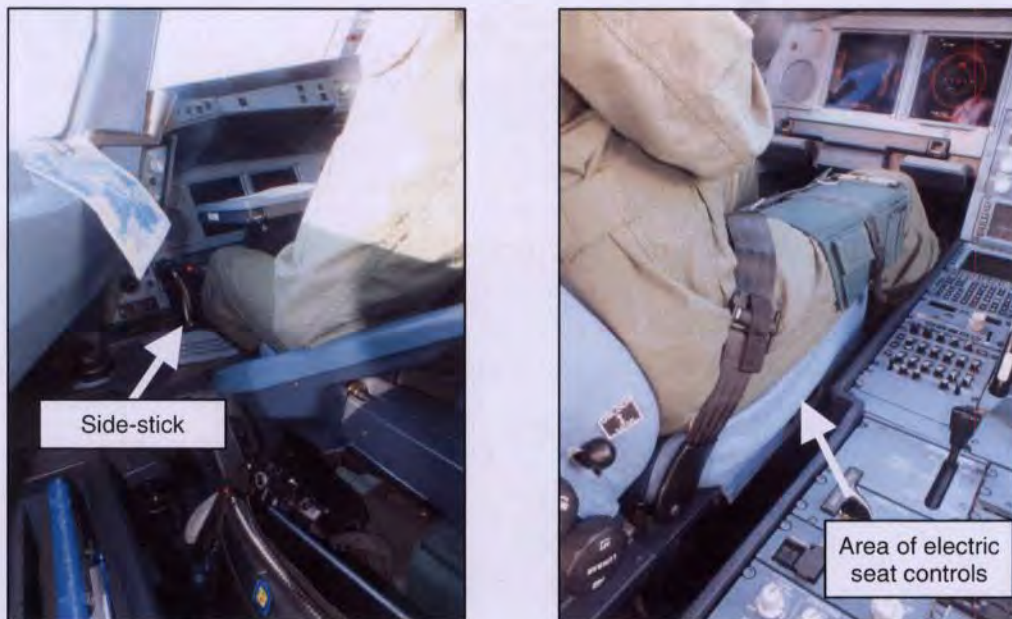
1.4.21 Early analysis of the CVR identified a distinctive noise on the flight deck at one minute and 44 seconds prior to the event, and at the onset of the event itself. Spectral analysis of the noise identified it as the electrical motor used to adjust the flight deck crew seats (identified by its frequency of 1900-2000 Hz). The seats are adjustable by means of a switch which is located on the base of the seat itself. The Captain's seat is on the left-hand side of the flight deck and his adjustment switch is on the bottom right-hand side of the seat (Figure 2). In the two minutes leading up to the event the Captain was the only person present on the flight deck, indicating that the motor noise came from the Captain's seat. There was no evidence that the seat had malfunctioned in flight and functional tests carried out after the event showed that the seat was fully serviceable. It was quite normal for the seat to be adjusted several times during the flight, either for reasons of comfort or for the performing of a specific task. The Captain confirmed that his seat may have moved forward at this time, although he could not specifically recall it.

**Figure 2: Captain's seat position.**

1.4.22 There was an obvious and strong temporal and directional correlation between the seat motor movement and the side-stick movement. The Panel examined the possibility that the movement of the Captain's seat and the Captain's side-stick were connected. For there to have been a direct relationship, the seat and the stick would have to be physically connected, either by the occupant of the seat or by an object (other methods of interference are dealt with in a separate

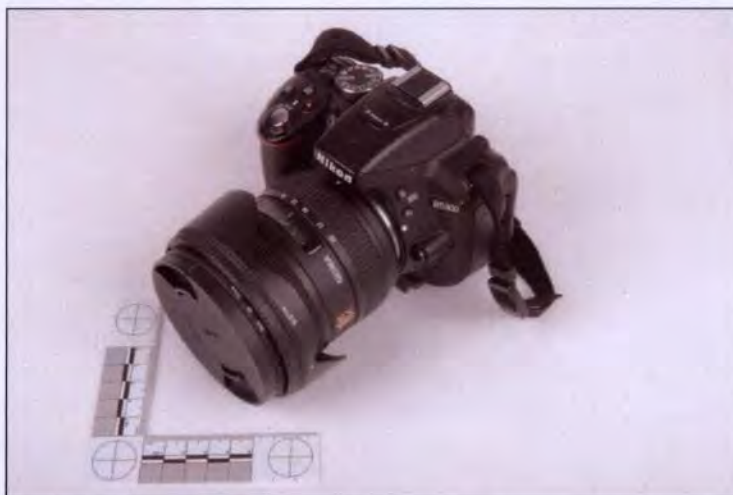
1.4.24 As a result, the Panel's focus turned to the possibility of an object connecting the seat and the side-stick. The Panel collected the official items and personal effects which had been on the flight deck at the time, in order to ascertain which of them could have interfered with the side-stick. In an interview with the Co-pilot, it became evident that a Nikon Digital Single Lens Reflex (D-SLR) D5300 Camera (Figure 3) belonging to the Captain had been present on the flight deck in the minutes leading up to the pitch-down event. Specifically, the camera had been seen by the Co-pilot on the surface area near the base of the Captain's side-stick shortly before the event. He had also seen the Captain using the camera during the flight.

**Figure 3: Nikon D5300 D-SLR camera as received.**

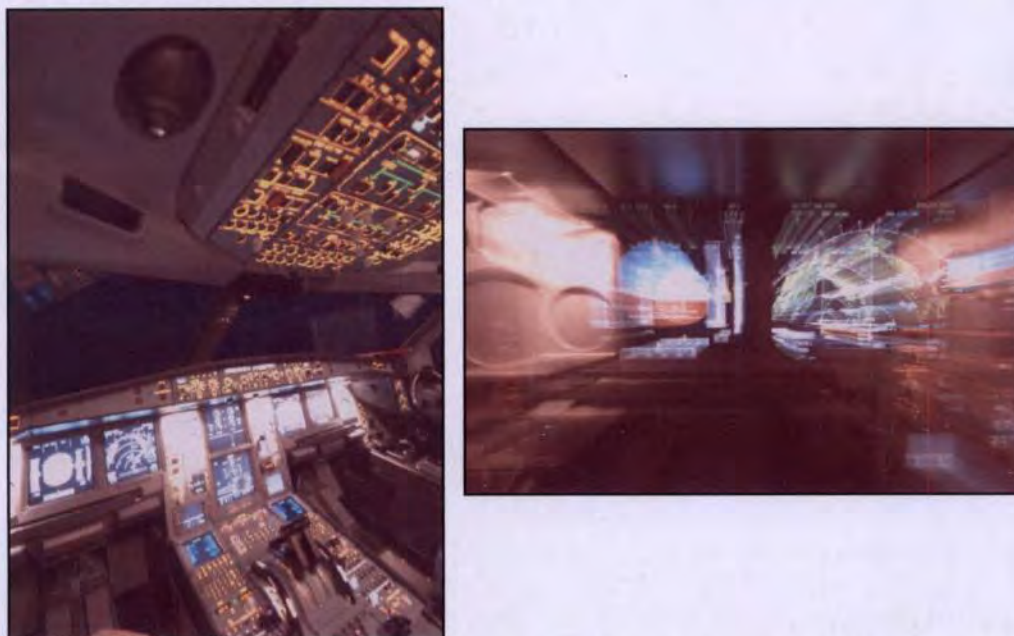
Analysis of [redacted] photographs submitted subsequently by the Captain indicated that 28 photographs were taken during a period of darkness between around eight minutes and three minutes prior to the incident (Figure 4). It was established that, in all, 77 photographs were taken during the flight. In one photograph, the GPS digital clock on the flight deck could be seen, allowing a comparison to be made between the aircraft's internal time measurement and that of the camera.

Figure 4: Sample of 28 photographs taken on flight deck shortly before incident.

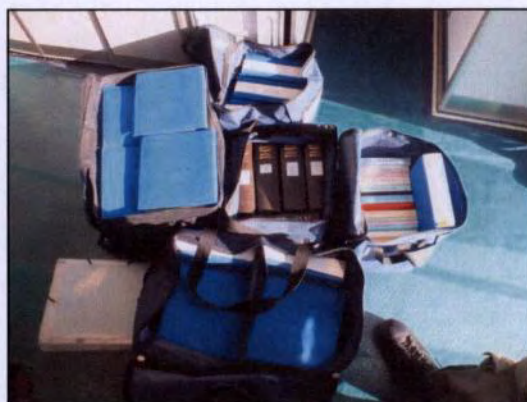
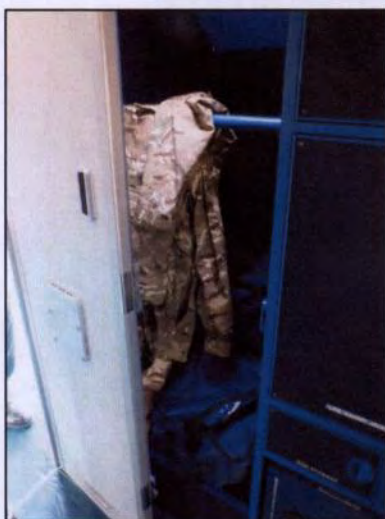
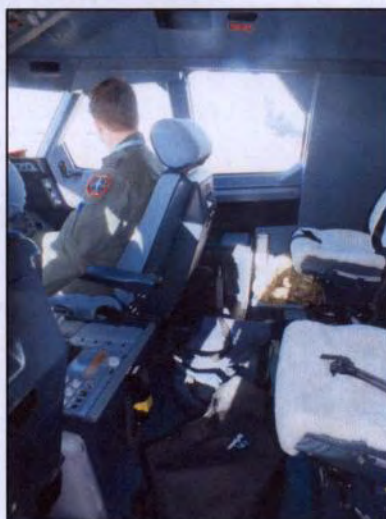
(3) The Panel saw and heard evidence that the issue of loose articles was not, in fact, limited to the C-130 fleet. The C-130 was the only aircraft type at RAF Brize Norton whose engineers were constituted separately (and geographically remotely) from its flying squadrons. As such, some Air Safety staff believed that the issue of loose articles was simply being dealt with more directly on other squadrons where the engineers were embedded, rather than reported officially. Similarly to C-130 crews, Voyager aircrew were required to take a large number of items of equipment on board the aircraft for operational flights. These items included two sets of body armour for each crew member, combat survival waistcoats, crew weapons, aircraft documentation, two route bags, a set of worldwide navigation kit and charts and a bag of classified material. Only some of these items had designated storage, with the rest usually found space around the flight deck; for example, on the floor behind the pilots' seats (Figure 11 and Figure 12). This volume of items was a result of the nature of the tasking and the associated volume of paperwork necessary to support the mission. It is likely that the number of required items on the flight deck promoted an attitude that it was generally acceptable to have a large volume of items on the flight deck, such that the carriage of a small number of personal effects would not have seemed unreasonable. Accordingly, all pilots interviewed on 10 Squadron by RAFCAM reported having a personally acquired tablet computer that they would take with them on the flight to enable access to the large amount of aircraft documentation. It was also considered normal to carry a personal

navigation bag in which items such as clipboards, their tablet computer and additional paperwork would be carried.

**Figure 11: Carriage of in-flight publications.**

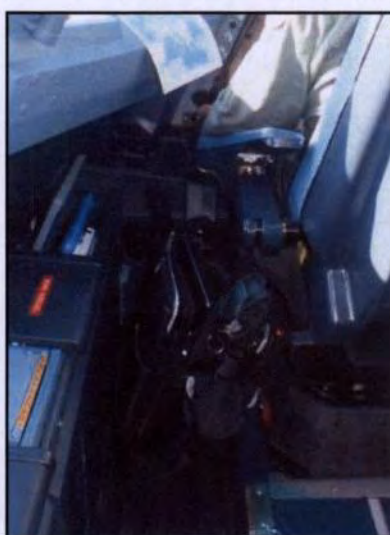
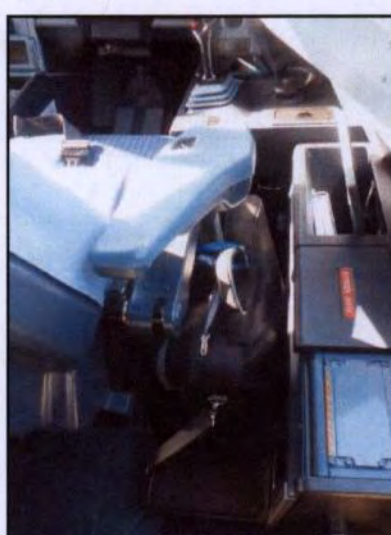
**Figure 12: Floor area around Captain's and Co-pilot's seat.**

(4) On the flight deck of any large aircraft a certain number of loose articles are inevitable if the aircraft is to operate effectively (pens, notebooks, spectacles etc). There was no evidence however, of official guidance or training within 2 Gp which related to the carriage and use of these items and how they should be stored and positioned on the flight deck, increasing the likelihood that personnel would develop their own norms and practices as a result of experience and advice of others. Photographs taken on the flight deck of ZZ333 shortly before the incident indicated that there were a number of loose articles placed in areas around the flight deck, some not officially designated for stowage (Figure 13). The selection of typical locations used to store items illustrates the challenge imposed by the imbalance between the available storage on the flight deck, the required volume of official equipment and documentation and the carriage of personal items. While the Voyager flight deck had adequate space for these items to be carried, there were not enough dedicated storage locations for the sheer volume of official items, resulting in items being stored on the floor and in ad hoc areas. In particular, the area around the side-stick appeared to be treated no differently to any other surface on the flight deck.

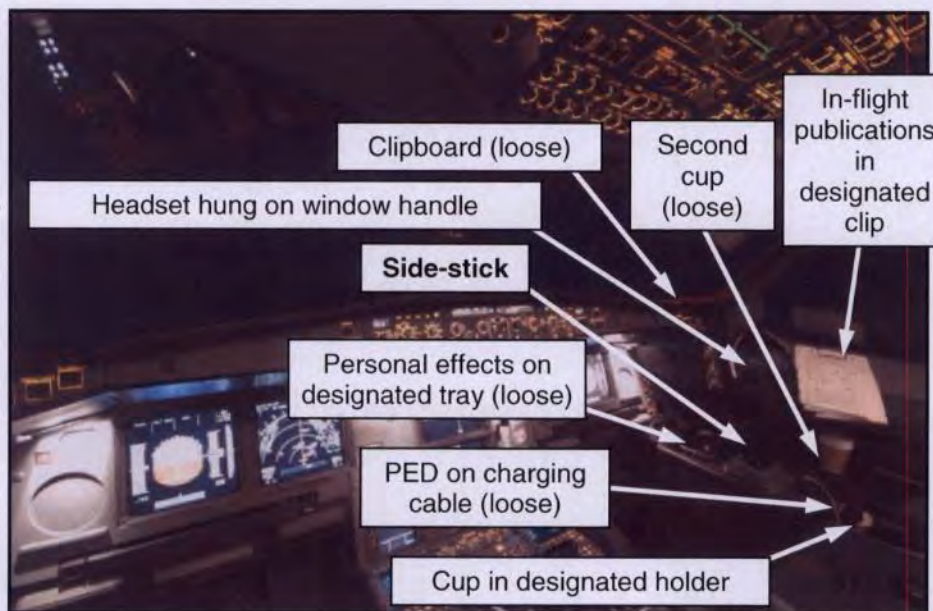
Figure 13: Photograph of Co-pilot's position 6 mins 15 seconds prior to incident.

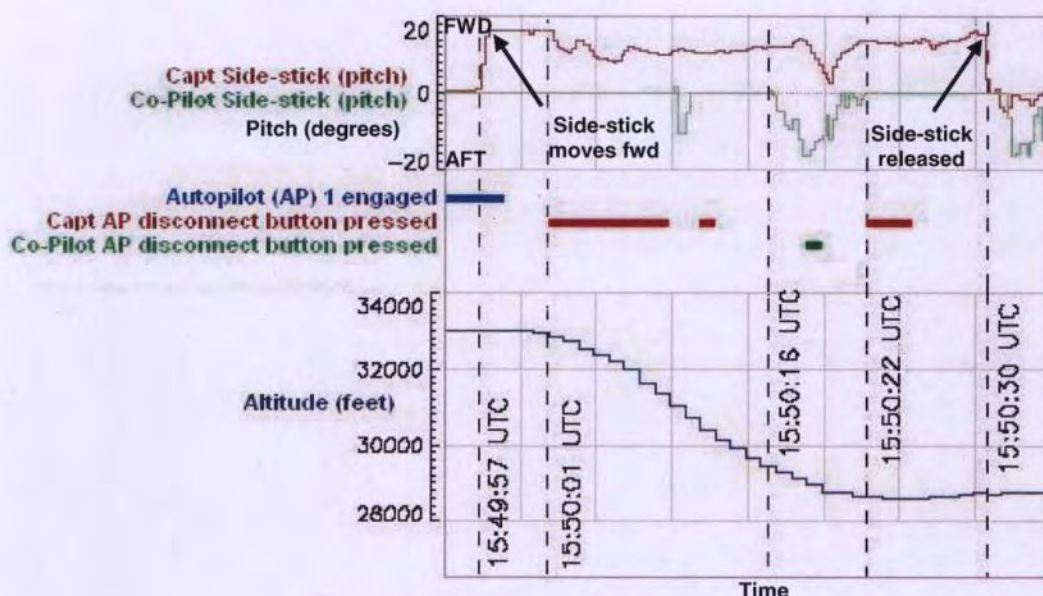
Figure 17: Composite DFDR trace.

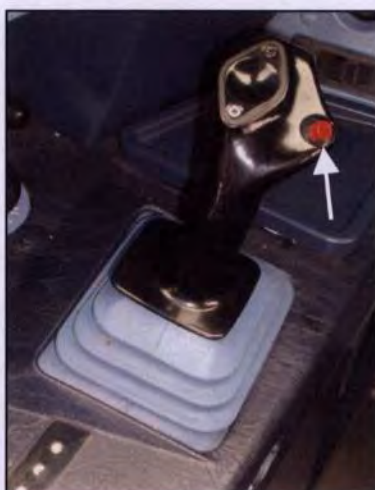
1.4.46 The normal method of disconnecting the autopilot is via the side-stick autopilot disconnect button (also known as the instinctive cut-out button), which is located next to the thumb's natural position on each pilot's side-stick (Figure 18). Disconnecting the autopilot using this button triggers an audio warning known as the 'cavalry charge' (because of its distinctive warble); the warning lasts for 1.5 seconds. Disconnecting the autopilot by any other means (for example, by a physical push on the side-stick of at least five deca-Newtons) is classed as an inadvertent disconnection. Such an action also triggers the 'cavalry charge', but as a *continuous* warning, and is accompanied by a flashing red 'master warning' caption in front of the pilot. As the pitch-down command began, a *continuous* 'cavalry charge' sounded and the red 'master warning' caption illuminated to indicate that the autopilot had been disconnected inadvertently.

Figure 18: Captain's autopilot disconnect button (indicated by arrow).

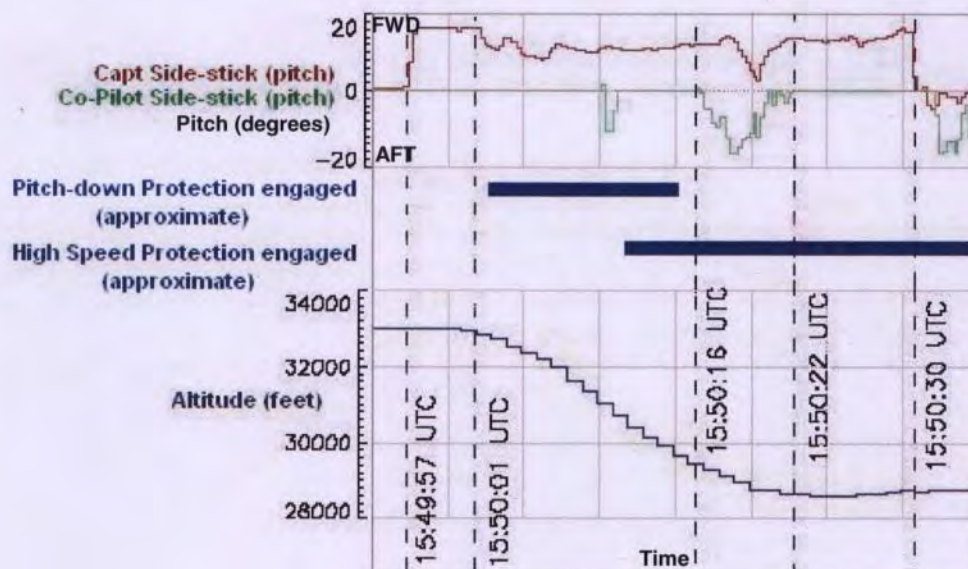
altogether at 15 degrees nose-down. The pilots have the authority to override these features by a small margin, but once the protection measures are active both pilots' inputs are limited until parameters fall back within limits. The protection features do not require the autopilot to be engaged. Analysis of the pilots' actions and the aircraft's response during the incident established the following points (Figure 19 refers):

Figure 19: Composite DFDR trace.

a. Pitch-down protection was triggered approximately three seconds after the pitch-down command. A pitch limit of approximately 17 degrees nose-down was achieved as a result of the Captain's side-stick remaining significantly forward of the neutral position for over 30 seconds. As the 17 degree attitude was approached, the position of the elevators was automatically reduced towards zero.

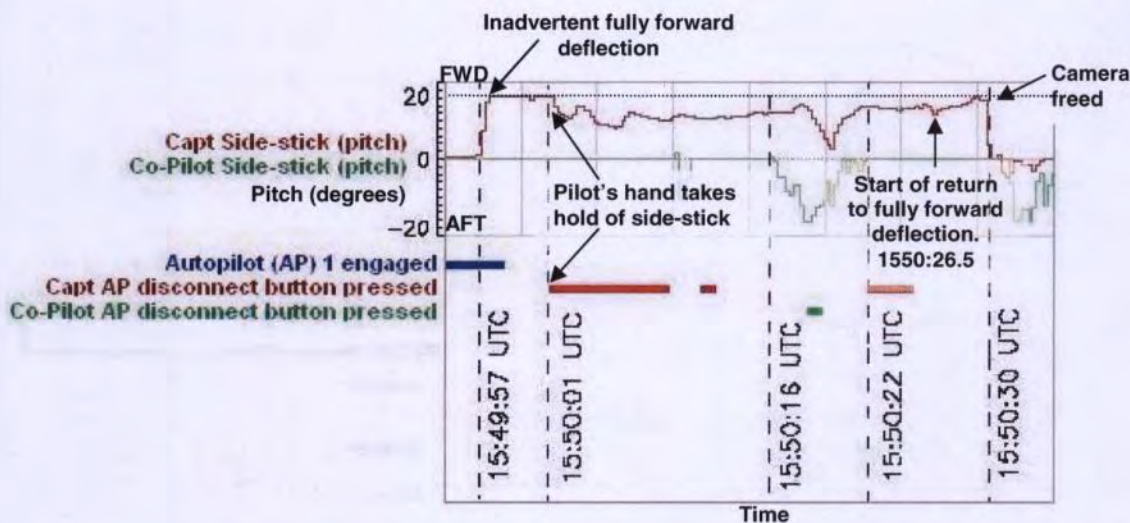
Figure 20: Composite DFDR trace.

1.4.54 Examination of the DFDR/CVR at the point the camera became free produced the following analysis:

a. Between **1550:26.5 UTC** and **1550:29 UTC**, the side-stick began moving towards a fully forward deflection, the first such deflection of the side-stick since the initial pitch-down at **1549:59 UTC** (Figure 20). At the point of this second fully forward deflection, the aircraft was still experiencing an overspeed and was in a relatively level attitude. The movement of the side-stick to a fully forward deflection, therefore, was unlikely to have been made in an attempt to control the aircraft as such an input would only serve to exacerbate the overspeed and recreate the dive.

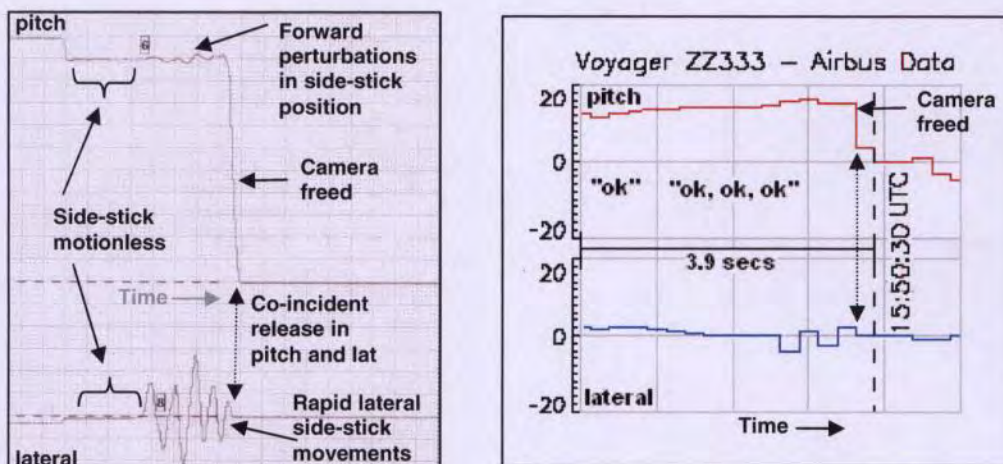
b. Small rapid lateral inputs on the side-stick occurred in the one second immediately prior to the camera becoming free (Figure 21, right-hand trace). The inputs were too rapid to have constituted an attempt to roll the aircraft, since the aircraft would not have had time to react to the roll inputs before they were reversed. Nor did there appear to be an obvious requirement to apply roll at this point, since the aircraft was in an approximately wings-level position.

The DFDR suggests that, the side-stick moved backwards under its own spring-loading to the neutral (central) position.

**Figure 21: Simulator trace (left) and ZZ333 DFDR trace (right) showing side-stick in pitch and lateral axes.**

1.4.55 In reconstructions of the incident in the simulator, a DFDR-type trace recorded attempts to remove a representative camera in a situation where the armrest and seat position were left unaltered. The simulator trace recorded the following key features (Figure 21, left-hand trace):

1.4.56 In all respects, the simulator trace showed striking similarities with the DFDR trace from ZZ333 (Figure 21, right-hand trace).

a. Between **1550:26.5 UTC** and **1550:28 UTC**, immediately prior to the camera becoming free, the Captain said, “ok ..... ok, ok, ok,” (superimposed on Figure 21, right-hand trace). It was not possible to confirm what this referred to. The Panel noted that there were no obvious changes in either the flight deck indications or the aircraft attitude at this point.

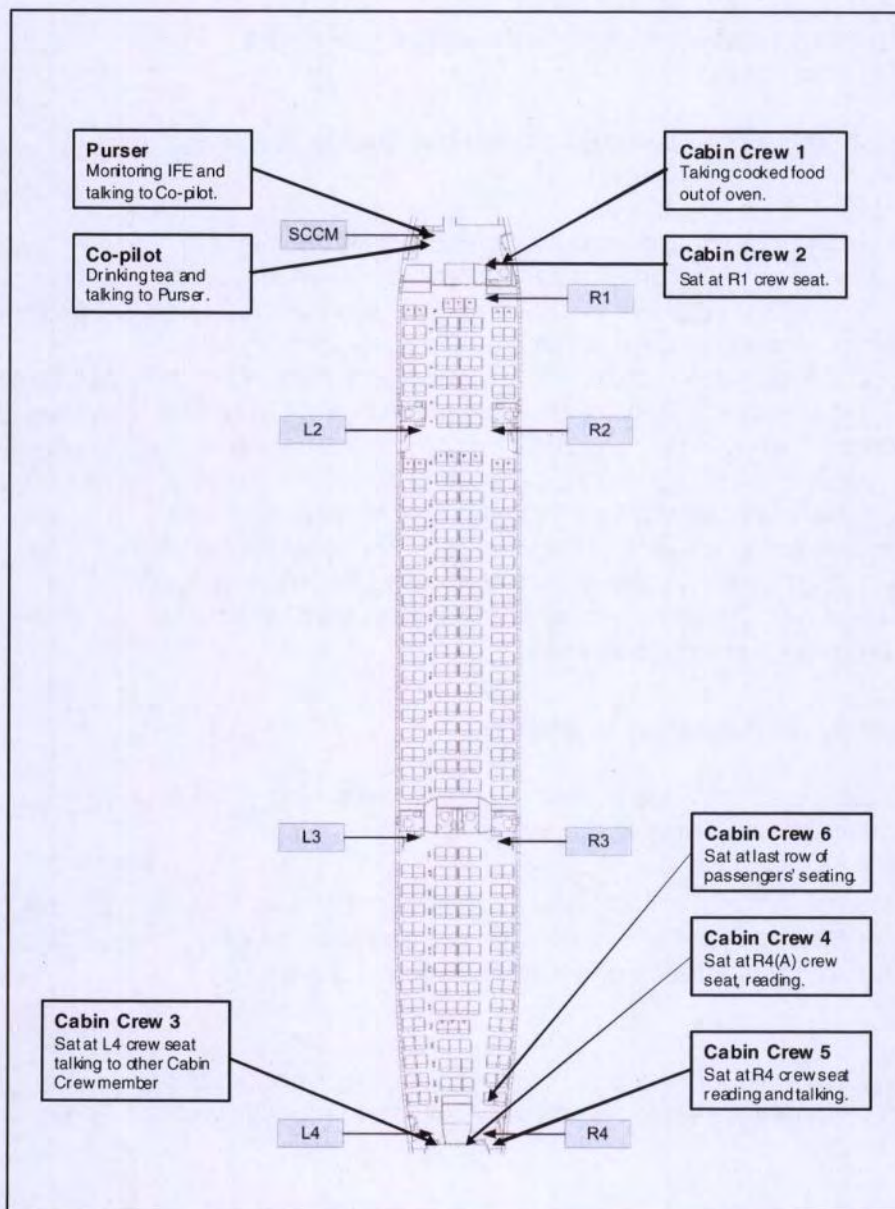
Figure 23: Cabin Crew positions at time of incident.

1.4.63 According to eyewitness accounts, most injuries were sustained as a result of impacts with the ceiling or overhead fittings. Some Cabin Crew injuries were the result of being struck by flying loose articles in the galley or burned by hot liquids. The primary physical injury types were bruising, cuts, neck or back injuries, and head injuries, with all of these being pertinent to those not wearing a seatbelt. Reported injuries amongst those wearing a seatbelt included whiplash and minor bruising, particularly where a seatbelt was fastened only loosely. Since Voyager flights do not operate allocated seating, and since the number of reported physical injuries was relatively low, it was not possible to conduct an accurate or meaningful analysis of passengers' injuries by location on the aircraft. The Panel assessed however, that **the following were aggravating factors:**
