# **AIRCRAFT ACCIDENT REPORT 1/2014**

**Report on the accident to  
Airbus A330-343, G-VSXY  
London Gatwick Airport  
16 April 2012**

**Air Accidents Investigation Branch**

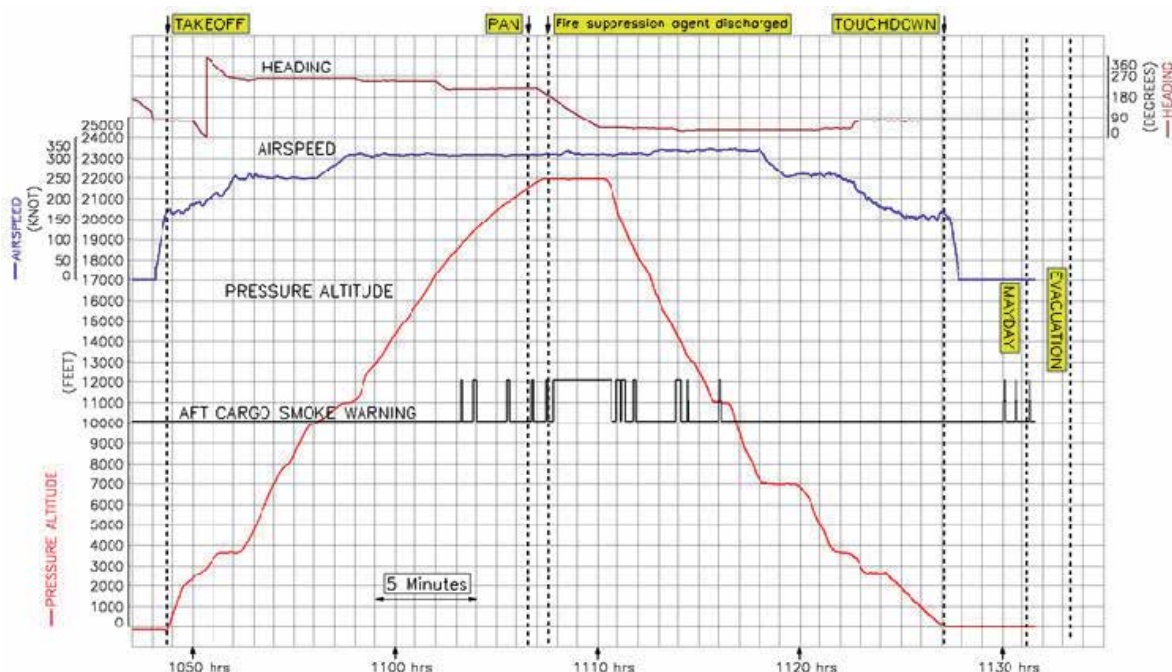
**Figure 9**

The aircraft was airborne for a total of 38 minutes and 36 seconds. Activation of the aft cargo smoke warning was recorded on fifteen separate occasions, 12 of which occurred in flight and three after landing. The total duration of the warnings was 260 seconds. Figures 9 and 10 provide more information on the activation times and duration of the warnings.

Flight profile - activation of aft cargo smoke warnings

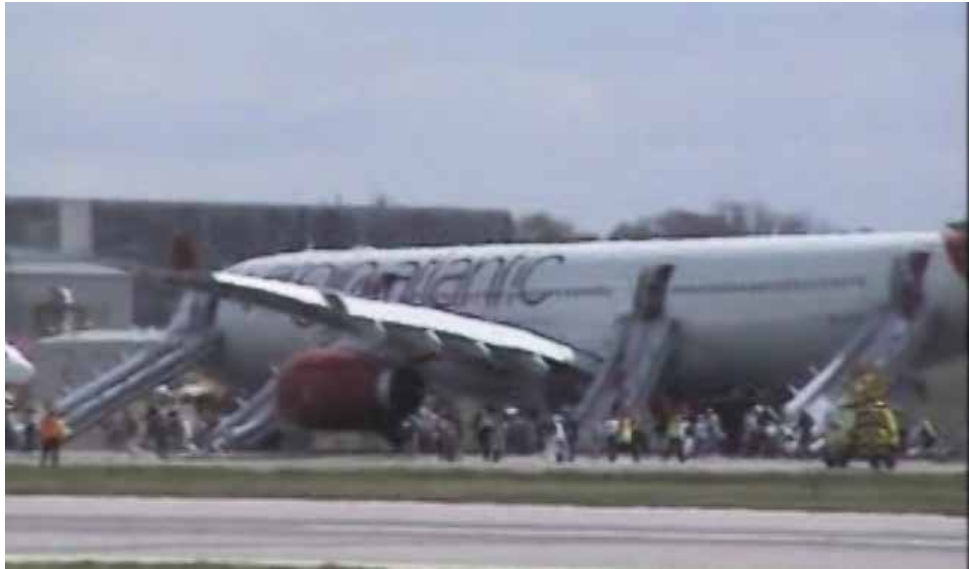
**Figure 12**

The videos showed that the flow of people from the left doors (Figure 12) was much quicker than from the right (Figure 13). On the right side a number of people sat down in the doorway before descending the slide; some people fell to the ground at the bottom of the slide and others slowed their own evacuation because they were carrying hand baggage (Figure 14). The video also showed members of the RFFS standing at the bottom of the slide at Door 3R directly in line with the escape path.

Still image from video showing left side approximately 30 seconds after evacuation commenced
