# Investigation Report

Type of Occurrence:	Accident
Date:	24 January 2005
Location:	Düsseldorf
Aircraft:	Airplane
Manufacturer / Model:	Boeing / 747-212B
Injuries to Persons:	No injuries
Damage:	Aircraft severely damaged
Other Damage:	Aerodrome equipment
Information Source:	Investigation by BFU
State File Number:	BFU AX001-05

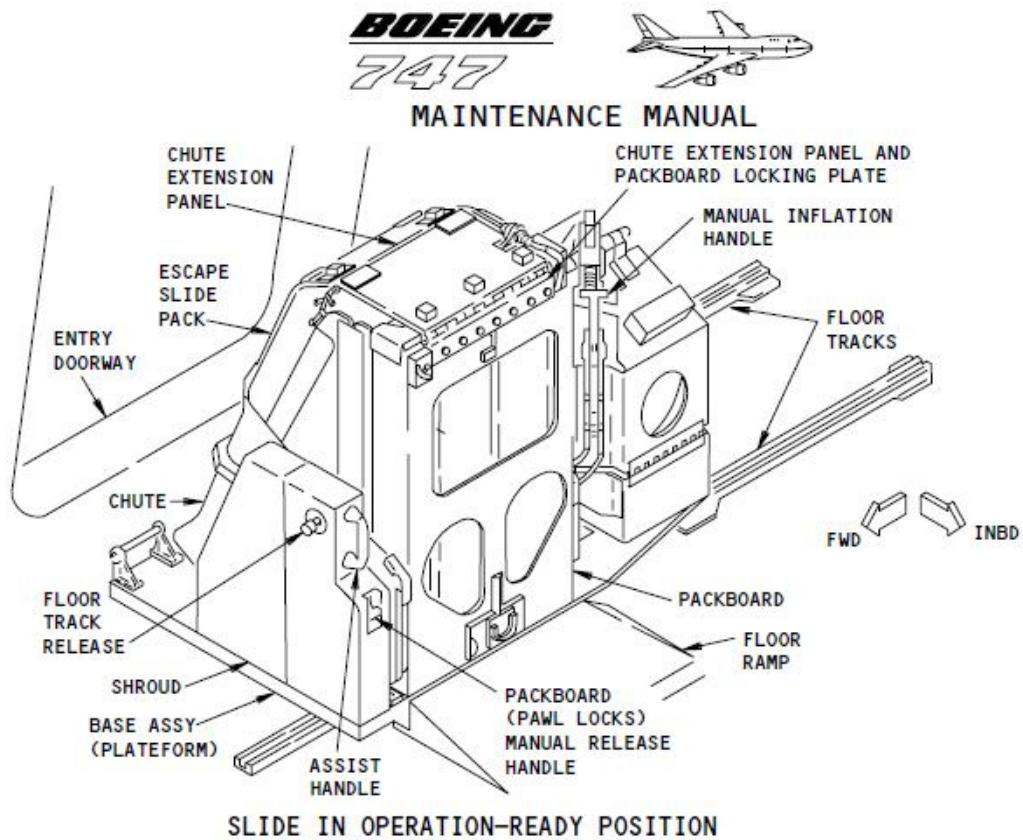
Excerpt Aircraft Maintenance Manual

The crew service door on the upper floor of the right fuselage was open and pushed aside (opposite the flight direction). The platform including the escape slide mounted on top was in the position operation ready and directly in front of the doorway.

The front deployment cable was fixed to the slider. The aft deployment cable was missing.

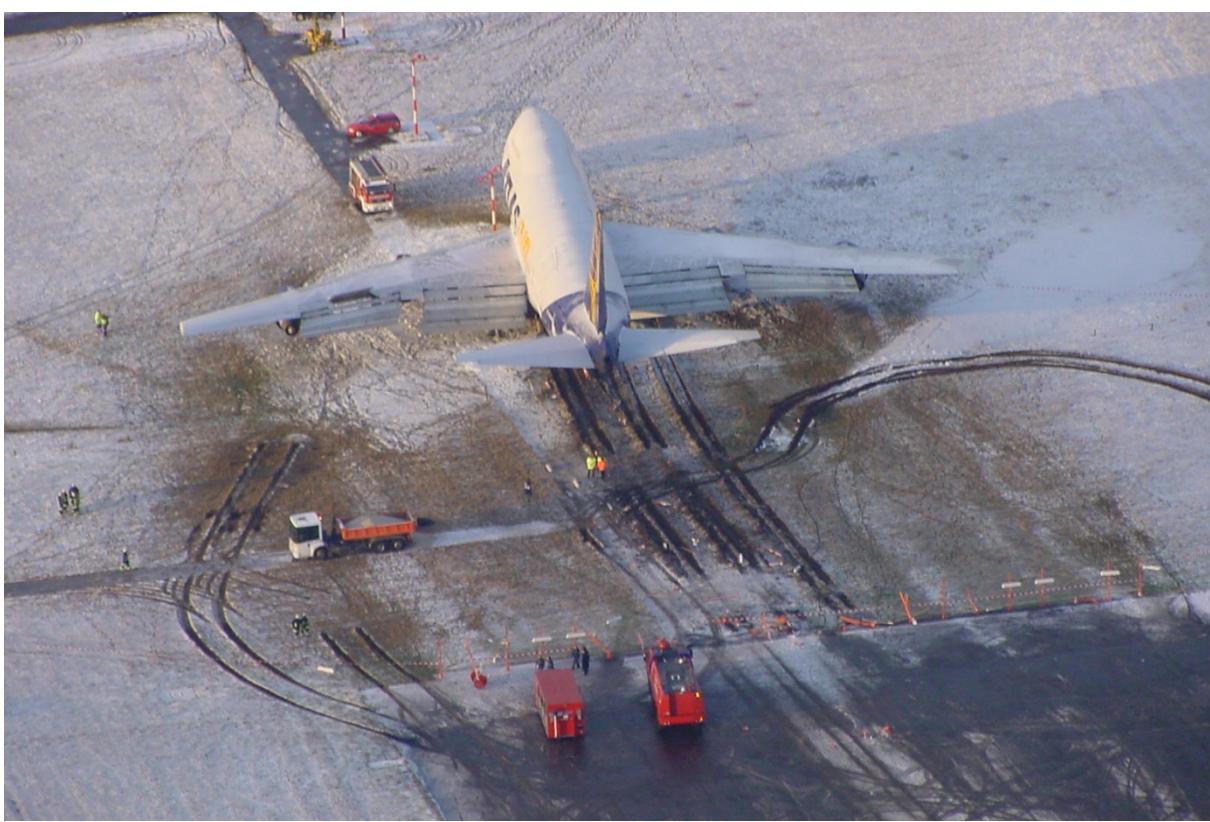
Overview (2)

The air intake of engine 1 showed damages in the 5 o'clock position. The entire air intake of engine 2 up to the fan was severed and was lying in front of the engine. Fire had destroyed the left engine fairing in the area of the fan and the low pressure compressor. The thrust reverser doors were in the open position. The air intake of engine 3 was damaged in the 7 o'clock position; the thrust reverser doors were in the open

position. The engine air intake of engine 4 showed damages in the 5 o'clock position. The fan blades of the engines 2, 3, and 4 were also damaged.

Parts of the ILS antennas were found in the engines. Fuselage and wings showed damages which were also a result of collisions with the antenna array.
