# Report

Serious incident on **16 August 2008**  
on **take-off from Paris Charles de Gaulle Airport (95)**  
to the **Boeing 737-800**  
registered **SU-BPZ**  
operated by **AMC Airlines**

**BEA**

Bureau d'Enquêtes et d'Analyses  
pour la sécurité de l'aviation civile

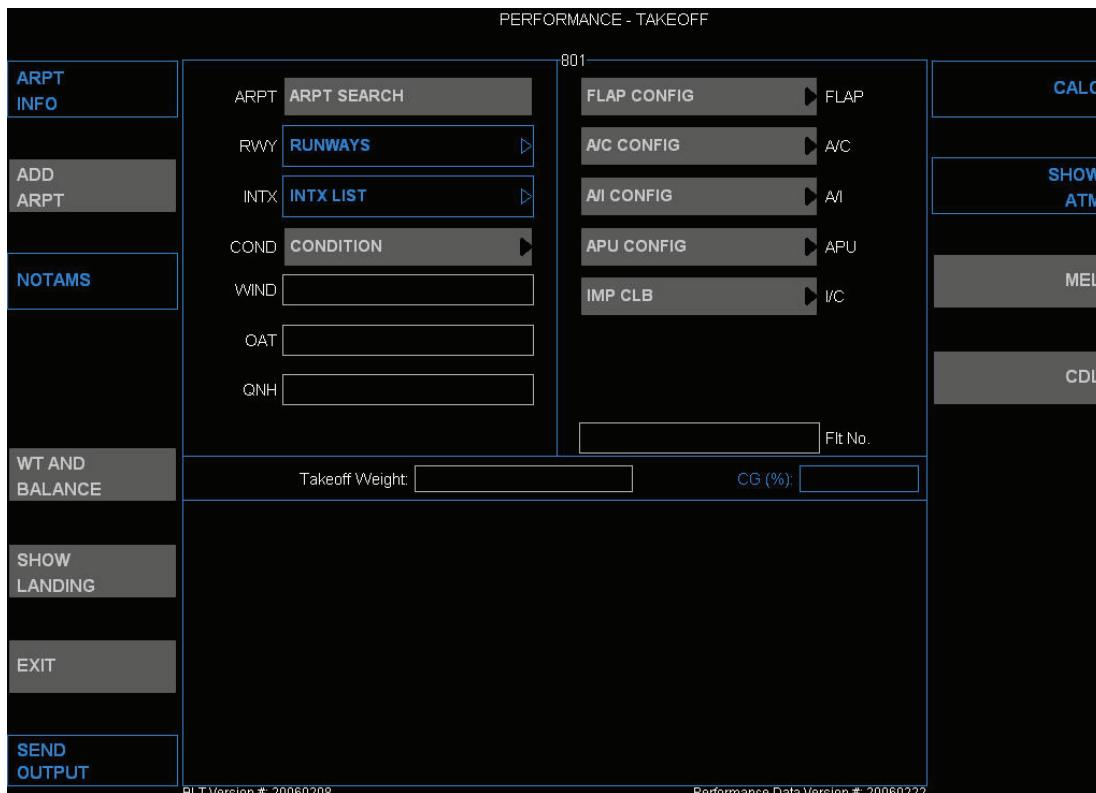
The operator AMC required its crews to use the OPT software supplied by Boeing to determine the configuration and the characteristic speeds (V1, Vr and V2) according to the thrust selected for takeoff. This software was installed on laptop computers used on board by the crew. The illustration that follows shows the main PERFORMANCE-TAKE OFF page in the "class 3" configuration, recommended by the manufacturer. AMC uses this configuration, with the further addition of a tab, not shown below, allowing the choice of maximum thrust.

The greyed tabs allow access to special pages, for example for the selection of an aerodrome or for keying in data on the load.

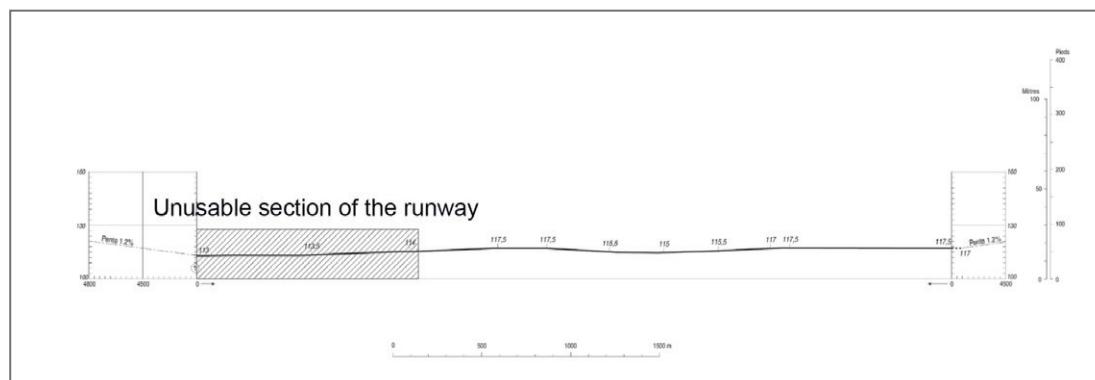
Profile of runway 27L

Repair works on runway 09R/27L were in progress between 4 and 20 August 2008. During this period, the last 1,240 metres of runway 27L were closed for flight operations. The provisional threshold altitude of runway 09R was 376 ft. The profile of runway 27L defined for the duration of the works was characterized by a zero slope in the first two fifths, a depression of around ten feet in the next two fifths and a descent in the last fifth.
