# Report

Accident on **16 October 2012**  
at **Lorient Lann Bihoué (56) Aerodrome**  
to the **the Bombardier CRJ-700**  
registered **F-GRZE**  
operated by **Brit Air**

Bureau d'Enquêtes et d'Analyses  
pour la sécurité de l'aviation civile

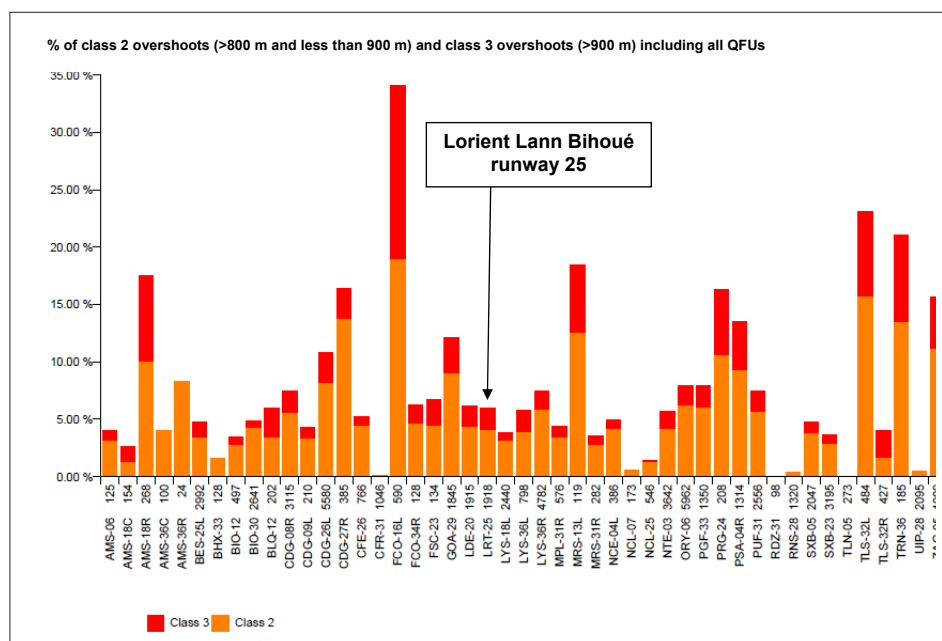
In the summer of 2012, a similar analysis was undertaken for the CRJ-700. As of the date of the accident, the operator had identified certain aerodromes at which overshoots were the most numerous.

The results for Lorient Lann Bihoué did not appear to be significant.

At the request of the BEA, the airline forwarded the graph for overshoots by CRJ-700 on runways where the LDA is less than 2,400 m. It shows that 551 out of 1,680 landings occurred more than 650 m from the threshold, i.e. 32.8% of the landings (see Appendix 9). In this classification, it can be seen that the largest number of overshoots occurred at Lorient Lann Bihoué.

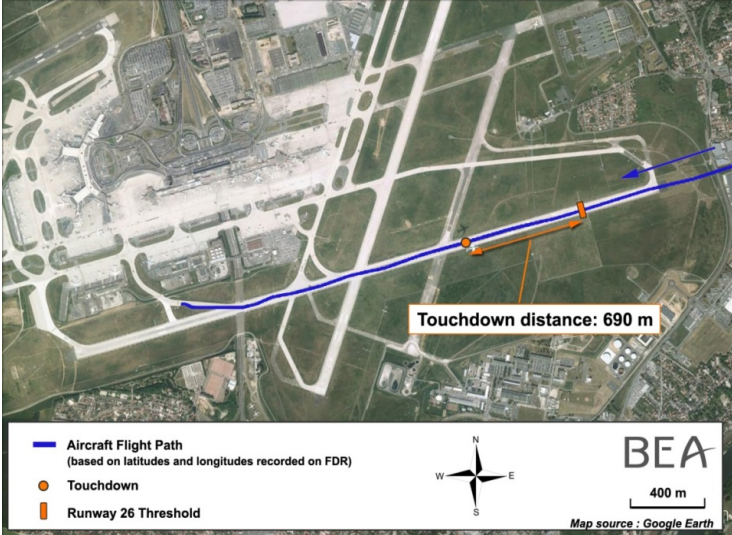
| External environment | Runway for landing | Aeroplane configuration | Ground speed on touchdown | Distance of touchdown in relation to runway threshold |
|---|---|---|---|---|
| <b>VOL N-1 (PF=CDB)</b> | | | | |

| External environment | Runway for landing | Aeroplane configuration | Ground speed on touchdown | Distance of touchdown in relation to runway threshold |
|---|---|---|---|---|
| Daytime<br>Visibility > 10km<br>Wind on passage over threshold = 170°/5 kt | Paris Orly runway 26 | <b>Flaps 45°</b> | 121 kt | <b>690 m</b> |

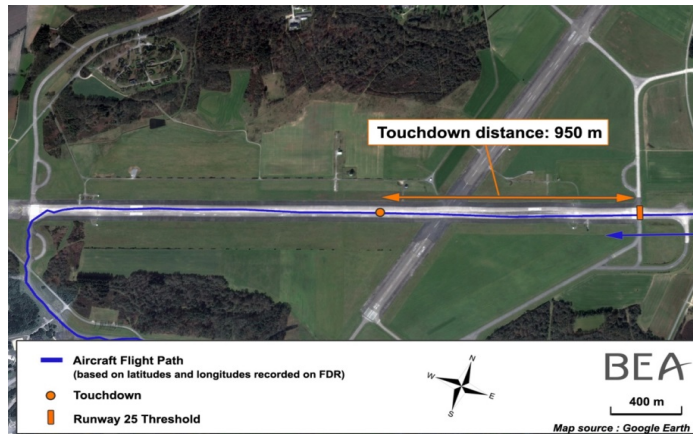
### FLIGHT N-2 (PF=Copilot)

| Daytime<br>Visibility > 10 km<br>Wind on passage<br>over threshold<br>=150°/18 kt | Lorient<br>Lann<br>Bihoué<br>runway<br>25 | <b>Flaps 45°</b> | 123 kt | <b>950 m</b> |

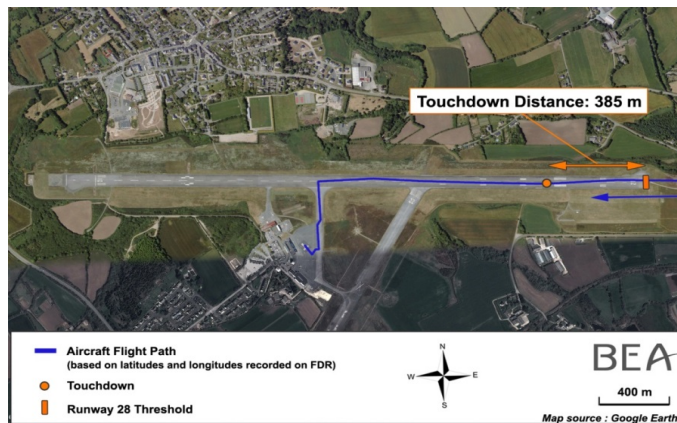
### FLIGHT N-4 (PF=Copilot)

| Daytime<br>Visibility > 10 km<br>Wind on passage<br>over threshold<br>=200°/4kt | Quimper<br>runway<br>28 | <b>Flaps 45°</b> | 128 kt | <b>385 m</b> |

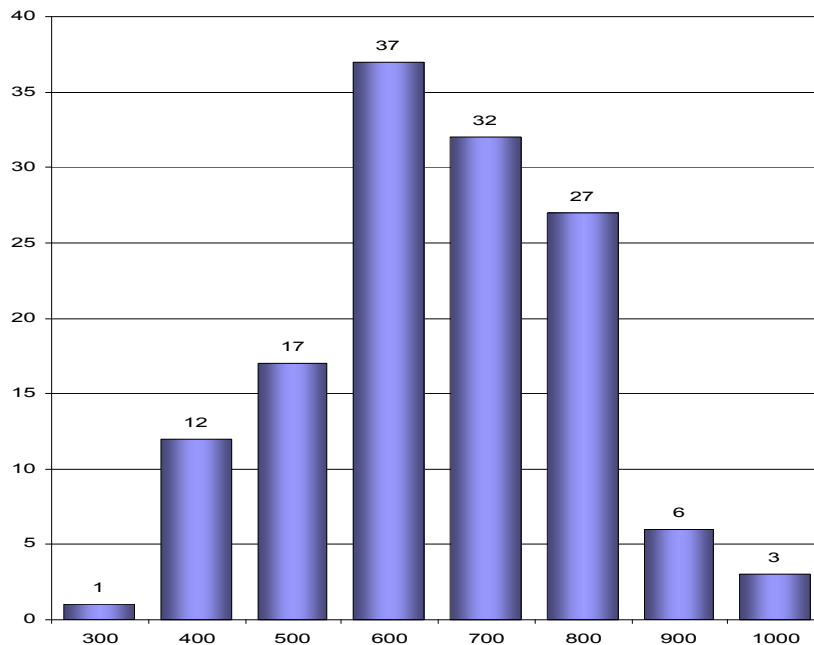
- Long landings in CRJ-1000 from May 2011 to December 2011 (Lyon Saint-Exupéry) runway 36 L (LDA: 4000 m)

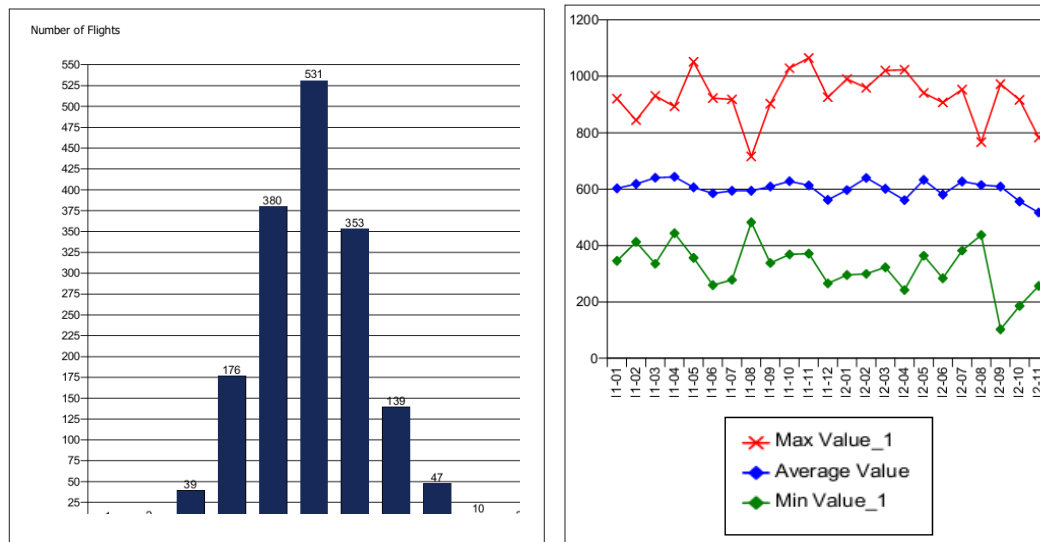
- Number of CRJ-700 long landings compared to the total number of CRJ-700 landings on runway 25 at Lorient Lann Bihoué from January 2011 to December 2012.
