Final Report

Concerning
Airbus A321 aircraft tail strike

At Hurghada Airport

On 28th February 2013

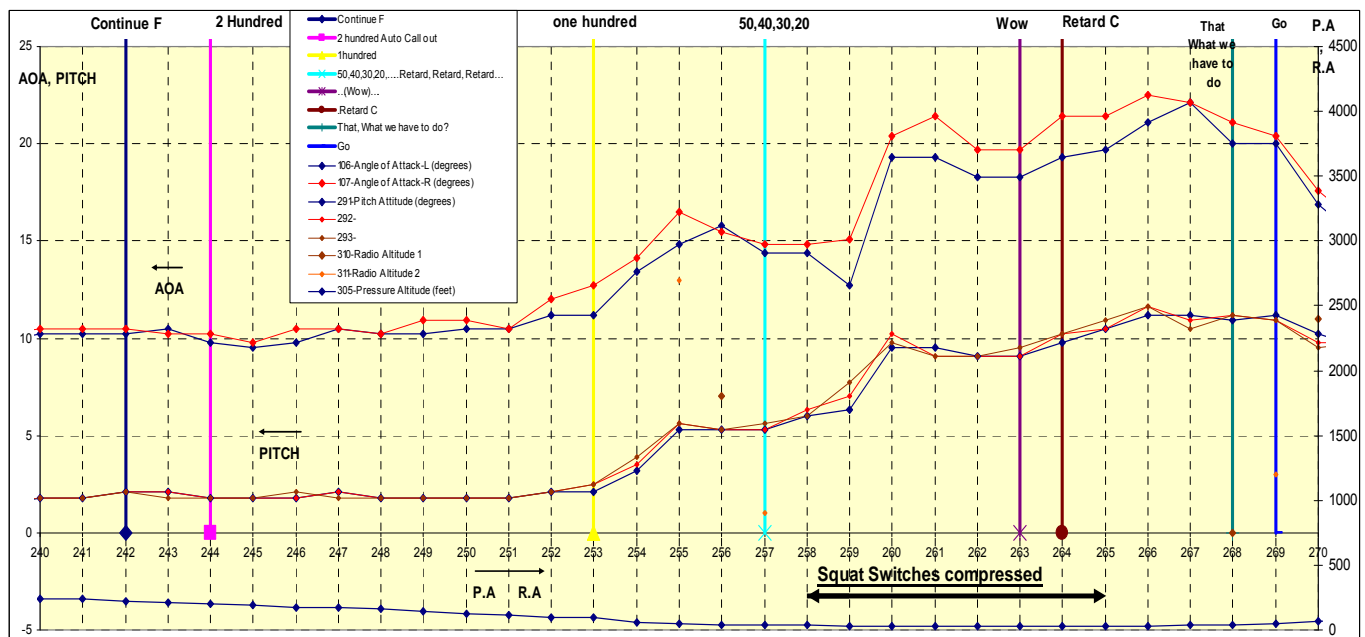
6. Time from to 240-270 FDR Ref time (seconds)

- The flight seemed to be normal, with no anomalies noticed up to the moment of the touch down
- During the time interval where the airplane was on ground (squat switches compressed, time between 258 seconds to 265 seconds), the pitch angle varied between 6.1 degree to 10.8 degrees, with a max value of 10.8 degrees at the time 265 second. (refer to section 2.6.4 for pitch limits for tail strike)
- The following conversations were selected as most relevant to the event and would explain what happened:
