Report

**Accident on 25 April 2010
at Nadi (Fiji)
to the Beechcraft B200
registered F-OIAN
operated by Air Alizé**

Electrical failure during approach, landing with gear retracted, lateral runway excursion

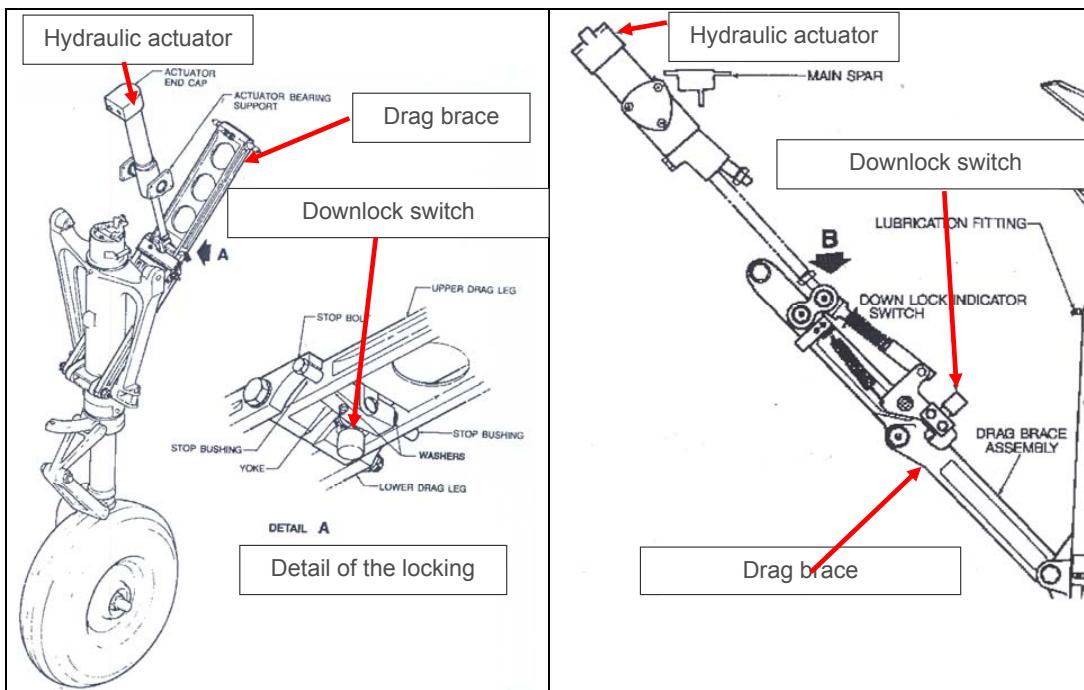
The nose gear is locked down both by a mechanical lock inside the hydraulic actuator and by locking a drag brace. The main landing gear is locked down by a mechanical catch installed on the drag brace, which is itself activated by the hydraulic actuator.

Nose gear

Main landing gear
