Final Report No. 2205 by the Swiss Accident Investigation Board SAIB

concerning the accident involving the
Embraer EMB-505 aircraft, CN-MBR

on 6 August 2012

St. Gallen-Altenrhein (LSZR) regional
aerodrome, Thal/SG municipality

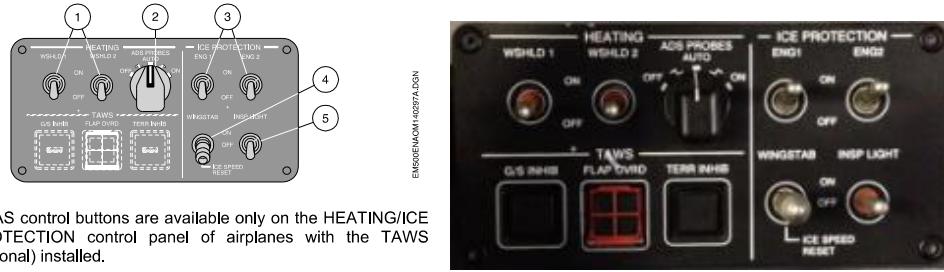
Figure 10: HEATING/ICE PROTECTION control panel
(left: POH 2908, 6-11-05; right: in aircraft CN-MBR)

Separate TAWS control buttons are optionally available on the Phenom 300 aircraft. The function of these control buttons and their corresponding use is not described in the POH. Aircraft CN-MBR was equipped with this option.

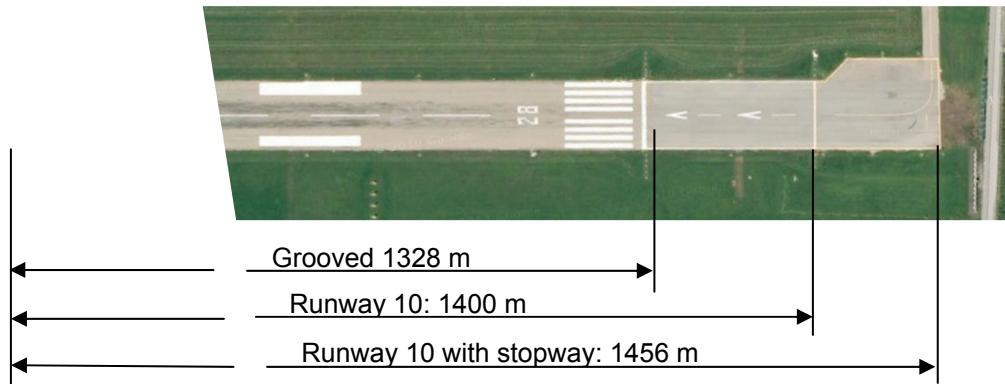
Figure 18: Longitudinal dimensions of runway 10

The runway length available on runway 10 was 1400 metres, plus a further 56 metres of hard surface (stopway). The first 1328 metres of runway 10 were grooved.

Runway 10 is equipped with instrument landing system (ILS). The glide slope is 4°. This value exceeds the maximum ICAO standard value of 3.5°. The approach itself is not categorised, since the runway does not meet the requirements for instrument approaches.

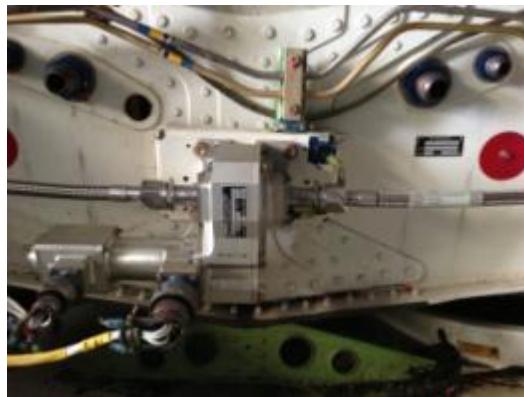
Figure 24: Flap drive system

The flap selector lever (FSL) was found in position 3. In this position the flaps would have had to extend to 26°. However, they were in a position between 9 and 10°. This corresponded to the recorded values. In view of the general condition of the aircraft, no mechanical functional check of the flap system could be carried out. However, a visual inspection produced no evidence of any pre-existing defects.

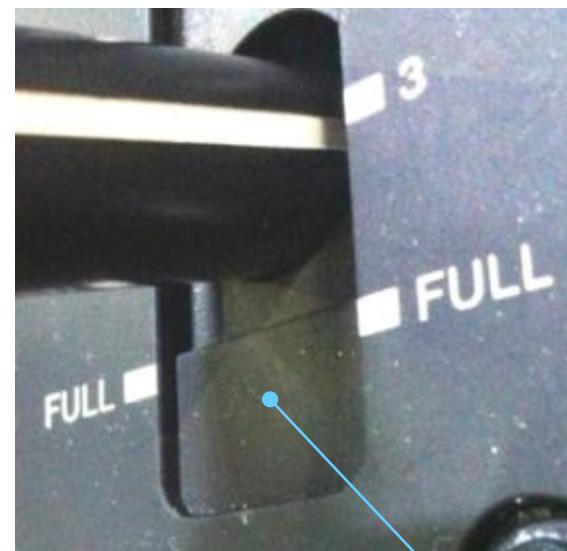
Figure 27: FSL with mechanical stopper

In addition, it was also examined whether the FSL had a so-called stopper present, which prevents the flap selector lever from being set in the FULL position, as this position is not permitted. Figure 26 was taken on the day of the accident in the cockpit of CN-MBR. There was no stopper fitted. Figure 27 shows the fitted stopper. This picture was taken on another Phenom 300 aircraft.

During which of these three FSL replacements the stopper fitted on delivery was lost is not apparent from the available documentation.

In the aircraft maintenance manual (AMM), Rev. 2 of 26 February 2010 valid at this time, the stopper is mentioned explicitly both in relation to the removal of the FSL (AMM 27-53-01, page 3 of 8) and in relation to installation (AMM 27-53-01, page 7 of 8) "FOR EASA CERTIFIED AIRCRAFT". The stopper is not mentioned "FOR ANAC OR FAA CERTIFIED AIRCRAFT".
