FINAL  
KNKT.11.12.30.04

# NATIONAL TRANSPORTATION SAFETY COMMITTEE

Aircraft Accident Investigation Report  
**PT. Sriwijaya Air**  
**PK-CKM**  
**Boeing 737-300**  
**Adisutjipto International Airport, Yogyakarta**  
**Republic of Indonesia**

**20 December 2011**

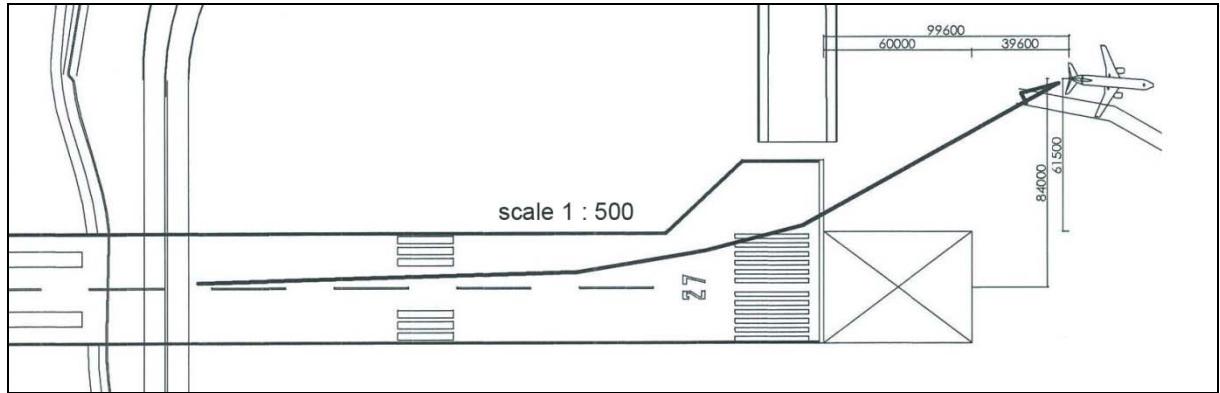
Figure 7: Location (source from AP I)

The aircraft stopped at left side of runway.

Aircraft tail position was 75 meters from the end of runway and 54 meters left side of runway centreline.
