AIRCRAFT INCIDENT REPORT AND EXECUTIVE SUMMARY

Reference:	CA18/3/2/1067								
Aircraft Registration	ZS-NMF / ZS-SZZ	Date of Incident	10 July 2014		Time of Incident	1108Z							
Type of aircraft	Bombardier CL600 / Airbus A320			Type of operation	Part 121 - Commercial								
Pilot-in-command licence type		Airline Transport	Age	38	Licence valid	Yes							
Pilot-in-command flying experience		Total flying hours	8 724.1		Hours on type	1 657.5							
Last point of departure		King Shaka International aerodrome (FALE), Kwa-Zulu Natal province											
Next point of intended landing		Port Elizabeth aerodrome (FAPE), Eastern Cape province											
Location of the incident site with reference to easily defined geographical points (GPS readings if possible)													
Overhead Port Elizabeth (GPS position: 33°59'38.02" South 025°35'35.30" East)													
Meteorological information	Surface wind: 040/5 knots, Temperature: 18°C, Visibility: +10 km

AIRCRAFT INCIDENT REPORT

Name of Owner : SA Express / South African Airways (Pty) Ltd
Name of Operator : SA Express / South African Airways (Pty) Ltd
Manufacturer : Bombardier / Airbus
Model : CL600-2B19 / A320-232
Nationality : South Afri

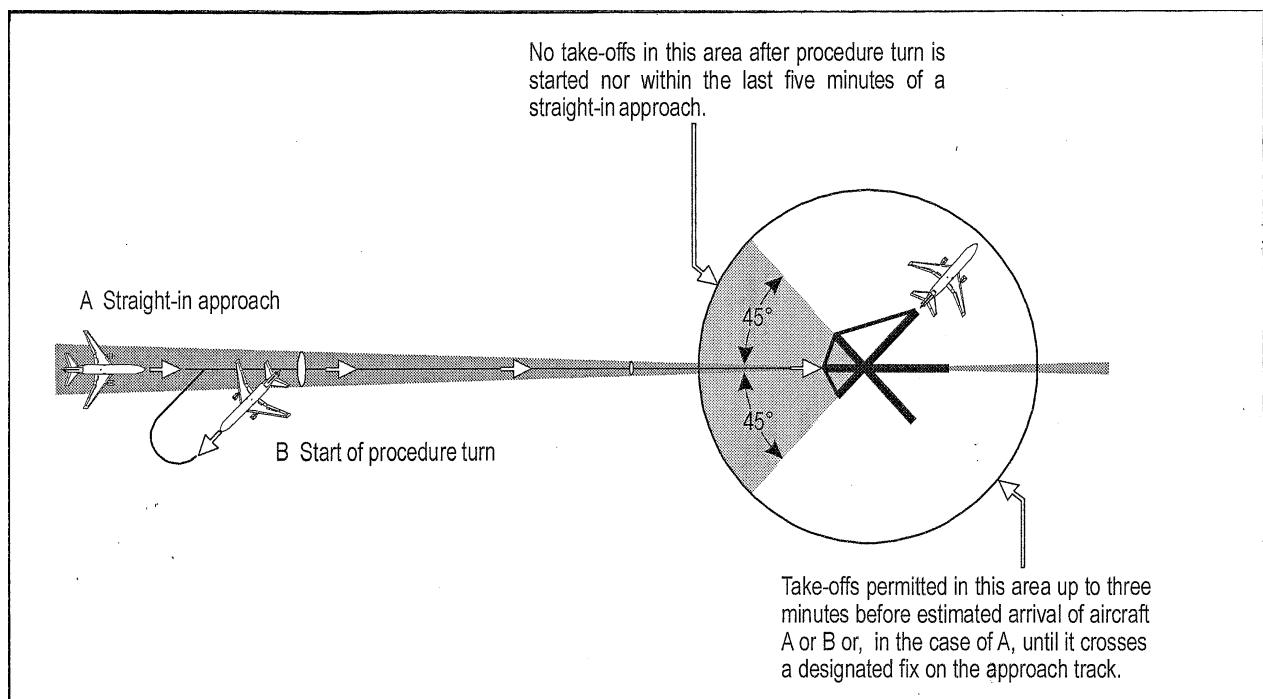
Figure 5. Separation of departing aircraft from arriving aircraft

- a) in any direction until an arriving aircraft has started its procedure turn or base turn leading to final approach;*
- b) in a direction which is different by at least 45 degrees from the reciprocal of the direction of approach after the arriving aircraft has started procedure turn or base turn leading to final approach, provided that the take-off will be made at least 3 minutes before the arriving aircraft is estimated to be over the beginning of the instrument runway (see figure 5).*

- a) in any direction until 5 minutes before the arriving aircraft is estimated to be over the instrument runway;
- b) in a direction which is different by at least 45 degrees from the reciprocal of the direction of approach of the arriving aircraft:
 - 1) until 3 minutes before the arriving aircraft is estimated to be over the beginning of the instrument runway (see figure 5); or
 - 2) before the arriving aircraft crosses a designated fix on the approach track; the location of such fix to be determined by the appropriate ATS authority after consultation with the operators".
