BULLETIN

Serious incident

BOEING MD-82

SE-DIK

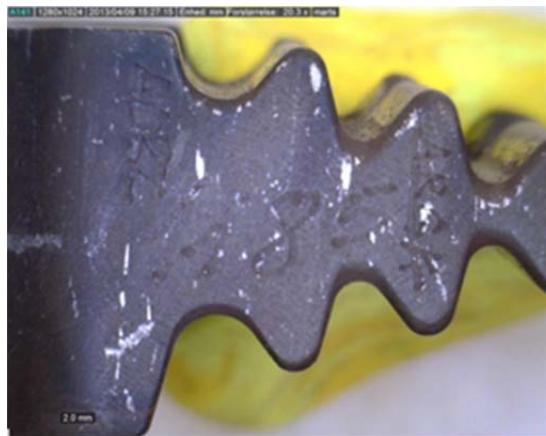
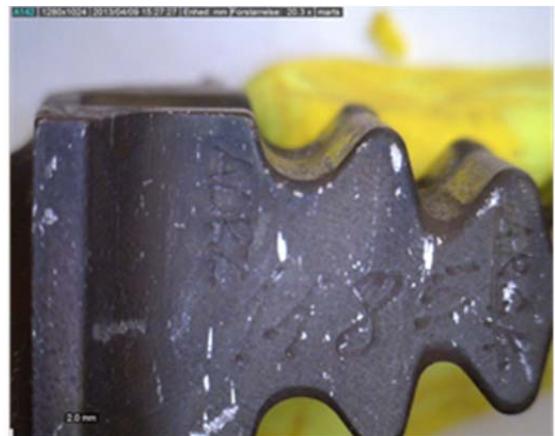
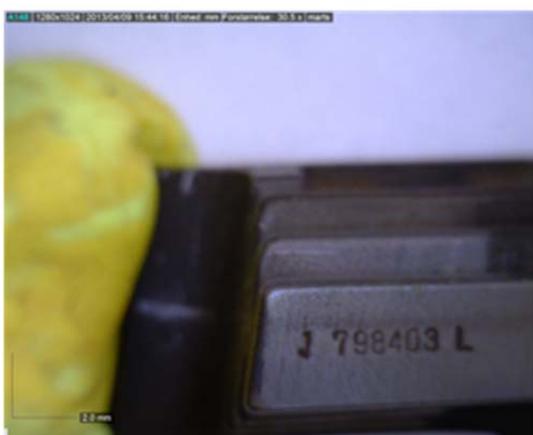
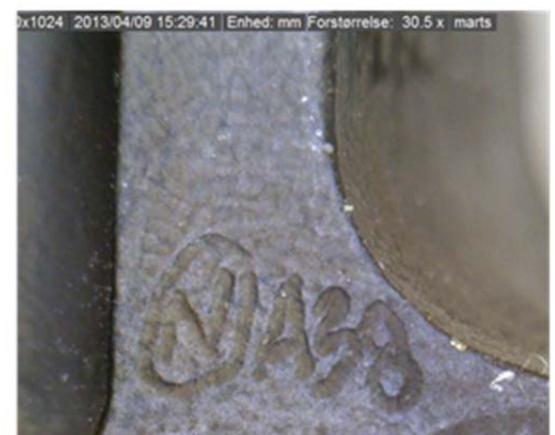
Fig. 20

Almost all 3rd stage LPT blades had unique markings. The marking on the suspected blade number one is shown in figures 20 and 21.

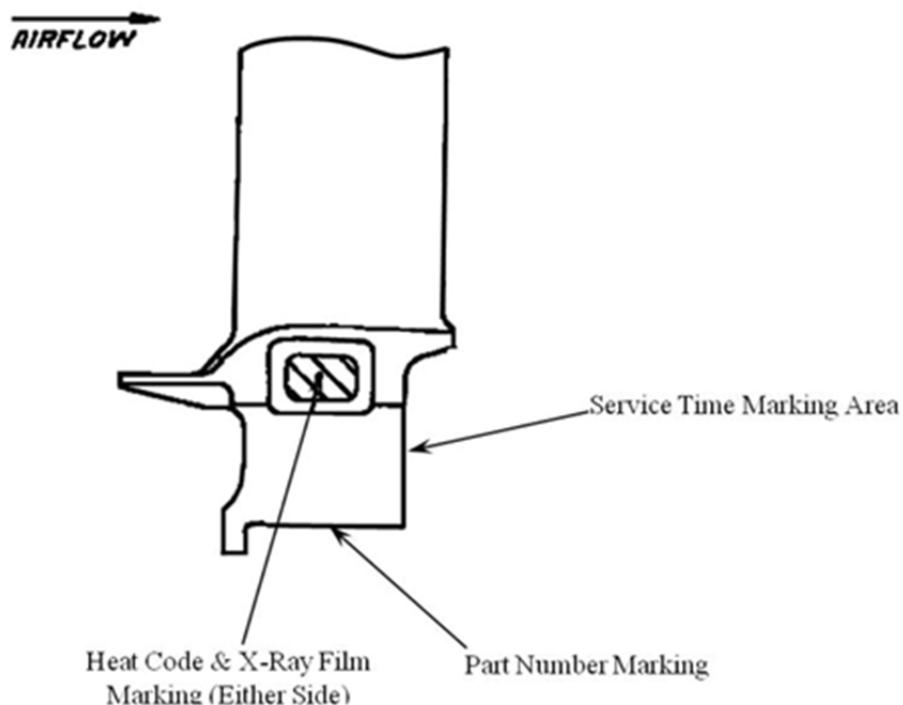
Fig. 22

The markings "Y 172" & "M 744" (blade No. 1), "J 625" & "T 397" (blade No. 2), and "T 347" & "G 697" (blade No. 88) are in areas of the blades designated for Heat Code and X-Ray Film marking, per figure 22.

The “1185”, “ARGK”, and “AORZ” markings are in the area of the blade designated for Service Time Marking per figure 22. The overhaul records should be reviewed to determine if the “1185” is related to service time on this blade.

Figure 22 is an excerpt from the part detail drawing utilized at Original Equipment Manufacturer (OEM). There are other opportunities in the life of a blade where markings could be applied that are not specified on the part detail drawing, including at the time the casting from which the finished part is produced, during the inspection process, and during overhaul. Specifically with respect to overhaul, the following is the engine manufacturer interpretation of certain specific markings on the blades:
