Flight path management and ground proximity warning involving Airbus A330-202 VH-EBV

15 km NNE of Melbourne Airport, Victoria, | 8 March 2013

ATSB Transport Safety Report

AO-2013-047

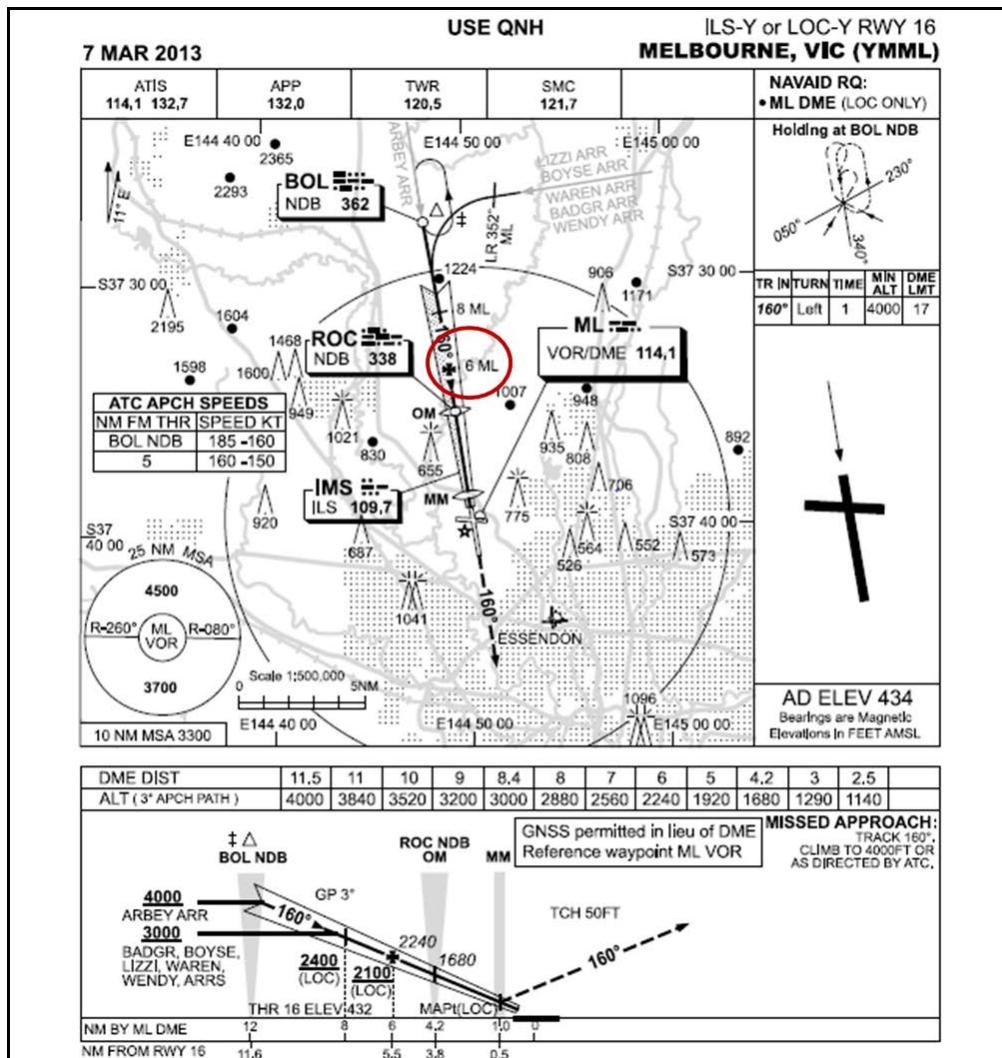
Figure 2: Melbourne instrument landing system chart showing the location of the final approach fix (circled)

At 1848:21, ATC asked the crew if they could accept an additional 2 NM (4 km) of track shortening direct to the Rockdale non-directional beacon (Figure 2). The crew declined that request.
