**Report on the accident to
Eurocopter (Deutschland) EC135 T2+, G-SPAO
Glasgow City Centre, Scotland
on 29 November 2013**

Air Accidents Investigation Branch

October 2015

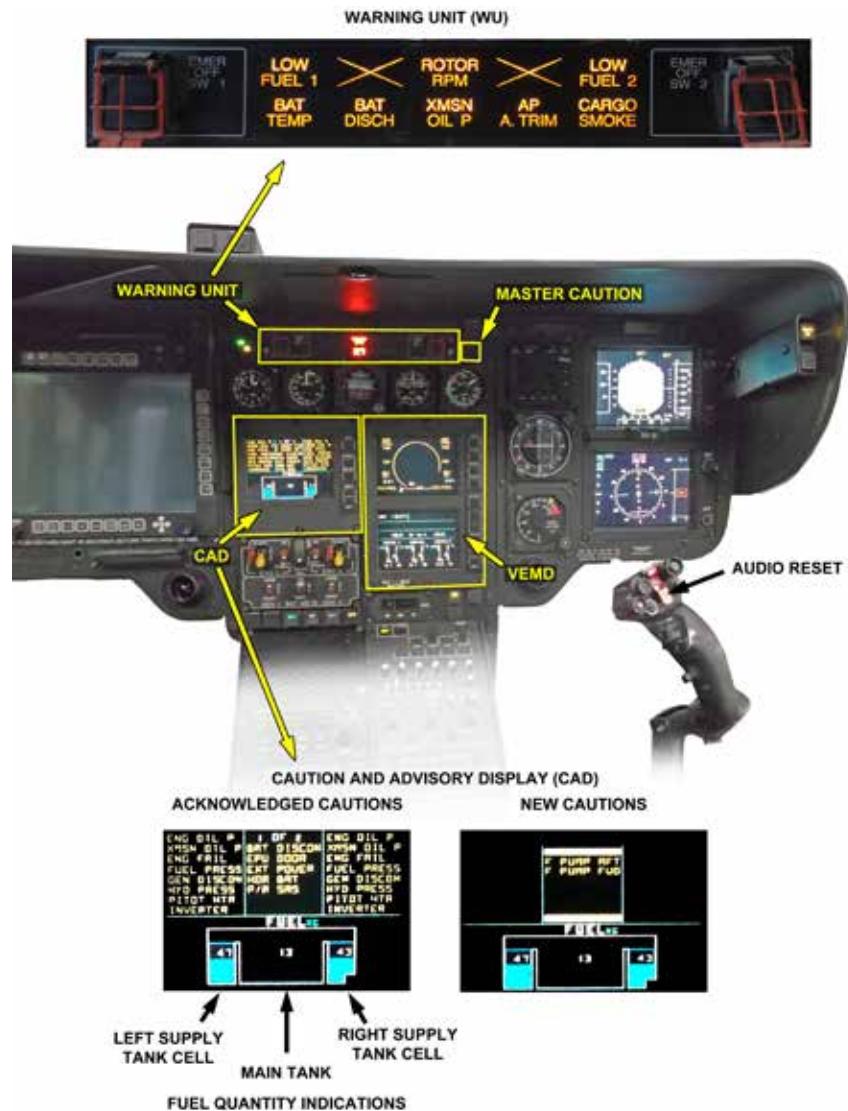
Figure 2
Warnings, cautions and systems displays

The Warning Unit (WU) is situated centrally on the instrument panel just beneath the cockpit glareshield (see Figure 2). This provides visual and audio indications when warning conditions are triggered. The WU accommodates eight warning captions. They appear red when illuminated and are unlit when inactive. Each caption simultaneously initiates an audible attention-getter 'gong'. The audio for some of the warnings can be silenced using the audio reset button on the top of the cyclic control stick but a visual warning cannot be cleared while the warning condition remains. All warning gongs are audible to the pilot and Observers, through their headsets. All warning captions can be dimmed for night operation.

The CPDS comprises the Caution Advisory Display (CAD) and the VEMD, (see Figure 2). The CAD displays caution and advisory messages and fuel contents indications. The VEMD consists of two screens, which display engine and transmission parameters and limits, and can present data relating to the helicopter's systems (eg electrical system, autopilot). The CAD and VEMD are linked, so, if one of the units or screens fails, the remaining screens can display the missing information and log a fault.

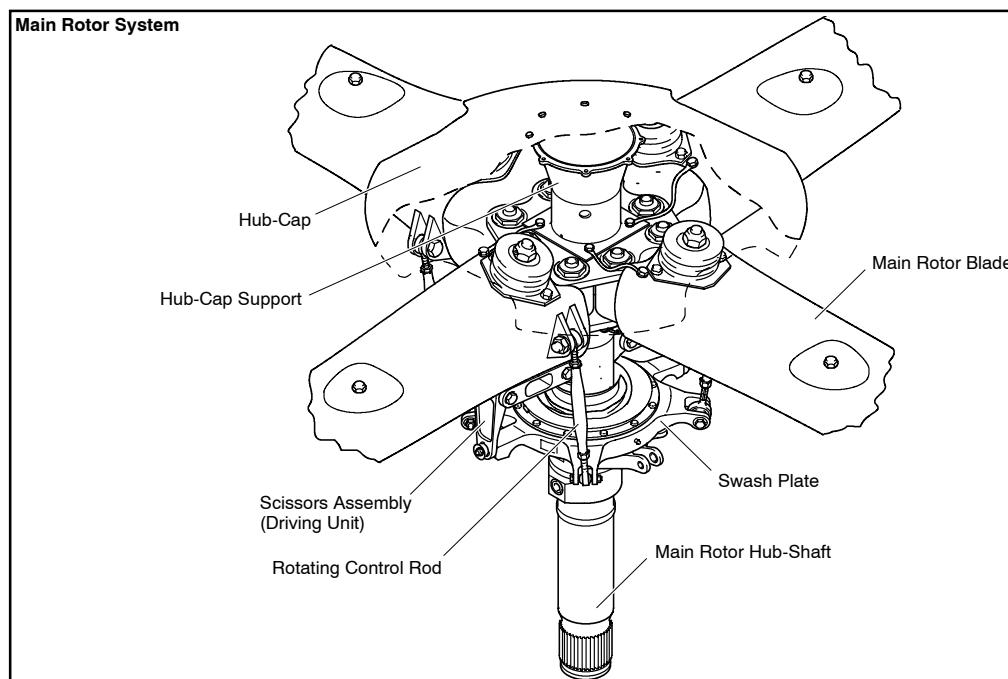
Figure 5
EC135 main rotor head assembly

The EC135 main rotor head is of a rigid design and composite construction. There are four main rotor blades, each of which is attached to the steel alloy rotor hub shaft flange plates by two bolts. At the root of each blade there is a 'flexbeam', made of a cruciform section composite material, which absorbs the centrifugal tensile loads. It is designed to twist, to accommodate pitch changes, bend in the vertical plane, to absorb flapping loads, and bend in the horizontal plane, to absorb lead and lag drag loads. The flexbeam is surrounded by the blade cuff.

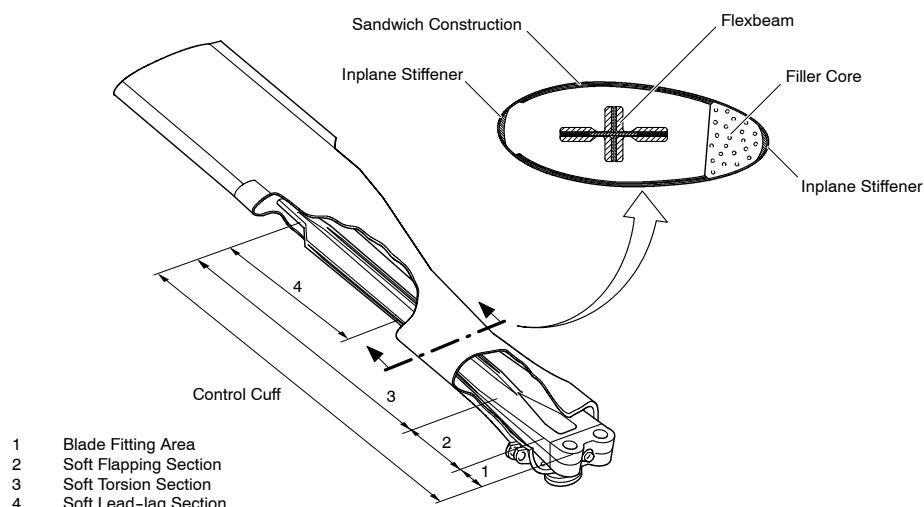
Figure 6
EC135 main rotor blade

The blade cuff is integrated into the blade skin and surrounds the flexbeam to provide a streamlined transition from the aerofoil section of the blade to the blade root (see Figures 6 and 7). The pitch angle of the main rotor blade is adjusted through a pitch horn, integral to the cuff. The cuff and flexbeam are held in alignment by a link rod, which passes through a spherical bearing in the flexbeam, and is attached to elastomeric¹³ mountings on the upper and lower surfaces of the blade cuff. The elastomeric mountings provide sufficient in-plane lead-lag damping of the main rotor blade to prevent ground and air resonance, within the normal operating N_r (rotational speed of the rotor blades) range.

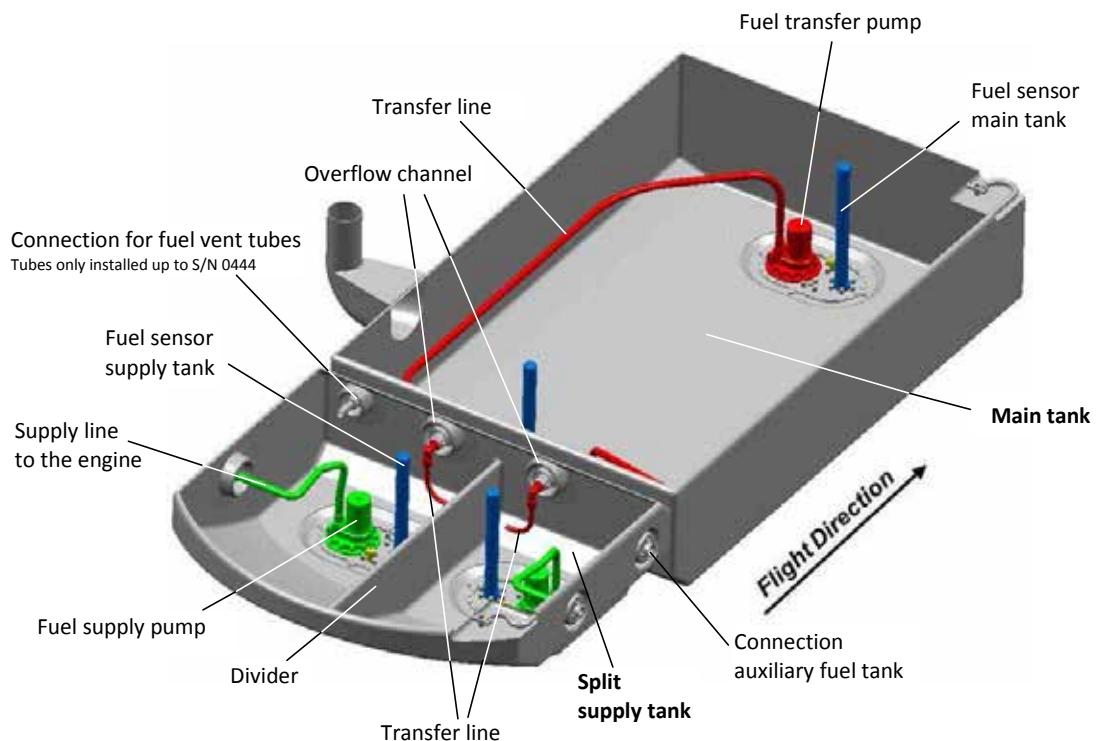
Figure 1: Overview, EC135 fuel tank (isometric view)

The fuel system of the helicopter comprises two fuel tanks: A main tank and a split supply tank. During flight, two transfer pumps continuously feed fuel from the main tank to the supply tank via the transfer lines. Any excess of transferred fuel is routed back into the main tank via two overflow channels.

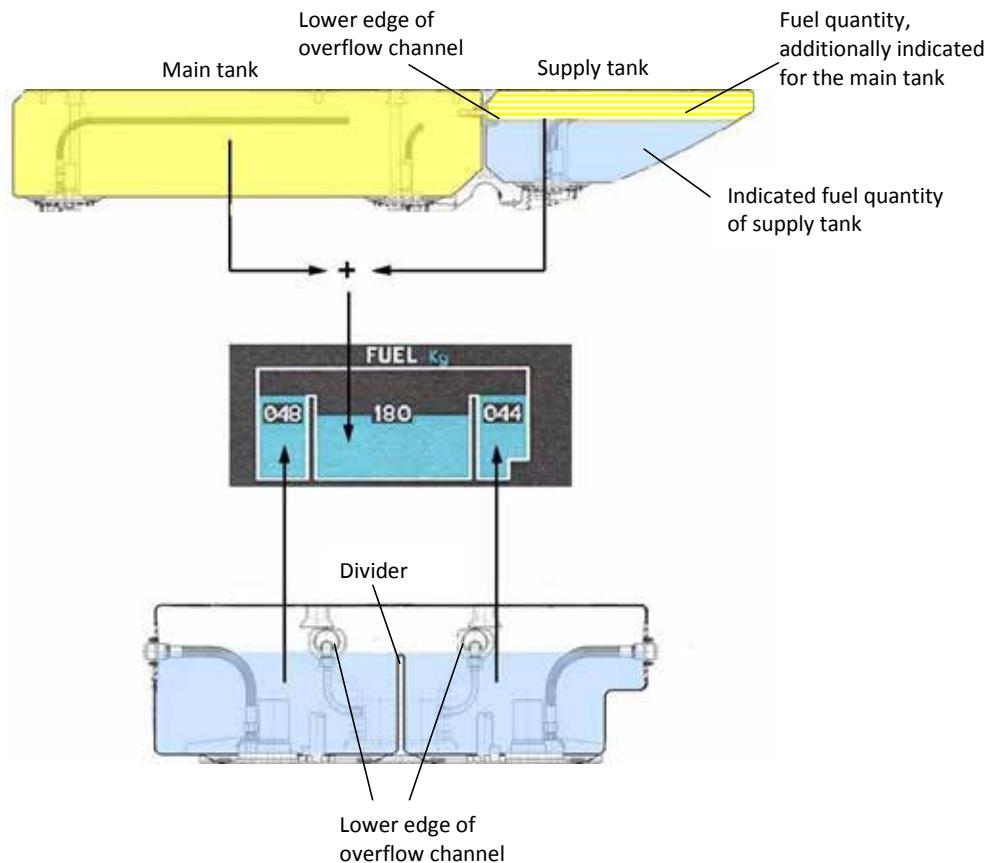
Figure 2: Fuel tank and fuel supply indication

The display system indicates the fuel quantity in the main tank and in the two supply tank chambers. The indicated fuel quantity of the two supply tank chambers represents the quantity measured up to the lower edge of the overflow channels (see Figure 2). The fuel quantity measured above the overflow channels located in the supply tank is added to the fuel quantity indicated for the main tank.

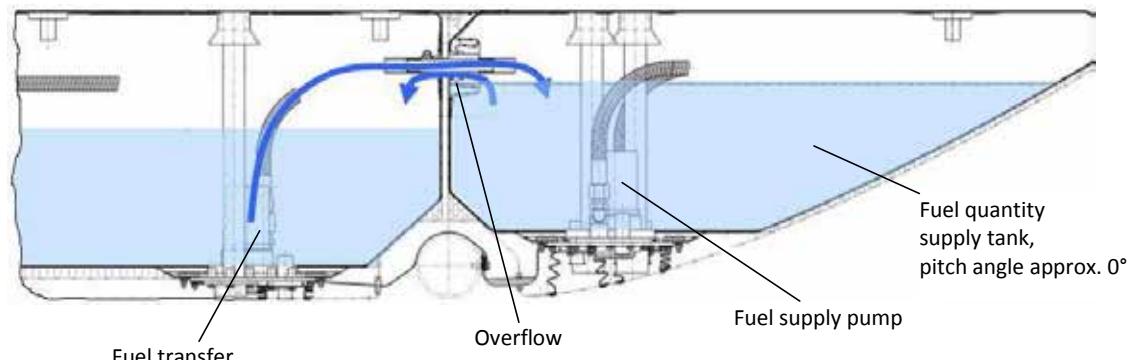
Figure 3: Supply tank, pitch angle approx. 0°

The actual maximum fuel quantity in the supply tank is defined for a pitch angle of 0° (see Figure 3).

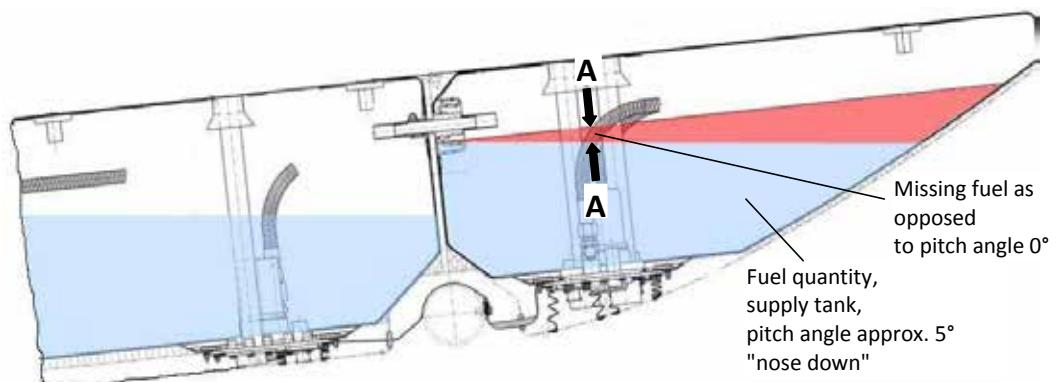
Figure 4: Supply tank, pitch angle approx. 5° „nose down“

The actual fuel quantity in the supply tank varies depending on the inclination of the helicopter. At "nose-down" pitch angles (e.g. during fast forward flight), the fuel quantity in the supply tank decreases (A-A, Figure 4). The fuel quantity indication of the supply tank also decreases but stabilizes at a certain level (depending on the pitch angle).

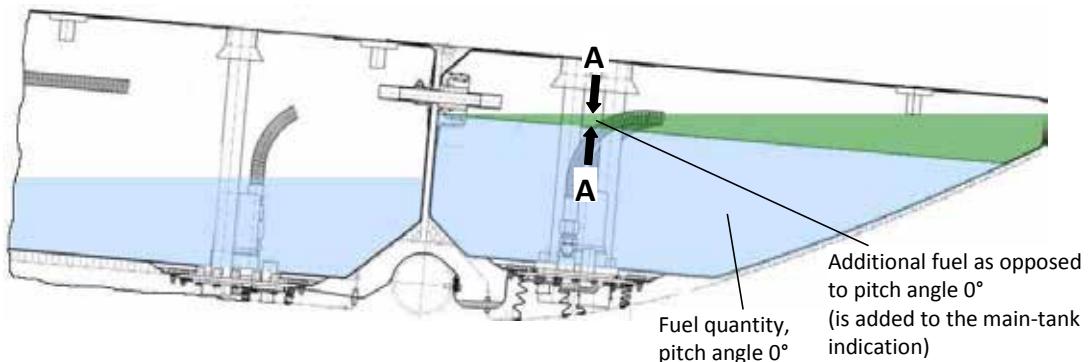
Figure 5: Supply tank, pitch angle approx. 5° „nose up“

At "nose-up" pitch angles (e.g. hover flight or when the helicopter is on the ground), the fuel quantity in the supply tank increases (see Figure 5). The additional fuel in the supply tank (A-A, Figure 5) is added to the fuel quantity displayed for the main tank. Therefore, in case of a certain fuel quantity and at certain pitch angles of the helicopter, a residual amount of fuel in the main tank may still be indicated although the main tank is already empty. At constant pitch angles and with decreasing fuel quantity, the fuel quantity indication of the main tank decreases before the fuel quantity indication of the supply tank also decreases.
