SL Report 2007/23

**REPORT ON THE AIRCRAFT ACCIDENT AT BODØ AIRPORT ON 4
DECEMBER 2003 INVOLVING DORNIER DO 228-202 LN-HTA, OPERATED
BY KATO AIRLINE AS**

June 2007

Type of aircraft: Dornier DO 228-202

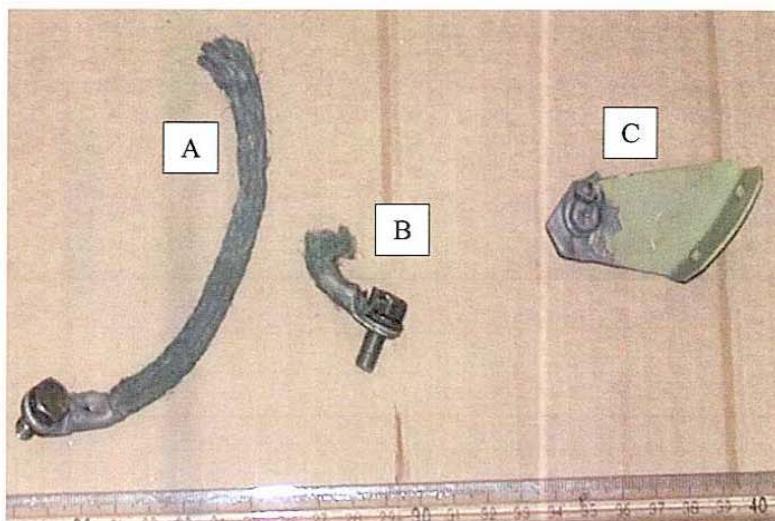
FOLAT, kjemi og materialteknologi, mottok deler av jordingskabler etter lynnedsLAG. Det var ønskelig å fastlå hvorvidt kablene hadde røket som følge av lynnedsLAGet, eller om kablene hadde vært utsatt for mekanisk slitasje. Det ble utført fraktografi i SEM samt metallografiske undersøkelser.

Figur 1 Oversiktsbilde av jordingskabler mottatt for undersøkelse, merket A, B og C.

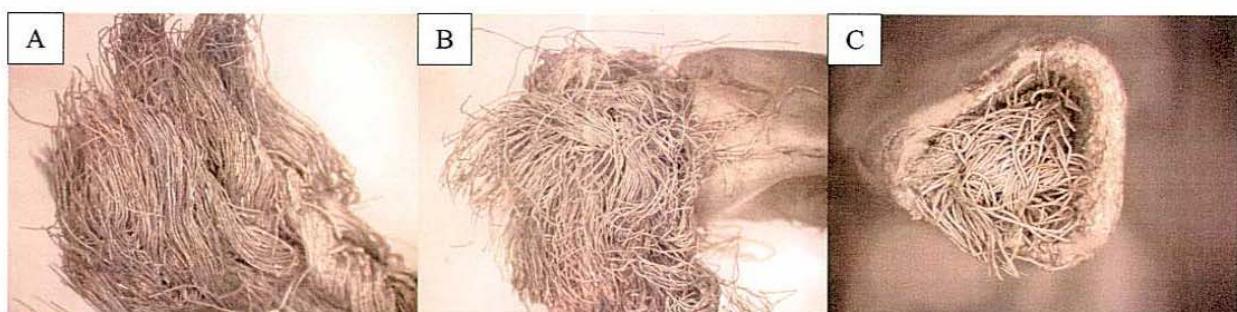
Noen karakteristiske bilder av bruddflatene på de ulike kablene ref. Figur 1 og Figur 2 er vist hhv. i Figur 3, Figur 4 og Figur 5. Gjennomgående kunne trådene deles inn i fire hovedgrupper: tråder med dimpler i bruddoverflaten, tråder med glatt overflate med liten/ingen innsnevring mot bruddflaten, tråder med innsnevring uten åpenbare dimpler, og tråder med smelteperler. Det var kun mulig å observere åpenbar smelting av noen få tråder på kabel A, se bilde b og d i Figur 4.

Det må også nevnes at fordi trådene var betydelig deformert, ref Figur 4a og Figur 5a var det vanskelig å få vurdert et tilstrekkelig antall bruddflater få å kunne gi en relevant statistisk vurdering av fordelingen til de ulike hovedgruppene.

Figur 2 Bilder tatt i stereomikroskop av de ulike kablene vist i Figur 1 (merket tilsvarende).

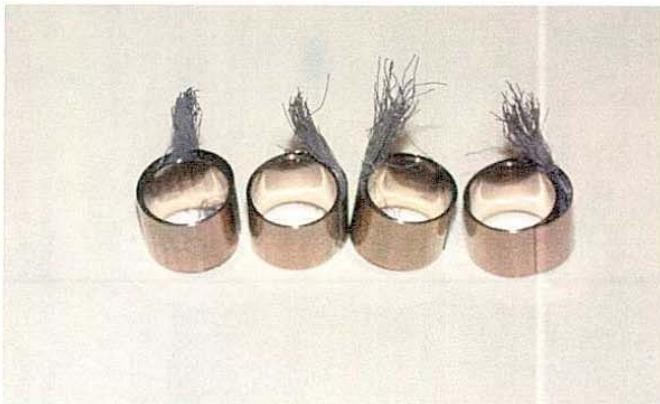
Kabelen merket A i Figur 1 ble valgt for å forsøke å gi et anslag på hvordan fordelingen mellom de ulike brudd typene var. Kabelen ble flettet opp, og fire prøver ble tatt ut, vist i Figur 6. Totalt 75 tråder ble undersøkt og delt inn i fire grupper: Dimpler: bruddflater med dimpler, Sm.Perle: bruddflater med smelteperler, U m/innsn.: Uidentifisert bruddflate med innsnevring og U u/innsn.: Uidentifisert uten innsnevring.

Figur 6 Oversiktsbilde av prøver tatt ut fra kabel merket A i Figur 1 for vurdering av bruddflater.

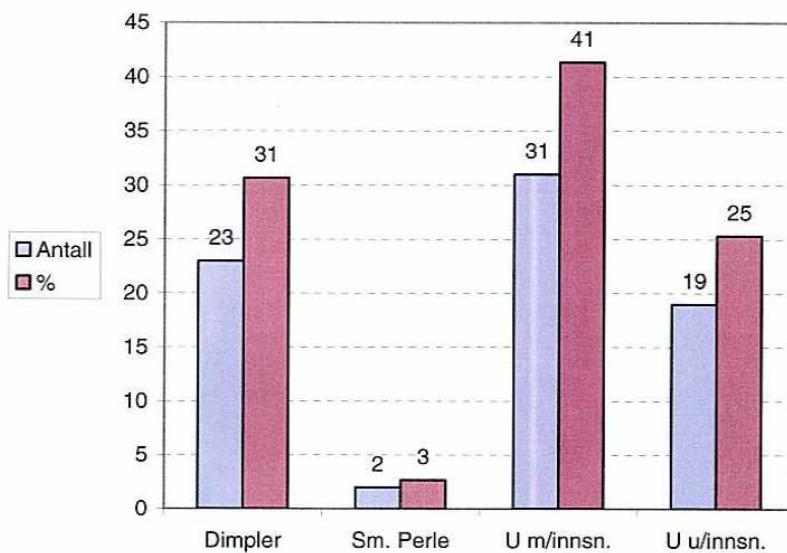
Figur 7 Grafisk presentasjon av fordeling (antall og prosentvis) av ulike bruddtyper. Totalt ble 75 tråder undersøkt.

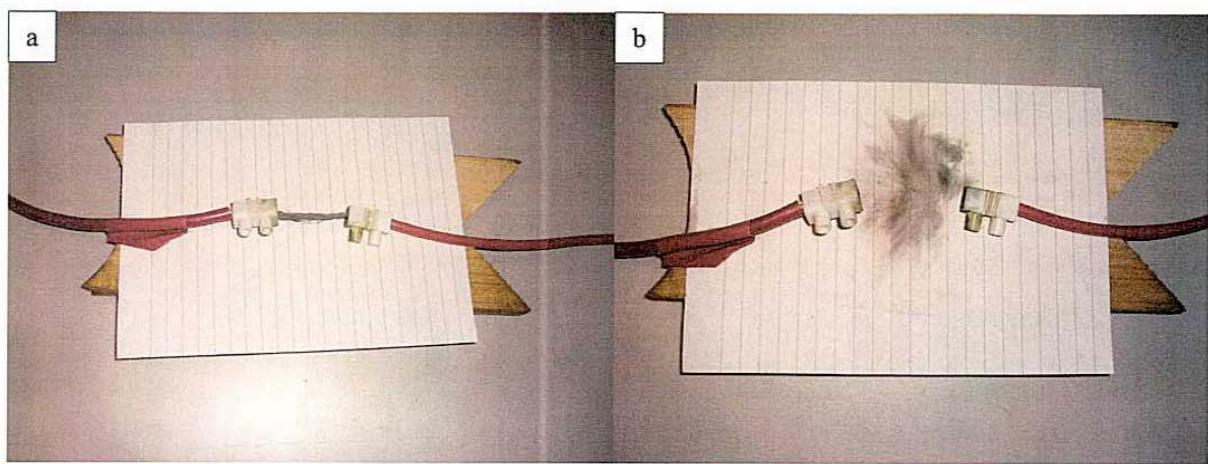
Lynnleder A (se Figur 1) ble flettet opp, og bunter med tråder ble utsatt for belastninger mellom 1500 og 2000 V. Forsøkene avdekket to forløp: i enkelte tilfeller ble lederen svidd av og delt i to, i de fleste tilfellene ble lederen pulverisert som vist i Figur 12b.

Figur 12 Oversiktsbilde av tråd før og etter belastning ved 2000V.

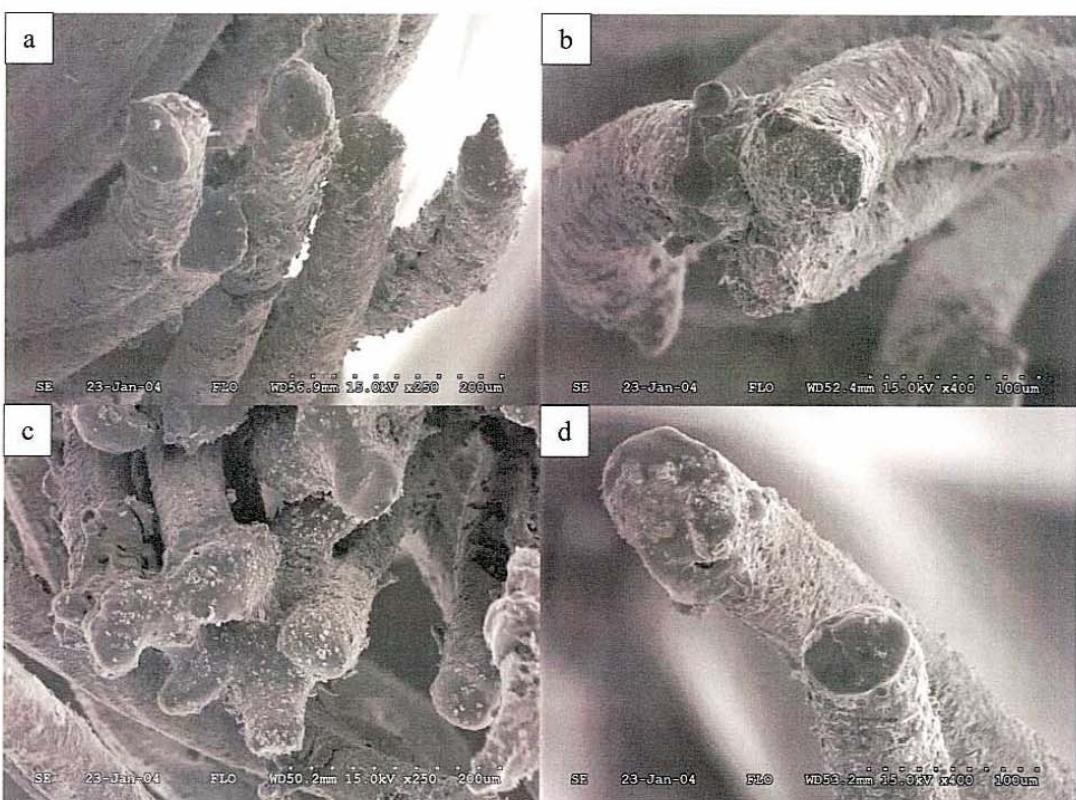
Brudflaten på to prøver der trådene ble svidd av ble undersøkt i SEM for sammenlikning med resultatene fra lederne undersøkt tidligere. Representative bilder av trådene er vist i Figur 13. Resultatene viser en noe større tendens til sammensmelting sammenliknet med observasjonene ovenfor, det kunne heller ikke observeres brudflater med dimpler.

Figur 13a-d Representative bilder i SEM av tråder etter avbrenningsforsøk, belastning 2000V.
