# Report

Accident on **13 July 2012**  
at **Le Castellet aerodrome (83)**  
to the **Gulfstream G-IV** aeroplane  
registered **N823GA**  
operated by **Universal Jet Aviation (UJT)**

Bureau d'Enquêtes et d'Analyses  
pour la sécurité de l'aviation civile

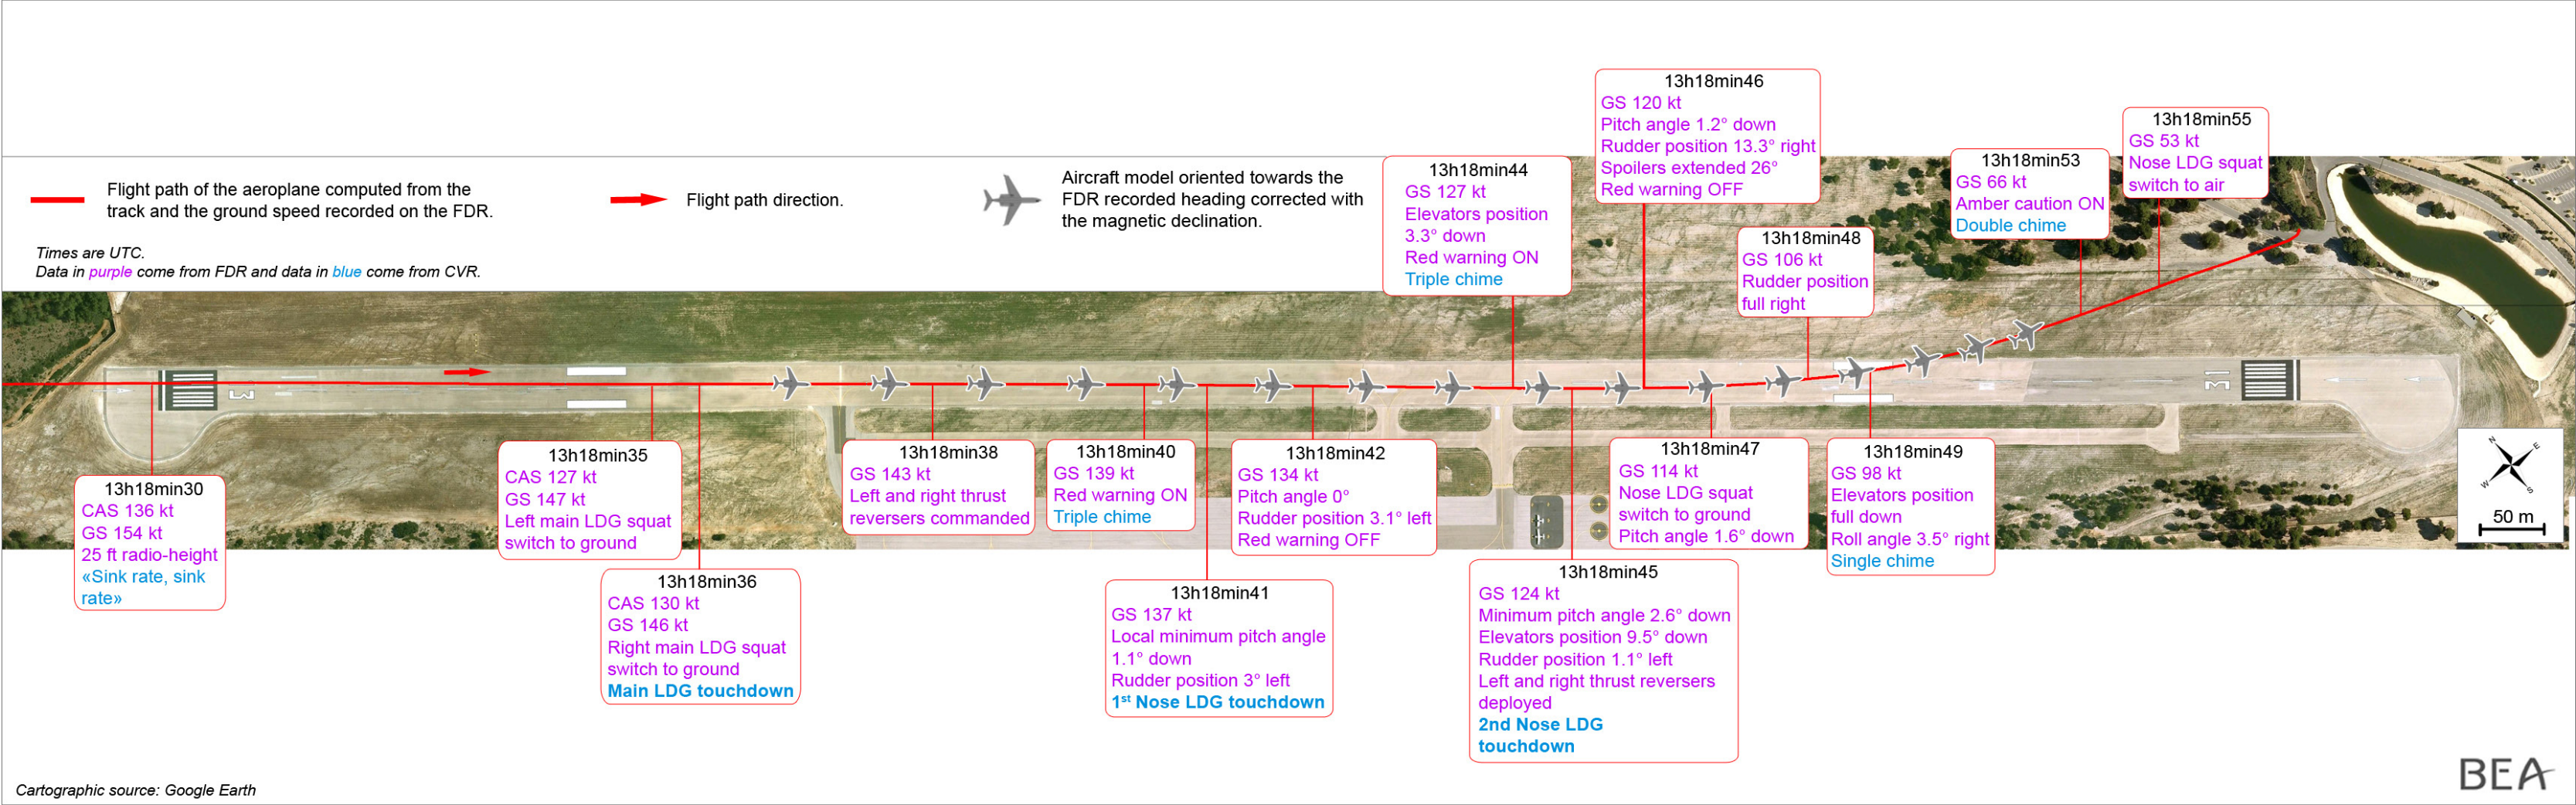
Figure 2: aeroplane flight path based on the track and the ground speed recorded on the FDR

The speedbrakes were then manually actuated by the crew with an input on the speed brake control, which then deployed the panels. Maximum thrust from the thrust reversers was reached one second later<sup>(6)</sup>. The aircraft at this time was 655 metres from the runway end and its path began to curve to the left. In response to this deviation, the crew made a sharp input on the right rudder pedal, to the stop, and an input on the right brake, but failed to correct the trajectory. The aeroplane, skidding to the right<sup>(7)</sup>, ran off the runway to the left 385 metres from the runway end at a ground speed of approximately 95 knots.

<sup>(3)</sup>Runway 13: 1 750 x 30 m, LDA 1 705m.

<sup>(6)</sup>The thrust reversers were fully deployed seven seconds after the command.

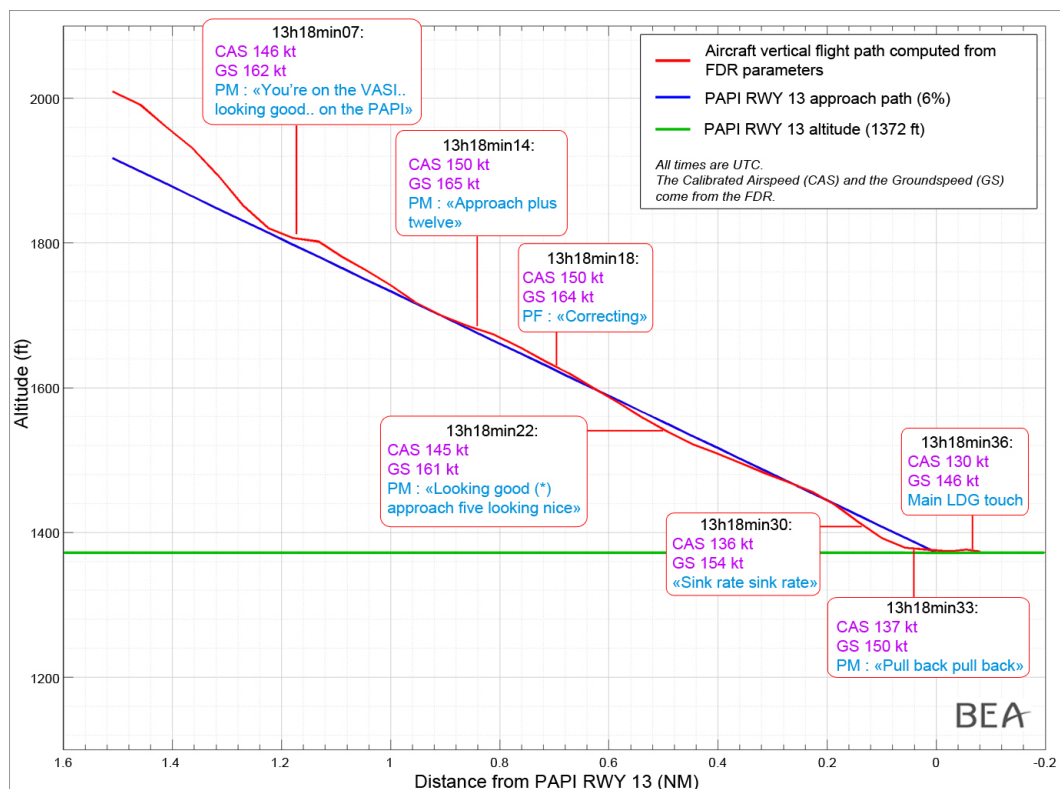
Figure 9: flight path in the vertical plane

The vertical path shows that during the final approach the crew intercepted the approach path indicated by the PAPI (6%) at a height of about 430 ft. This path was maintained with an indicated airspeed of 150 kt, close to the theoretical Vapp (148 kt). A tailwind component of ten knots was present on the final approach. On approaching the threshold the airspeed decreased towards the Vref of 138 kt.

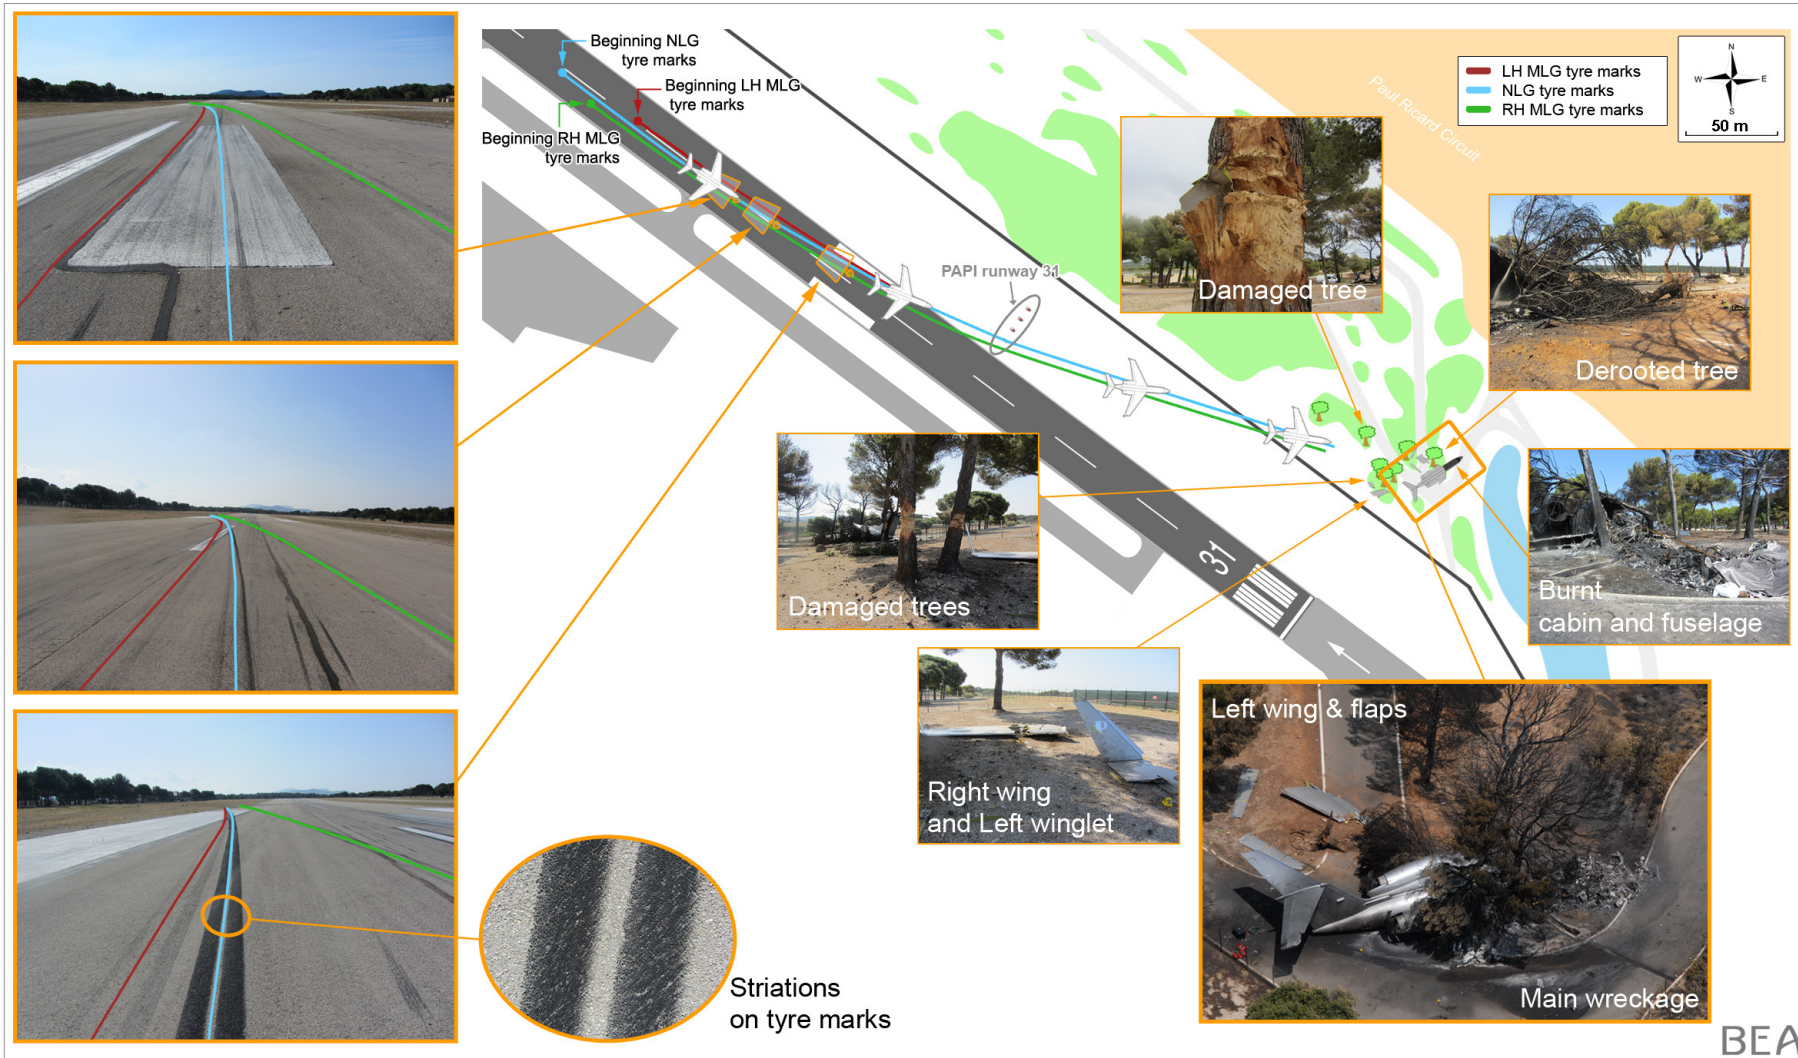
The first tyre marks observed on the runway attributed to N823GA were left by the nose gear<sup>(19)</sup>. They were continuous to the runway edge over a longitudinal distance (in relation to the runway centre line) of 270 metres. The marks from the right main landing gear start 30 metres after those of the nose gear, those of the left main landing gear started 25 metres after those of the right main landing gear (*see the diagram and photographs below*).

Particular attention was paid to the nose gear marks. The tyre grooves were initially visible (*photos 1 to 3 in figure 12*) and the marks were not very noticeable. They then became darker and the tyre grooves disappeared. The width of the marks left by each tyre increased with the travel of the aeroplane and the gap between the two marks decreased until they disappeared.

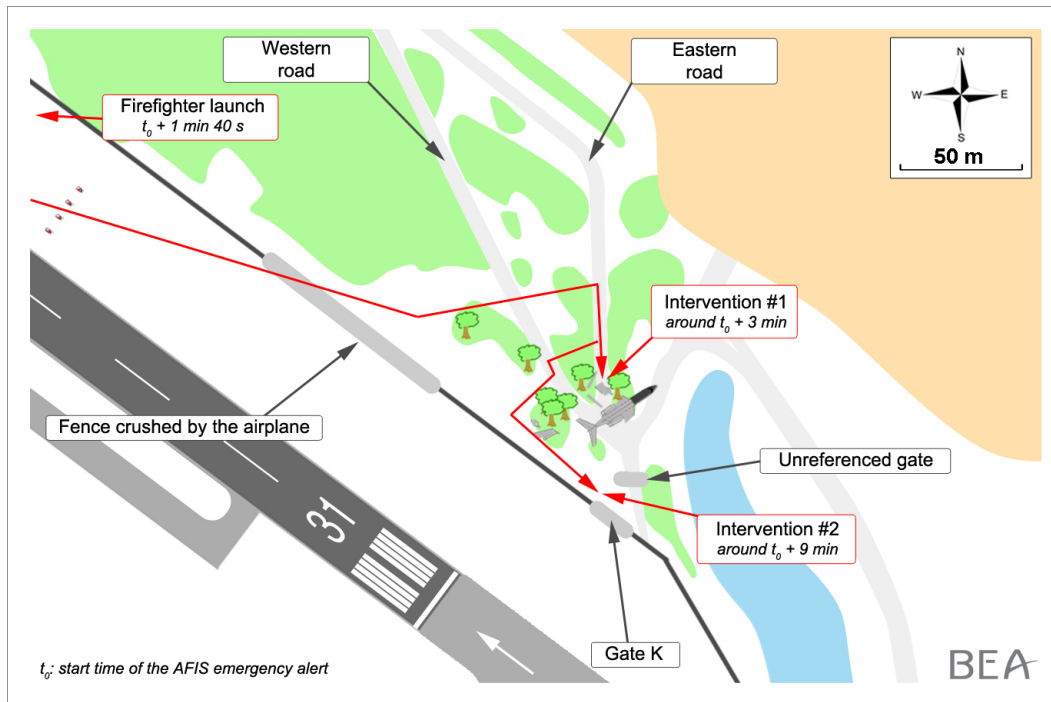
Figure 15: estimated fire-fighter routing and intervention positions, based on his interview

He was notified immediately after the runway excursion by the AFIS officer and intervened at the site about 3 minutes after the alert was given. He carried out the first intervention without moving about 30 metres from the wreckage using the cannon on the foam response vehicle (VIM), at full flow about 30 seconds. Hindered by trees located between him and the aeroplane, he changed strategy and decided to go around the wreckage to the south. The second intervention took place about 6 minutes after the first operation, also without moving at about 30 metres from the wreckage, first on the stretch of water on which the fuel was burning<sup>(20)</sup>, then on the wreckage itself. The cannon was used at half-flow until all of the water was used up. A detailed chronology of the intervention can be found in **appendix 4**.

<sup>(20)</sup>The firefighter said in his interview that he initially thought the cockpit was located here.

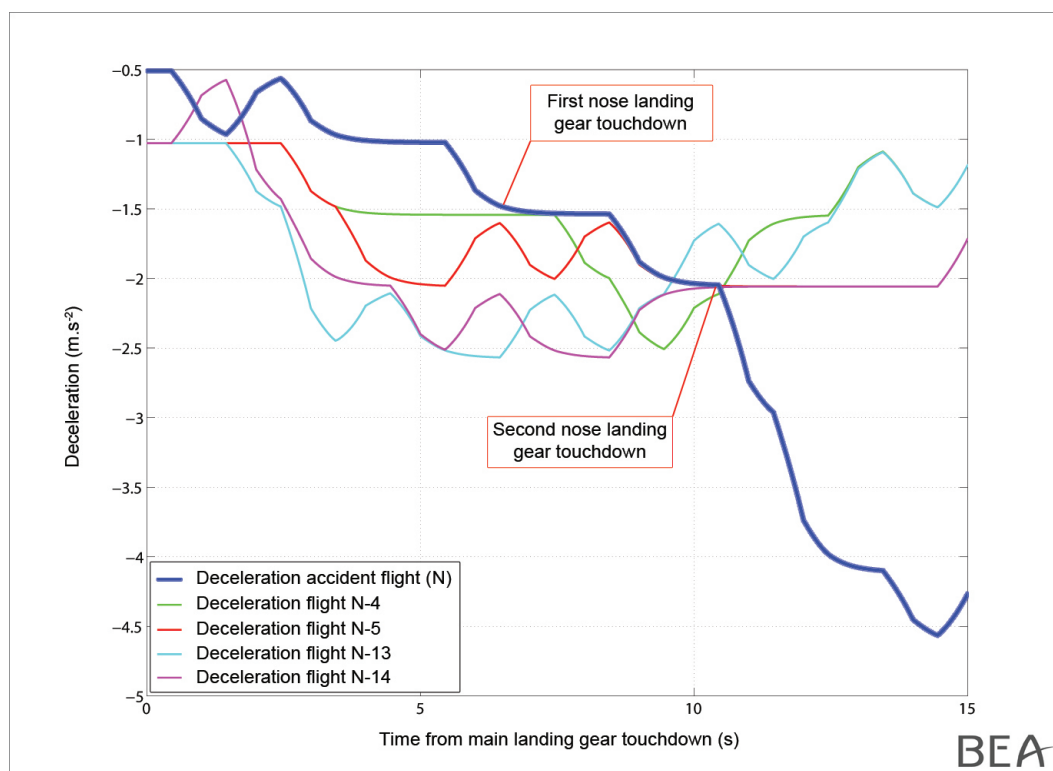
Figure 16: deceleration

This deceleration was compared to that of four of the other touchdowns by N823GA recorded on the FDR, in which the technique used was found to be similar to that of the accident until the first touchdown of the nose gear wheels.

<sup>(21)</sup>During the event, the speedbrakes deployed 10 seconds after the wheels touched down (see figure 2).

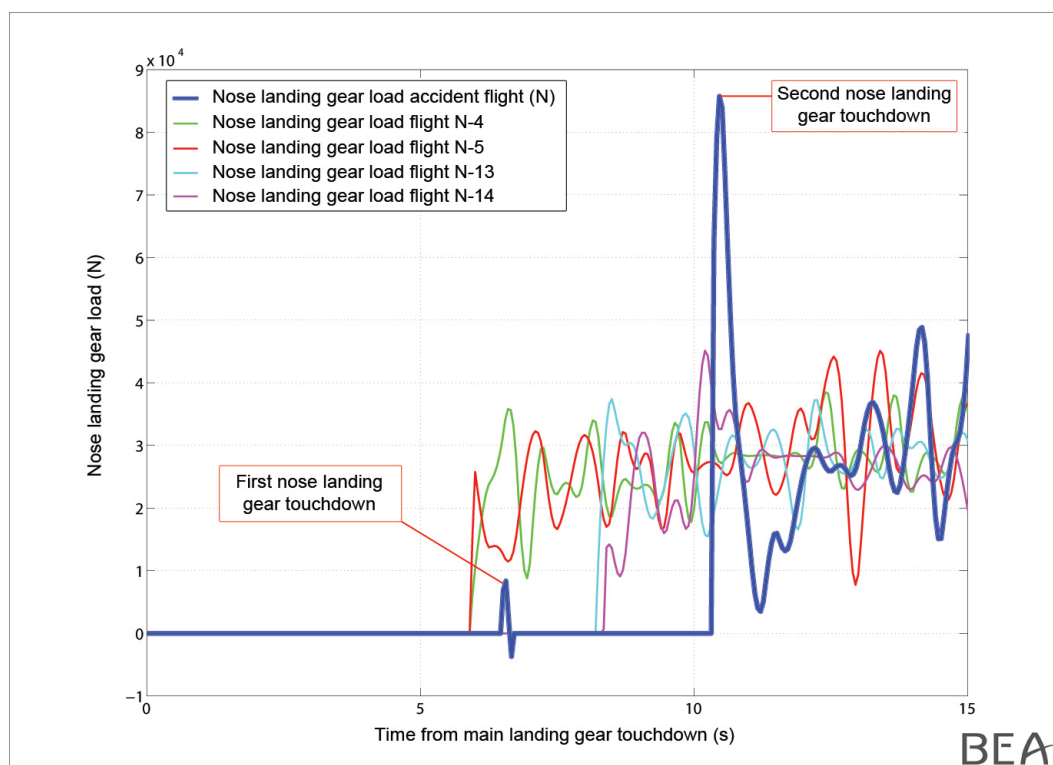
Figure 19: comparison of vertical loads on the nose gear

The results show that the vertical load on the nose landing gear at the first touchdown was of low value, lower than that observed on previous flights. On the second touchdown, the load reached the value of 85,000 N<sup>(25)</sup> (a value 3 times higher than the average value calculated for the other landings), close to the permissible nose gear limit load. Due to the precision of the calculations, it is nevertheless not possible to state that the limit load was not exceeded. This was followed by a rebound effect, a decompression of the nose gear characterized by a load 2 to 3 times lower than that of the other landings. The nose gear was then compressed again and the loads were similar to those of the other landings, in terms of their mean value, their amplitude and the frequency of the oscillations.

<sup>(25)</sup>The nose gear of the G-IV has been certified for a limit load of 98,000 N (ultimate load is 147,000 N).

The various calculations and simulations carried out as part of this investigation, therefore, did not reveal high loads on the nose gear apart from the maximum value reached immediately after the second touchdown (see figure 19). The values of the loads calculated on the nose gear and the main landing gear during the accident aeroplane's landing were of the same order of magnitude as those calculated for previous landings. A "wheelbarrowing" phenomenon cannot therefore explain the aeroplane's lateral deviation to the left.

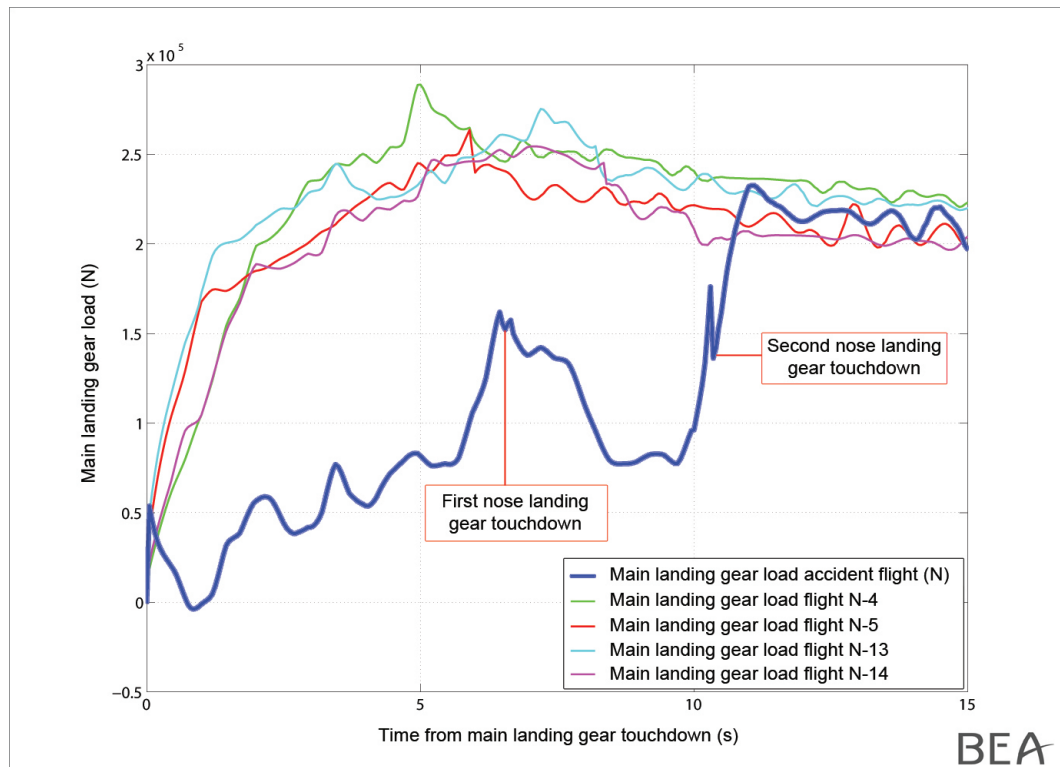
Figure 20: comparison of the vertical loads on the main landing gear

The calculated load on the main landing gear during the accident flight landing was about 2 to 3 times lower than for other landings during the first ten seconds of landing roll and then reached values similar to those of the other landings.

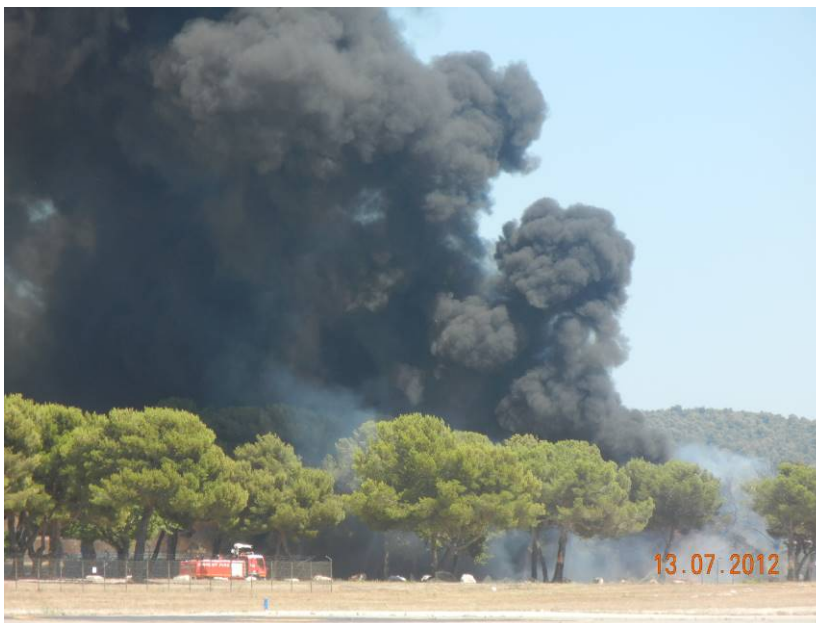
Photo 1

On photo 1, the foam response vehicle (VIM) has stopped (discussion with circuit staff). It is on its way to the site of the second intervention.

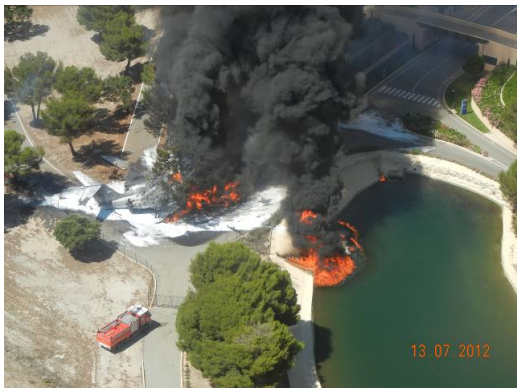
Photo 4

The second intervention probably took place at about 13 h 28 on the lake and then on the wreckage. About 6 minutes elapsed between the photo taken on the "west" access road and photos 4 (second intervention had not yet started) and 5 (second intervention under way).

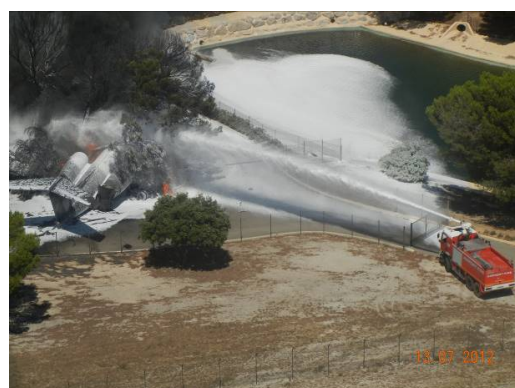
Photo 5

On photo 5, the vehicle is approximately 30 meters from the wreckage with the water cannon being used at half flow rate until it ran out of water.

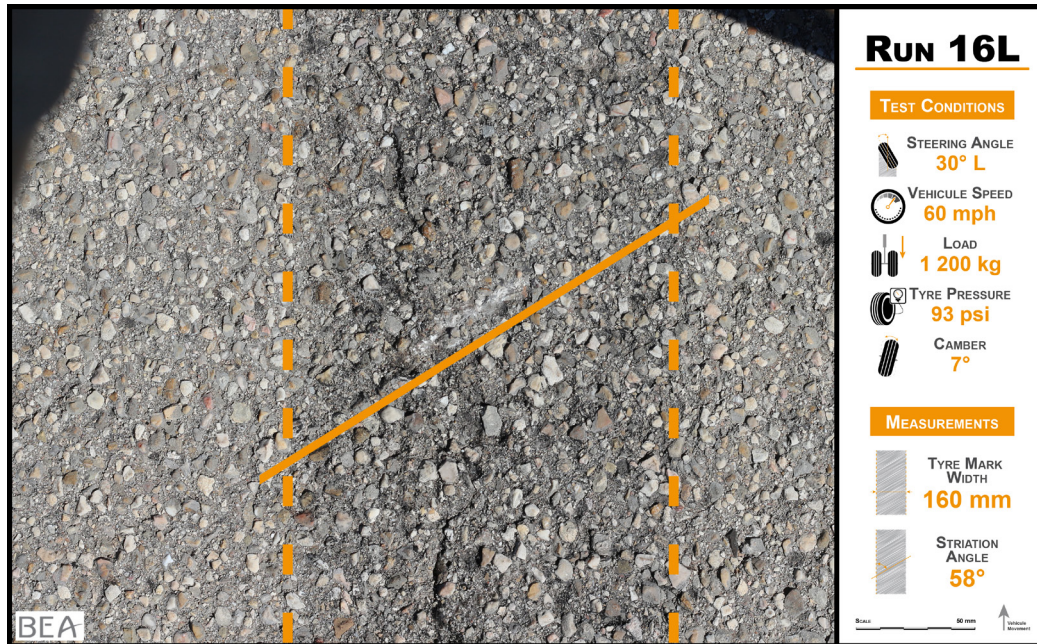
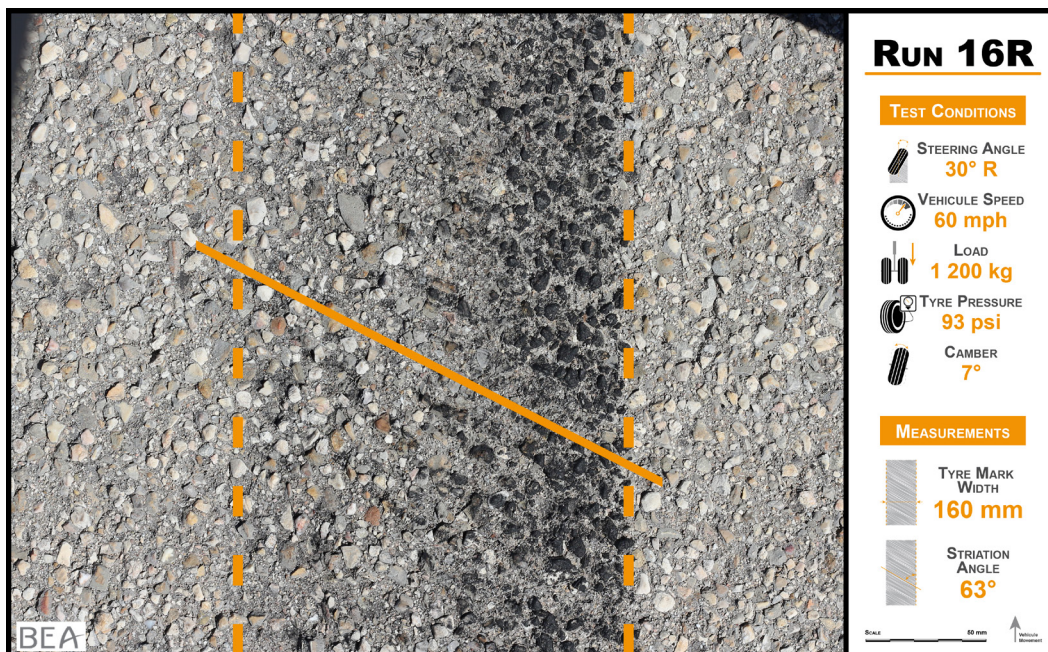
Figure 3: photograph taken at the end of a test

- ❑ no striations were observed for wheel orientations of 10°;
- ❑ the angle of the striations (whatever their direction) appears to be primarily dependent on the orientation of the wheels. The other parameters (load, vehicle speed, camber, tyre pressure) do not appear to have a significant influence on the striation angle<sup>(6)</sup>;

- an increase in the camber does not have much influence on the width of the marks. However the latter seem darker.
