Civil Aviation Accident
Investigation Board (JIAAC)

Technical Report 096/2011

Accident that occurred on 18 May 2011

**Aircraft Saab 340 A, LV-CEJ. Location: Caltrauna,
between Los Menucos and Prahuanieu, province of Río
Negro**

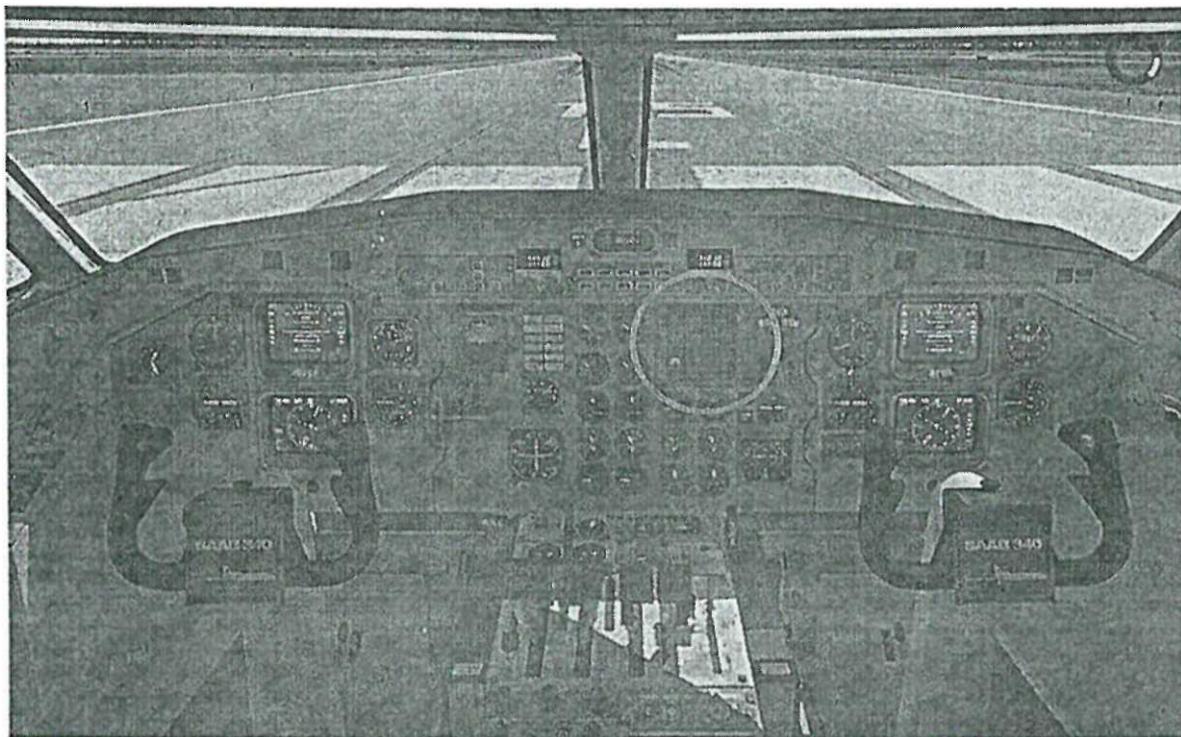
The Central Warning Panel (CWP) is composed of a total of forty (40) light indicators. Each of these indicators has two micro-incandescent lamps that light up simultaneously to give an announcement. In order to determine whether an alarm was activated at the time of the accident, the remains that could be retrieved were sent to the manufacturer's facilities for referral (under the supervision of SHK Sweden).

Blueprint of the cockpit, which details the location of the central alarm panel.
