Air data system failure involving Airbus A330-243 A6-EYJ

near Brisbane Airport, Queensland | 21 November 2013

ATSB Transport Safety Report
Aviation Occurrence Investigation
AO-2013-212
Final – 6 May 2016

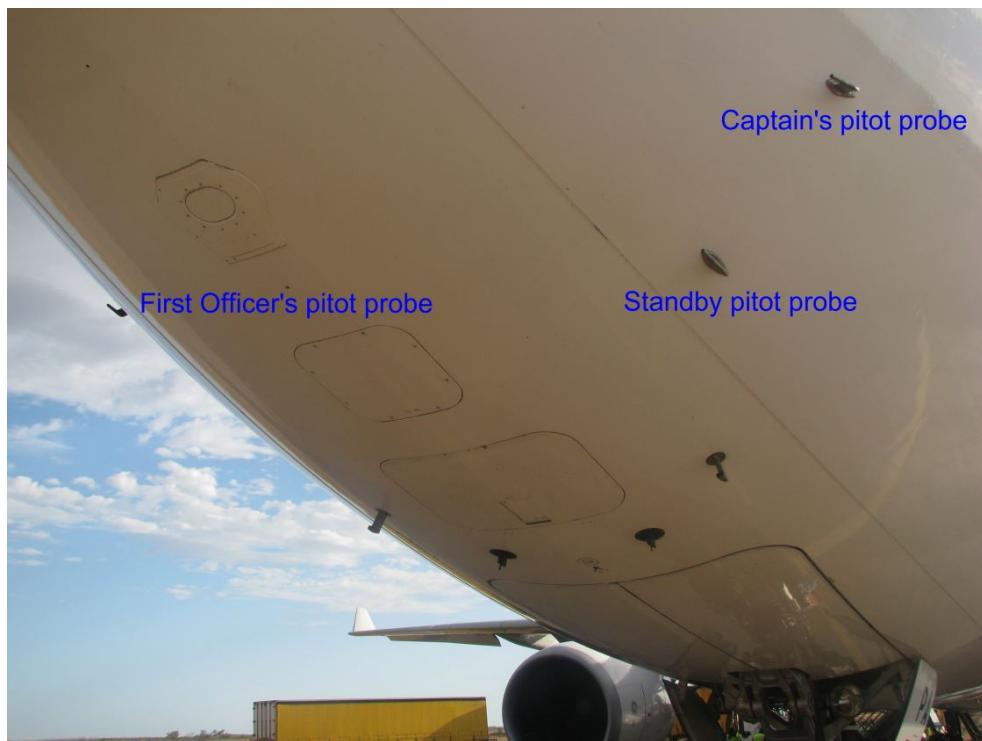
Figure 2: Locations of pitot probes

The locations of the aircraft's pitot probes are shown in Figure 2.

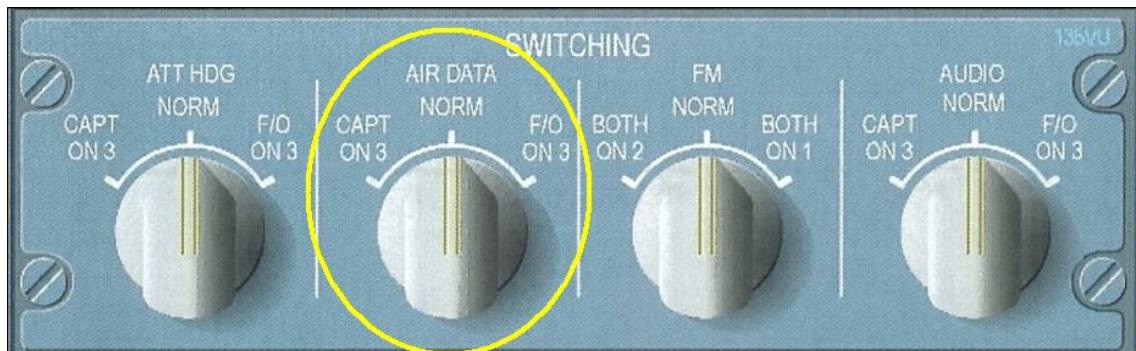
Figure 3: Air Data Switching

Normally, the airspeed displayed to the captain uses the captain's pitot probe and ADIRU 1, but the source can be manually switched by the crew to the standby system (standby pitot probe and ADIRU 3) if required. Similarly, the airspeed displayed to the first officer (FO) normally uses the first officer's pitot probe and ADIRU 2, but the source can be manually switched by the crew to the standby system if required (Figure 3).
