Air Accident Investigation Unit Ireland

SYNOPTIC REPORT

SERIOUS INCIDENT
Boeing 757-224, N41140
80 NM Southwest of Dublin, Ireland
20 October 2013

AAIU Report No: 2016-007

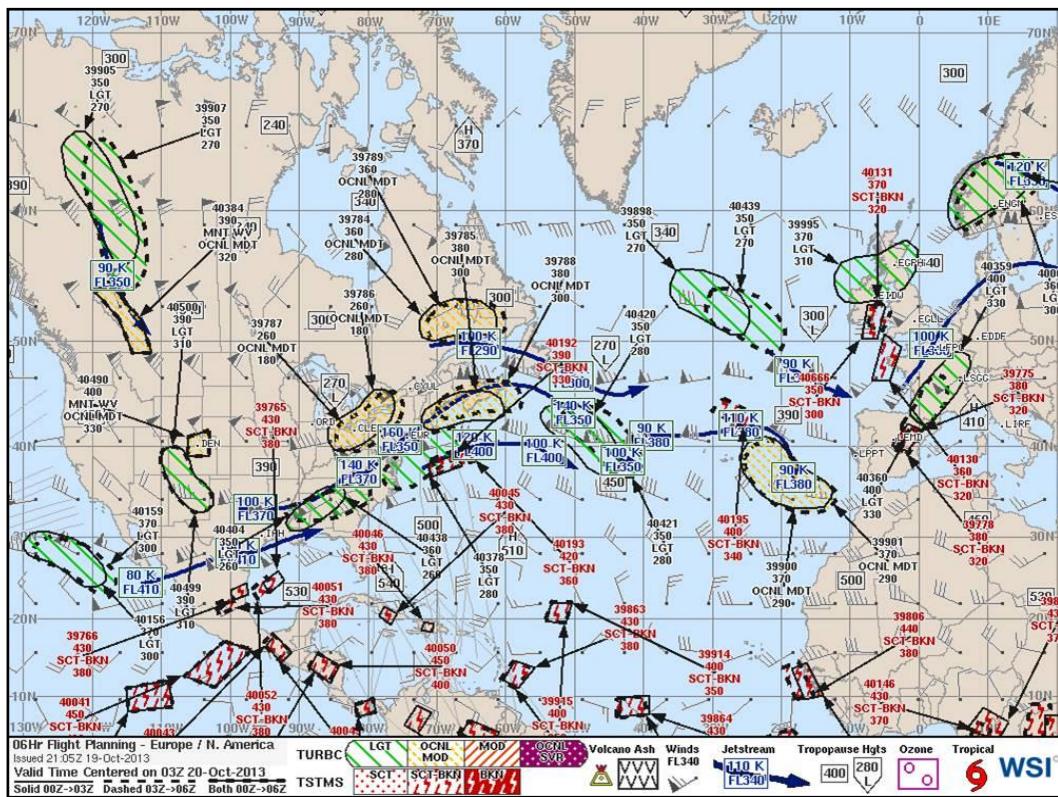
Figure No. 3. Significant Weather Chart, available to Flight Crew of this flight

The Operator provided the Investigation with a copy of a weather chart, which it describes as '*Significant Weather Briefing chart (available to the crew by 19/2105z)*'. This is shown in **Figure No. 3**. The chart indicates the possibility of scattered to broken thunderstorms over the south-eastern part of Ireland, and light turbulence forecast for the midlands and northern half of Ireland.

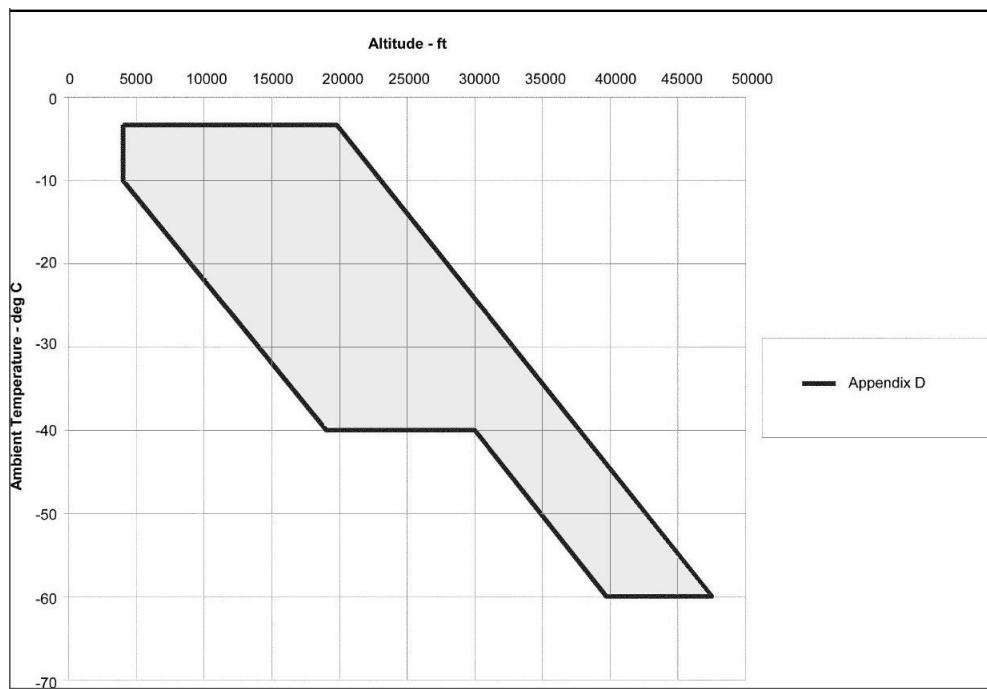
Figure No. 5: The Convective Cloud Ice Crystal Envelope as depicted in FAR Part 33, Appendix D

Part 33, Appendix D of the regulation, referred to above, defines the convective cloud ice crystal icing envelope in graph format (**Figure No. 5**). The shaded area of the graph shows the conditions in which ice crystal icing is most likely to occur in association with convective cloud activity.
