Air Accidents Investigation Branch

**Report on the accident to  
Boeing 737-236 series 1, G-BGJL  
at Manchester International Airport  
on 22 August 1985**

15 December 1988

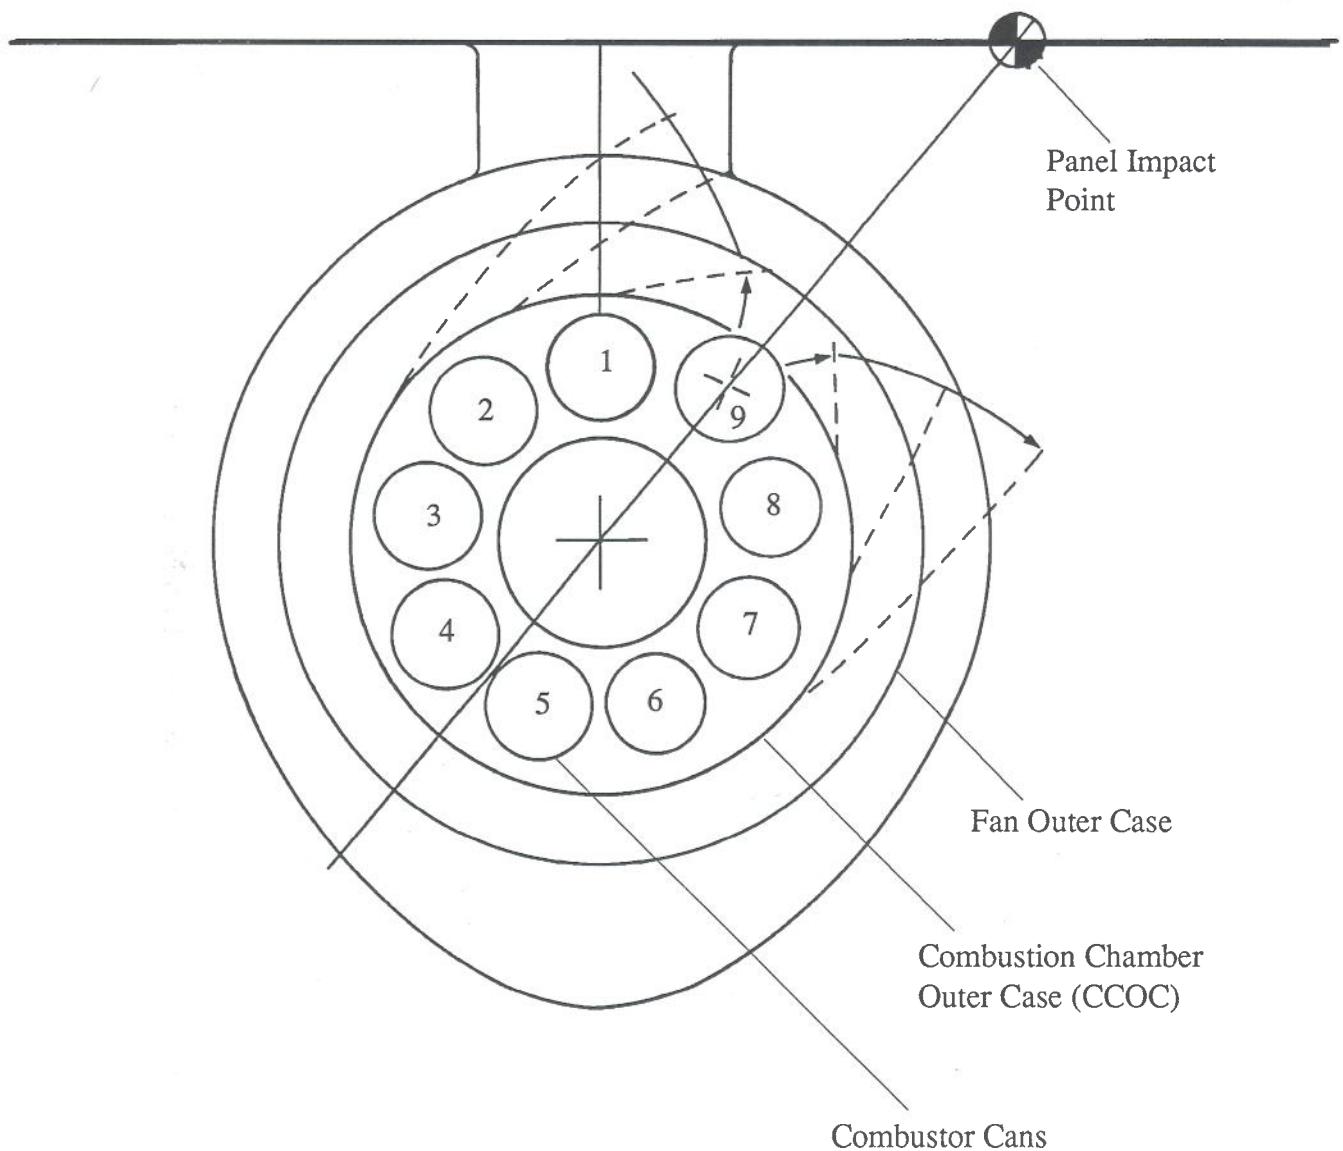
Appendix 5 fig f

Engine Section Through Combustion Chamber  
Looking Aft

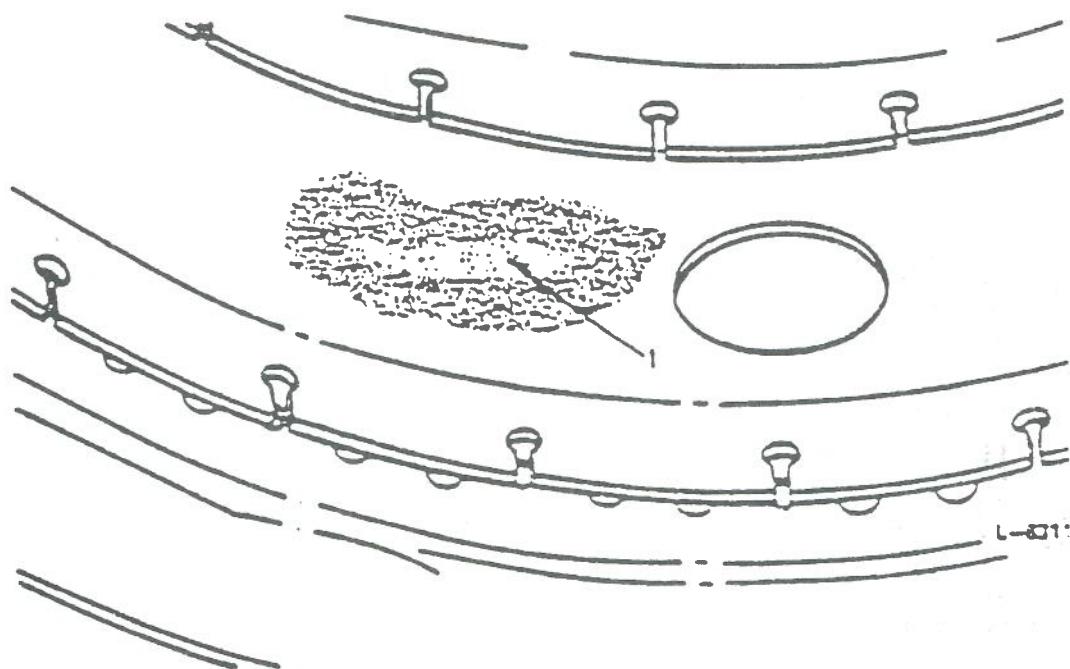
Appendix 5 fig.h

"(g) Severe local distortion and/or oxidation of liners is not acceptable and is not weld repairable. See figure 807. Replace liner if condition exists.  
(Appendix 5 h)

Severe Local Oxidation And  
Distortion (Unacceptable)  
Figure 807  
(Subtask 72-41-14-22-046)

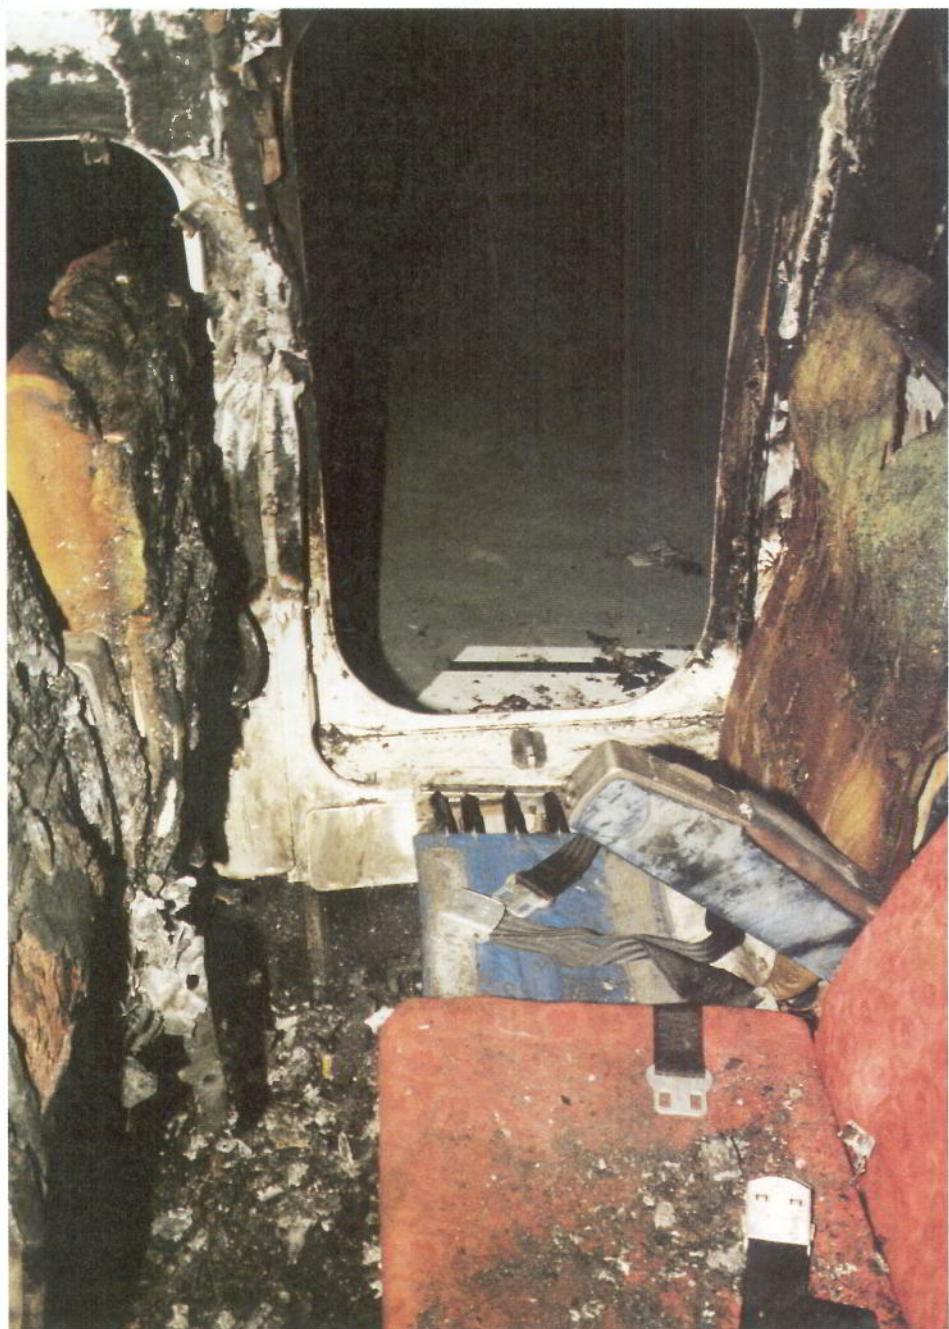
Area Adjacent to the Right Overwing Exit
