# AIRCRAFT ACCIDENT REPORT 1/2017

Report on the accident to  
**Hawker Hunter T7, G-BXFI**  
near Shoreham Airport  
on 22 August 2015

### Air Accidents Investigation Branch

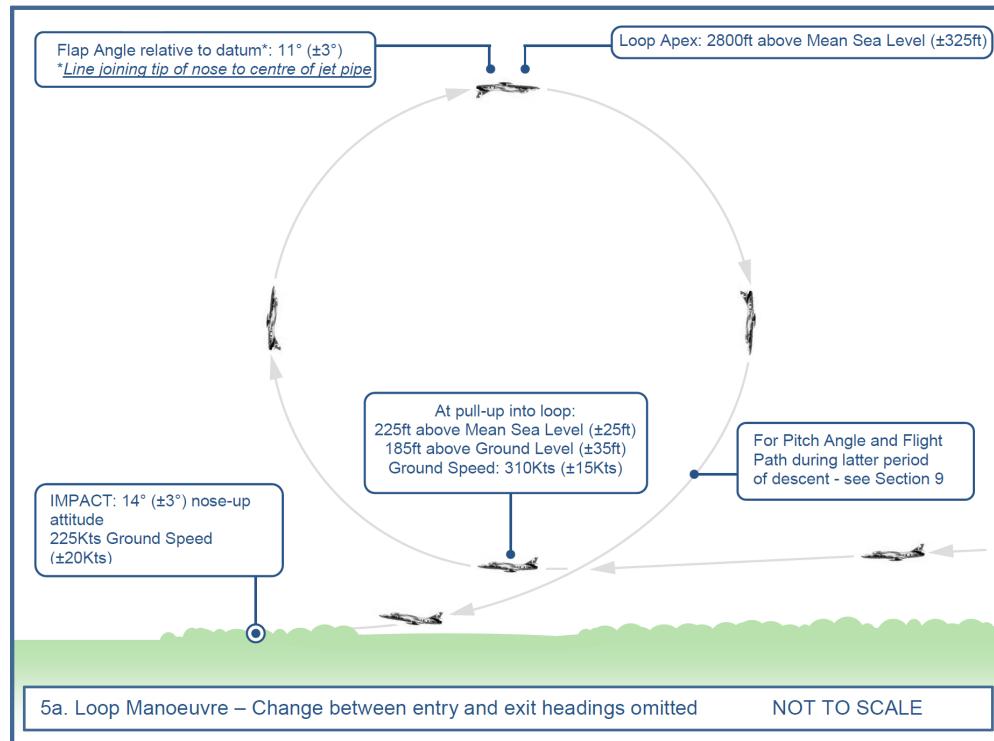
**Figure 12**

An extract from the MOD photogrammetry report showing a schematic representation of the accident manoeuvre.  
The change in heading is not shown

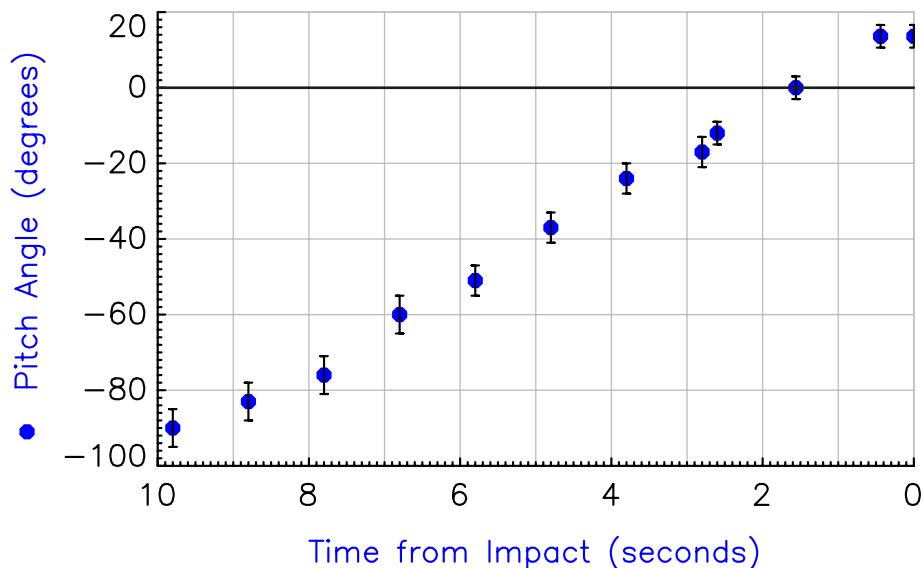
**Figure 13**

Pitch angle data in the last 10 seconds of flight.  
Data extracted from the MOD photogrammetry report

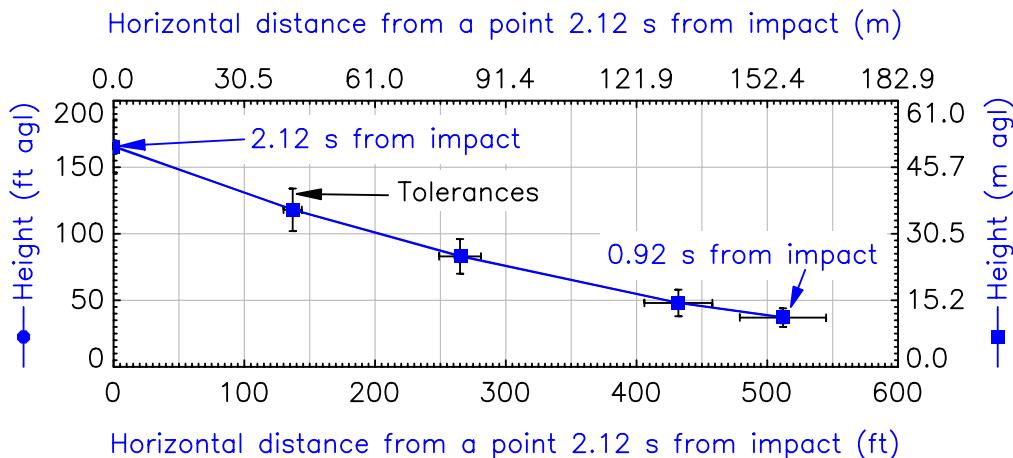
**Figure 14**

Flight path geometry during the final seconds of the descent.  
Data extracted from the MOD photogrammetry report

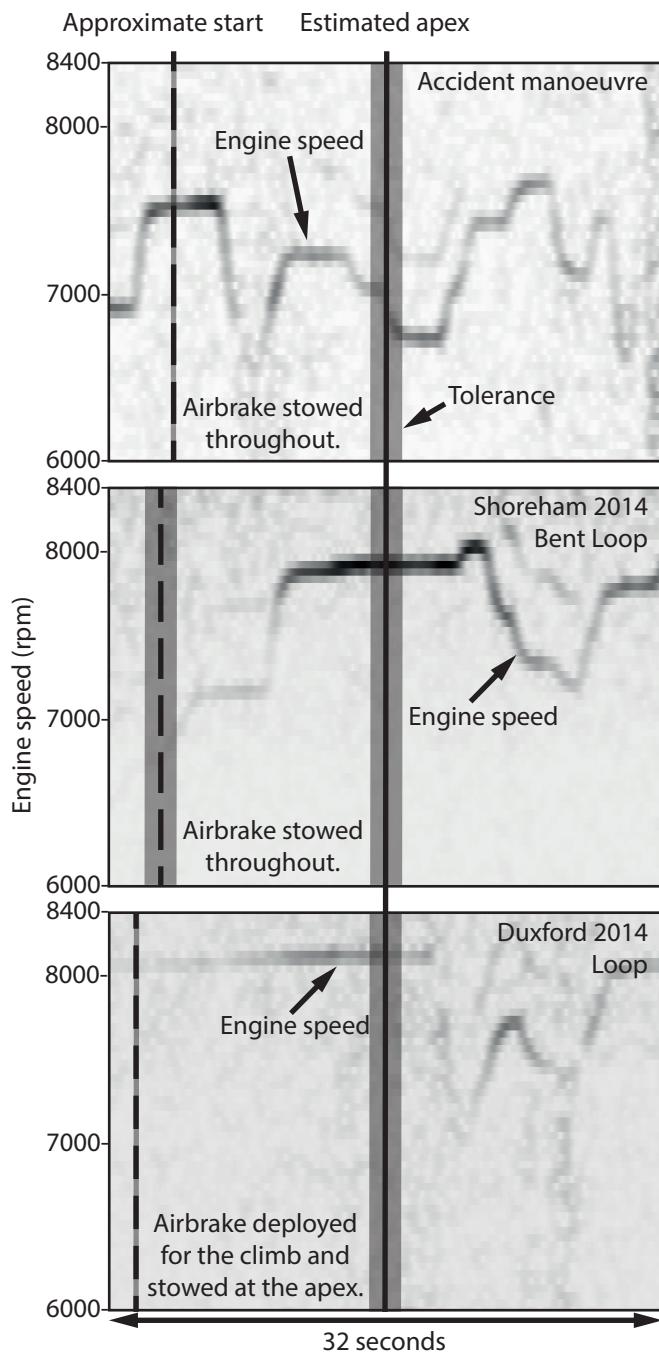
**Figure 15**

[Figure 15](#) shows the audio signature associated with engine speed for the accident manoeuvre, derived from audio spectrum analysis, and compares it with the two successful loop manoeuvres captured by the cockpit action cameras from previous displays flown by the same pilot.

Engine speed during the loop at Duxford in 2014 was approximately the maximum allowable throughout the climb. The Shoreham 2014 manoeuvre was initiated with a low engine speed which then stepped up in two stages, levelling at slightly under 8,000 rpm for the last part of the climb. The climb for the accident manoeuvre was initiated with an engine rpm approximately half way between the initial engine rpms of the other two manoeuvres. The engine speed then reduced to below 7,000 rpm, recovered to and briefly held at 7,250 rpm, and then reduced further, passing below 7,000 rpm at the apex. At the apex of the accident manoeuvre, the engine speed was approximately 1,000 rpm lower than for the other two manoeuvres. A further distinction of the accident manoeuvre is that the engine speed increased during the descent whereas during the other two comparison manoeuvres the general trend was a reduction in engine speed.

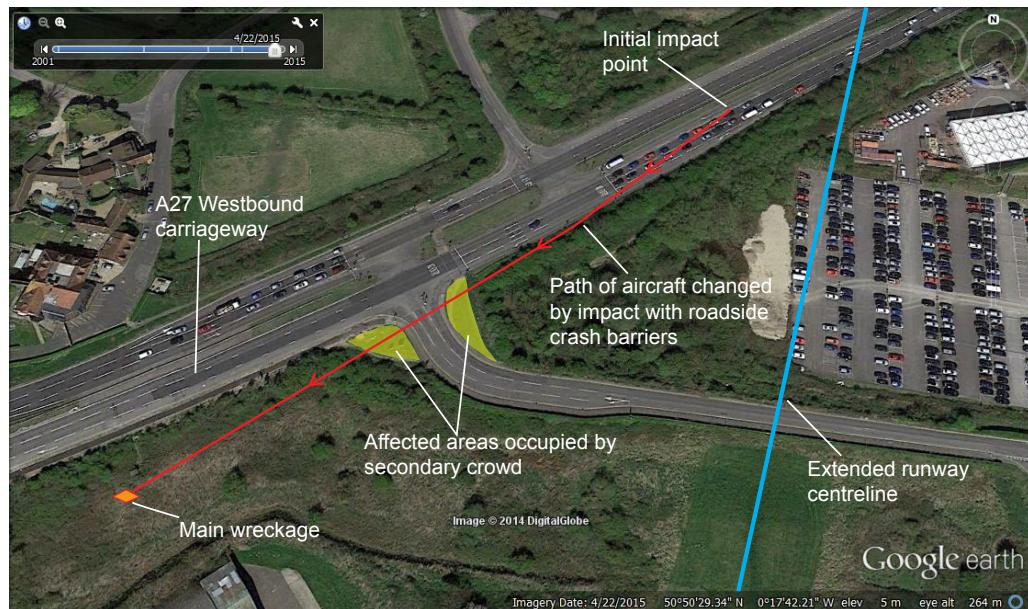
The aircraft crashed on to the westbound carriageway of the A27, Shoreham Bypass, near its junction with Old Shoreham Road and Coombes Road, which is close to the northern perimeter of Shoreham Airport ([see Figure 16](#)). During the impact sequence the aircraft struck occupied vehicles and people around the road junction, traffic light stanchions, road signs and a crash barrier.

The aircraft continued across the junction and passed through a number of small trees and down a bank into a shallow overgrown depression to the south of the A27. It came to rest in four main pieces which were close together, approximately 243 m from the initial point of ground contact, as shown in [Figure 16](#).

**Figure 16**  
Illustration of accident site location (image not from the day of accident)

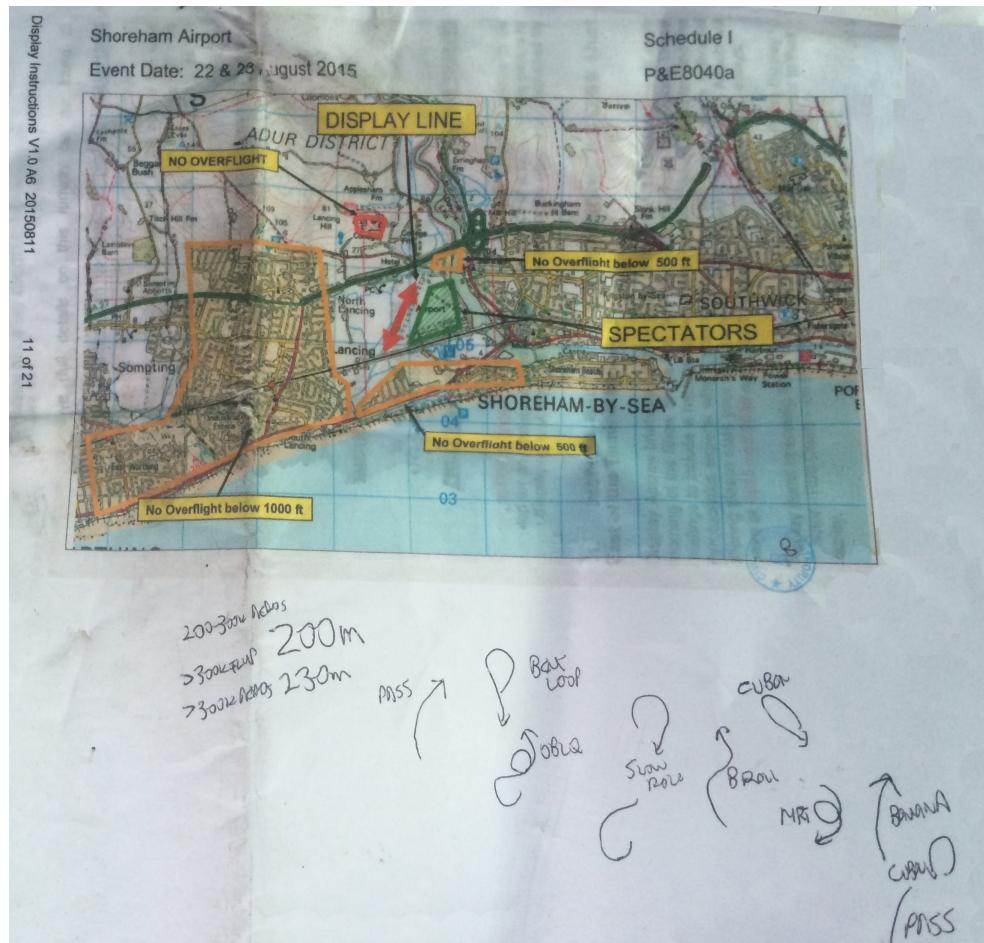
**Figure 17**

The pilot had annotated one of the display maps for the 2015 Shoreham Airshow ([see Figure 17](#)) with the sequence of manoeuvres he intended to fly during the display, and other reference information such as relevant frequencies; this was found folded in a separate pocket, and would not have been visible to the pilot during the flight.

Annotated display map from pilot's pocket.  
The image has been edited to remove damage sustained in the accident

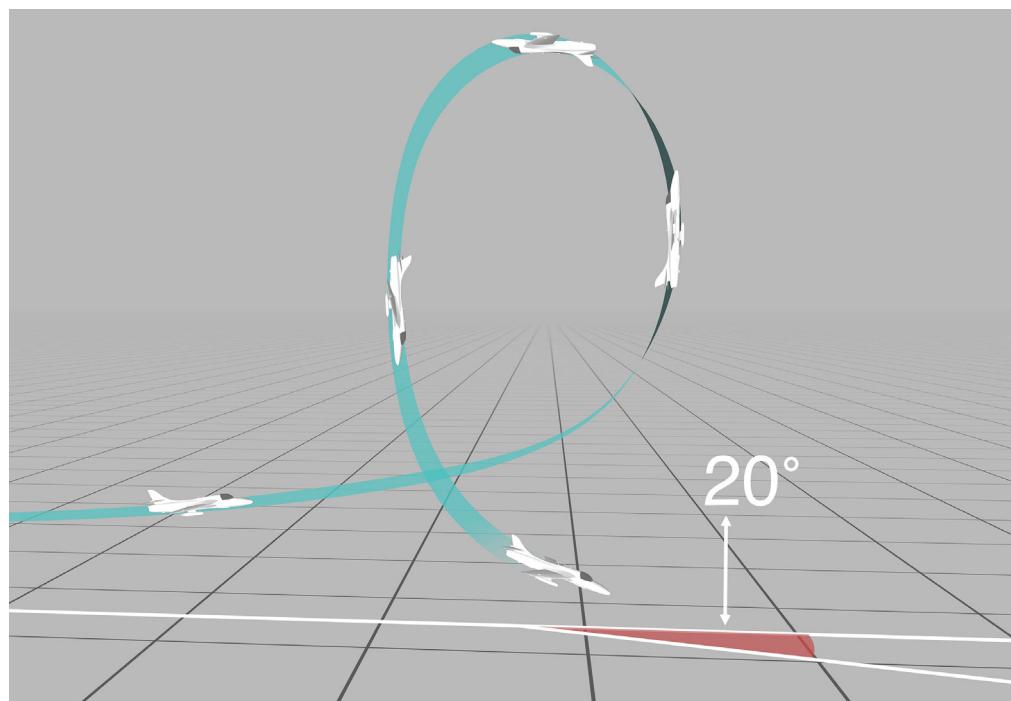
**Figure 23**  
Manoeuvre with vertical component and roll resulting  
in a change of ground track

In the accident manoeuvre the aircraft rolled through a greater angle than in the manoeuvre intended by the pilot and resulted in an exit ground track approximately 60° right of the entry ground track.

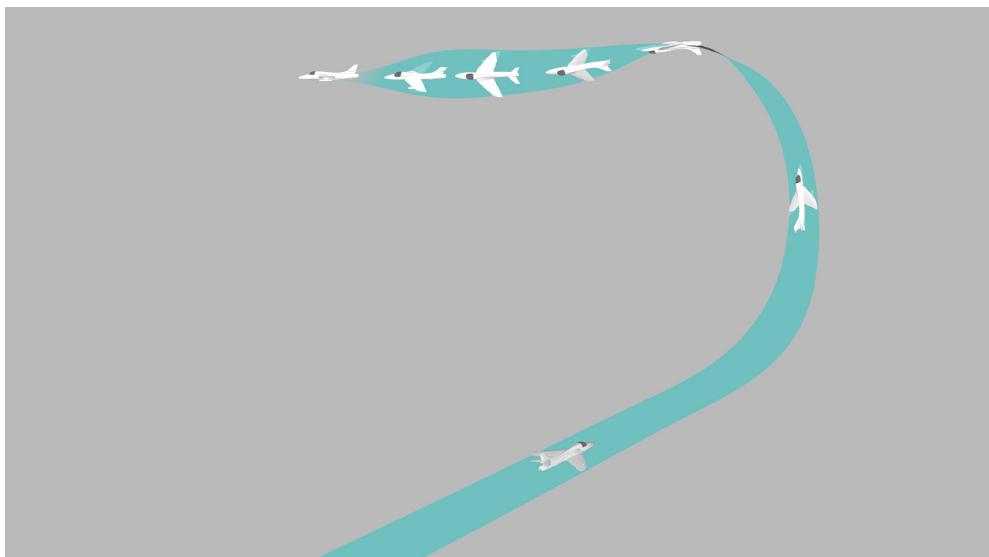
*by the pilot of G-BXFI and was less than his normally expected airspeed of 150 KIAS. In these circumstances the correct action would have been to perform an escape manoeuvre; rolling erect and then pulling out of the resulting dive [shown in [Figure 24](#)].'*

**Figure 24**  
Illustration of a rolling escape manoeuvre

If the height at the apex of the loop is less than the gate height, the stick is moved forward to stop the pitch rate and the aircraft is then rolled through 180°, with the wing unloaded, and then recovered from any descent and returned to level flight.

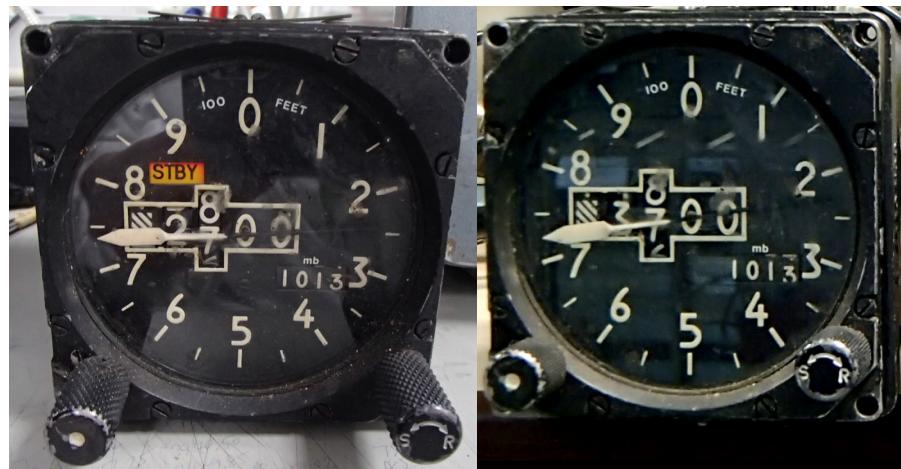
**Figure 28**

The pilot's head movements approaching and at the apex were mainly directed outside the cockpit but he appeared to look at the area of the flight instruments briefly twice at the apex. It could not be positively determined if the altimeter was scanned during this time. The primary information required for the decision to continue or abandon the manoeuvre was the aircraft height. The study considered that the single-pointer needle of the altimeter, indicating hundreds of feet, was easily read, but that with the single-pointer between 700 and 800 ft, the thousand feet height counter number could be partially obscured as shown in [Figure 28](#). The study identified three possibilities for his decision to continue the manoeuvre:

Altimeter height counter partially obscured by pointer  
(Barometric pressure setting not as found)

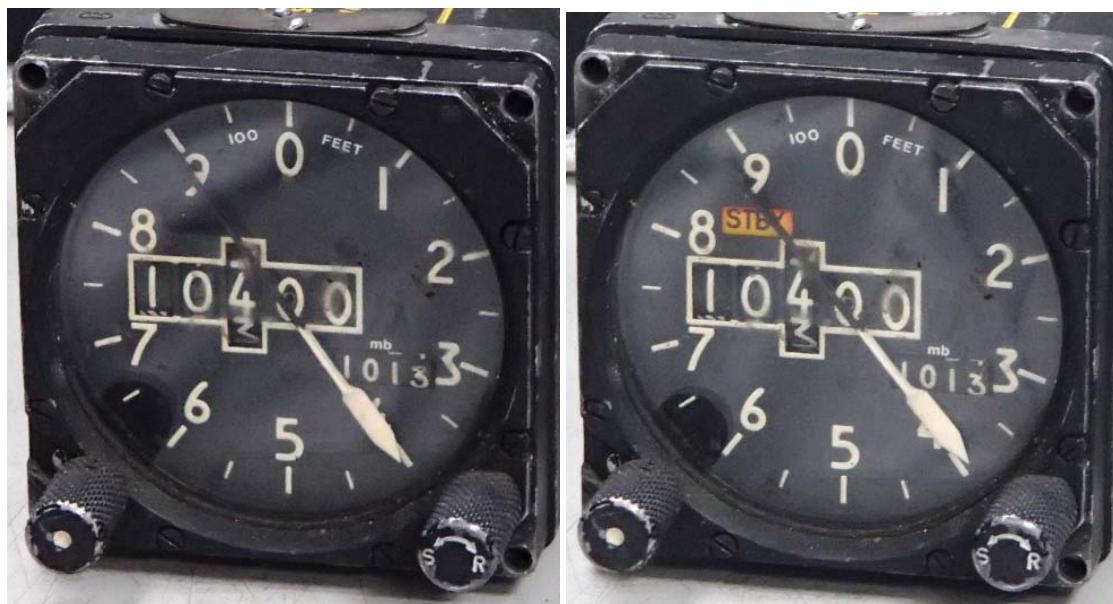
**Figure A2**

Mk 29B altimeter in servo mode (left image) and standby mode (right image)

The Mk 29B failed the manufacturer's test because it exhibited an offset of approximately -100 ft between the actual altitude and the displayed value across its entire range. The manufacturer stated that this finding suggested the altimeter may have been calibrated incorrectly at build or when last serviced. It was also considered possible that the offset could be attributed to minor slippage within the altimeter gear train due to accident impact forces. The effect of this offset is that the Mk 29B would read approximately 100ft lower than the actual aircraft altitude.

The testing also identified a number of anomalies relating to excessive backlash and friction within the mechanical components of the gear train and height counter drum, which resulted in the Mk 29B failing these elements of the test. These anomalies were attributed to wear in the gears and pivots of the gear train and height counter, and were considered to be consistent with expected component wear in an altimeter of this age, which may not have been serviced for many years. The effect of friction is that the displayed altitude could lag the measured altitude. This effect was particularly evident on the Mk 29B when it was tested in standby mode, and more so when the vibrator motor was switched off.

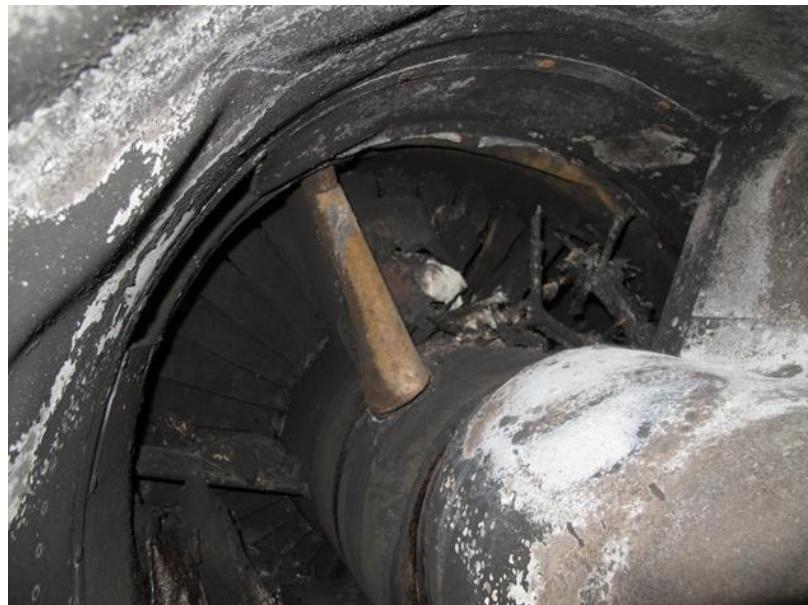
The engine did not detach from the airframe during the accident and remained installed. The airframe was held in the AAIB hanger facility which allowed a visual inspection of the intake and exhaust to be made. The air intake contained a large quantity of debris ingested during the accident. However it was possible to view a number of inlet guide vanes which appeared to be intact, (figure 1).

Figure1: A view looking at the front of the engine while installed

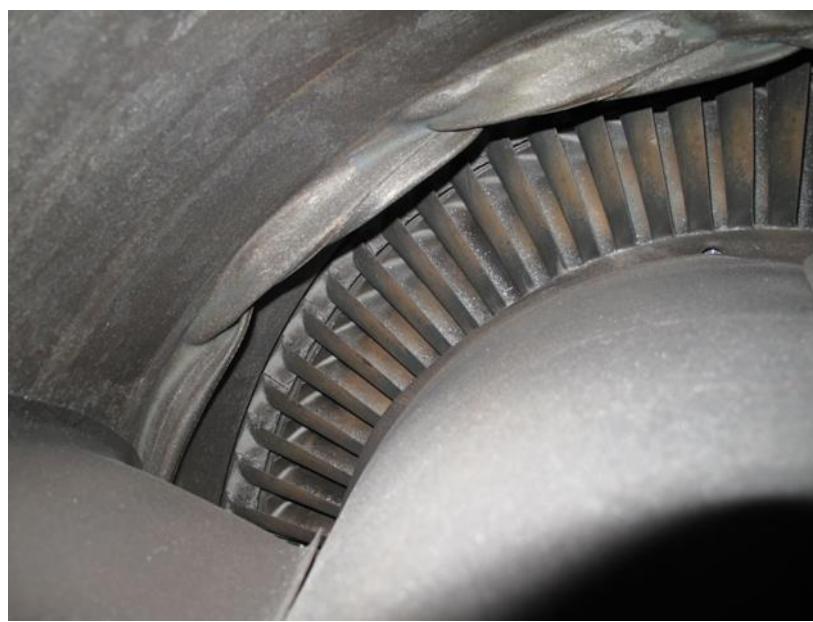
The engine's jet pipe had detached during the accident impact sequence which allowed the top section of the 2<sup>nd</sup> stage turbine blades to be seen. The blades that were visible were intact with no visual evidence of material loss. The lower section of the exhaust unit was distorted which restricted a complete view of the turbine (figure 2).

Figure 2: A section of the 2nd stage (LP) turbine viewed through the distorted exhaust unit.

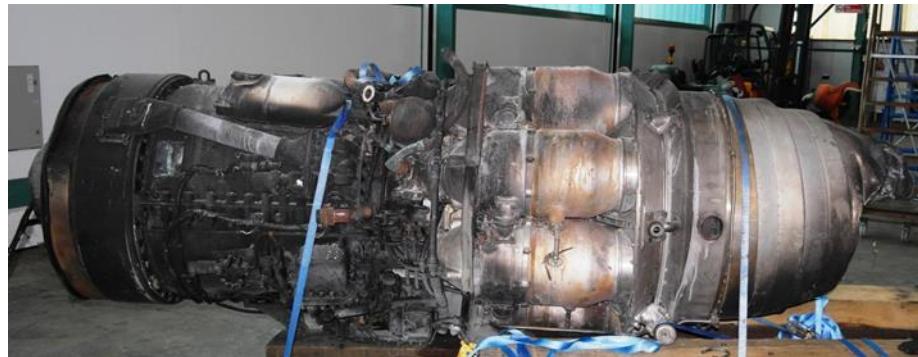
The main engine casings and external surfaces were covered in a layer of soot / carbon (figure 3); this was considered to be the result of the post-crash fire. There was no evidence of any high energy disruption of the casings to support that the engine had suffered an uncontained mechanical break out.

Figure 3: A view of the left side of the engine after removal from the airframe. Although the front half is coated in a layer of soot from the post-accident fire, the engine is complete.

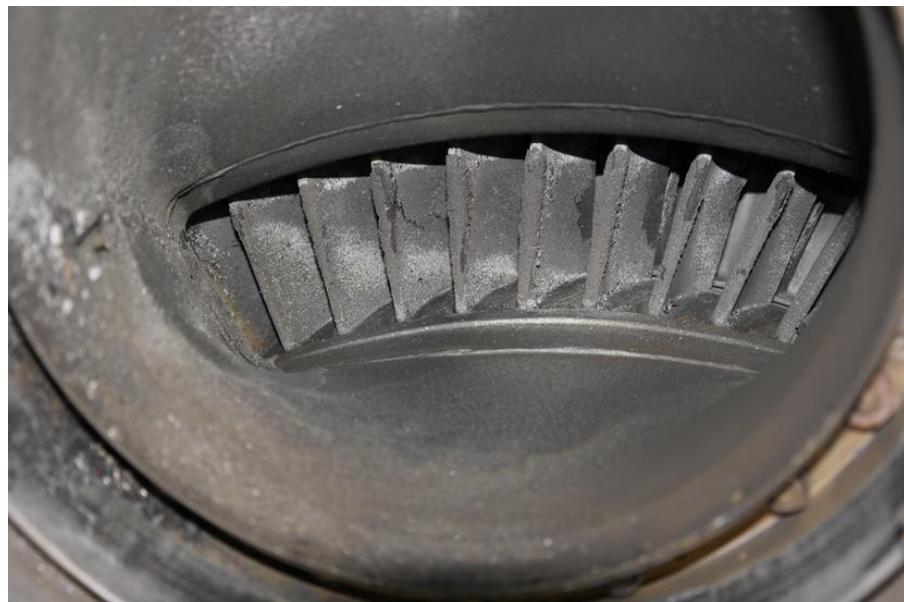
Removal of four combustion chambers facilitated a visual examination of a number of HP guide vanes. The vanes were coated in a layer of carbon commensurate with engine operation. All the vanes viewed were intact and there was no visual evidence of any pre-accident distress (figure 12).

Figure 12: A section of HP guide vanes viewed through the nozzle box.

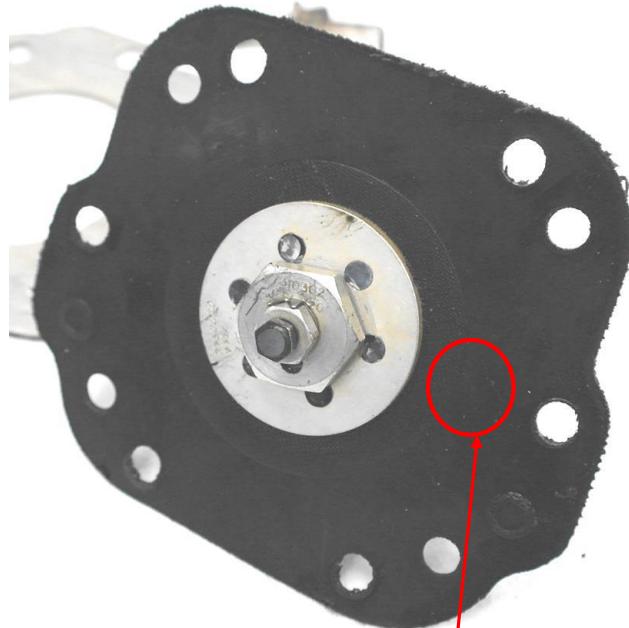
Figure 16: a general view of the dual fuel pump diaphragm.

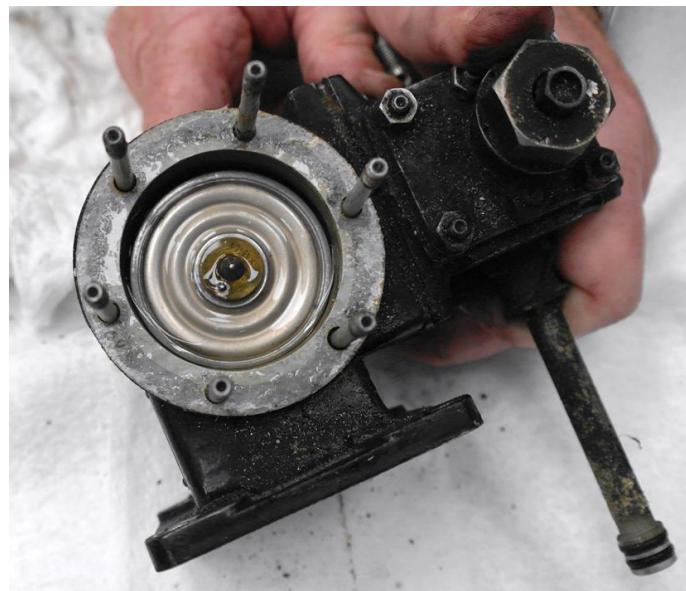
Figure 24: The bellows assembly of the BPC while installed. The damping oil around the bellows was clean with no visual evidence of contamination.

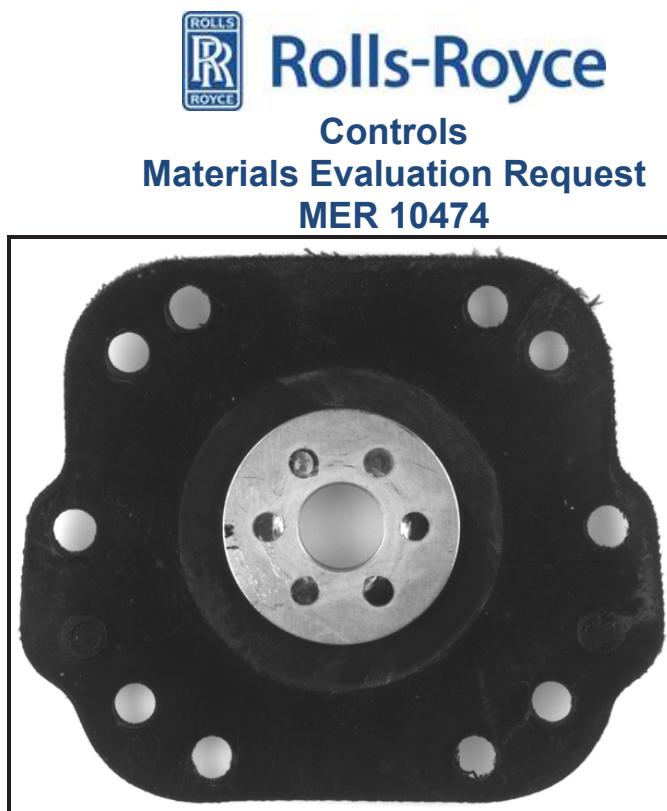
Figure 1 █ GD64-1A Pump Diaphragm (Face-1)

The laboratory assessment of the diaphragm found that the convoluted area on both sides had been significantly degraded. The rubber had the appearance of "Mud-Cracking" across the entire working surface. On one side of the diaphragm a "Tide-Mark" could clearly be seen across the convolution, (figure 17).

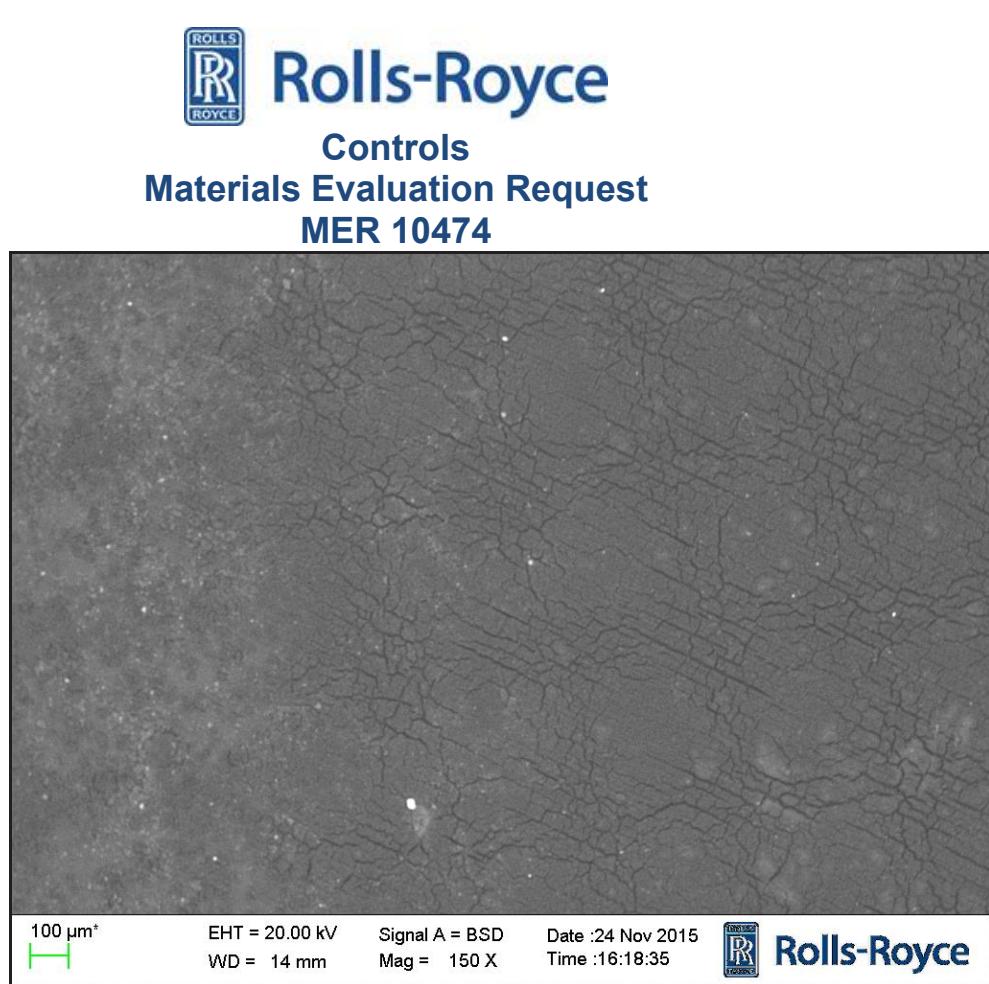
**Figure 9** █ GD64-1A Pump Diaphragm Convolution (Face 2)

2.1.1.12 The "Mud-Cracked" surface of Face -2 is shown by Figures-9 and 10.

2.1.1.13 The "Mud-Cracking" on Face 2 appeared to have a degree of directionality.

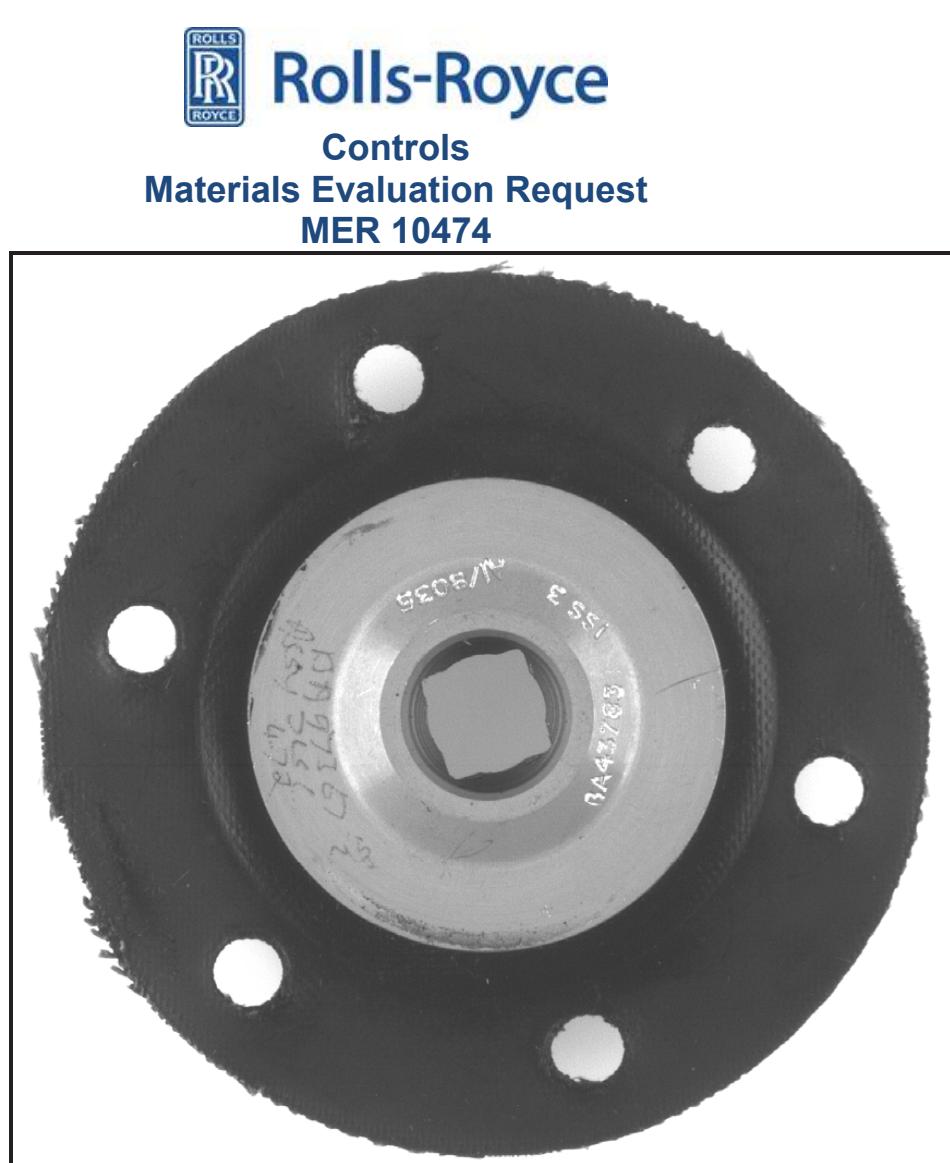
**Figure 17 Acceleration Control Unit Diaphragm (Large) Face-1**

- 2.1.7 The larger diameter diaphragm, (~63mm) consisted of two plies of a Polychloroprene rubber proofed textile.
- 2.1.8 None of the rubber surfaces, convolution or clamped area, exhibited evidence of aging, *i.e. cracks, splits or rubber reversion*. See *figures-17 to 20*.
- 2.1.9 The rubber to metal bonding was in good condition with no evidence of delamination or loss of adhesion to the metal plates.

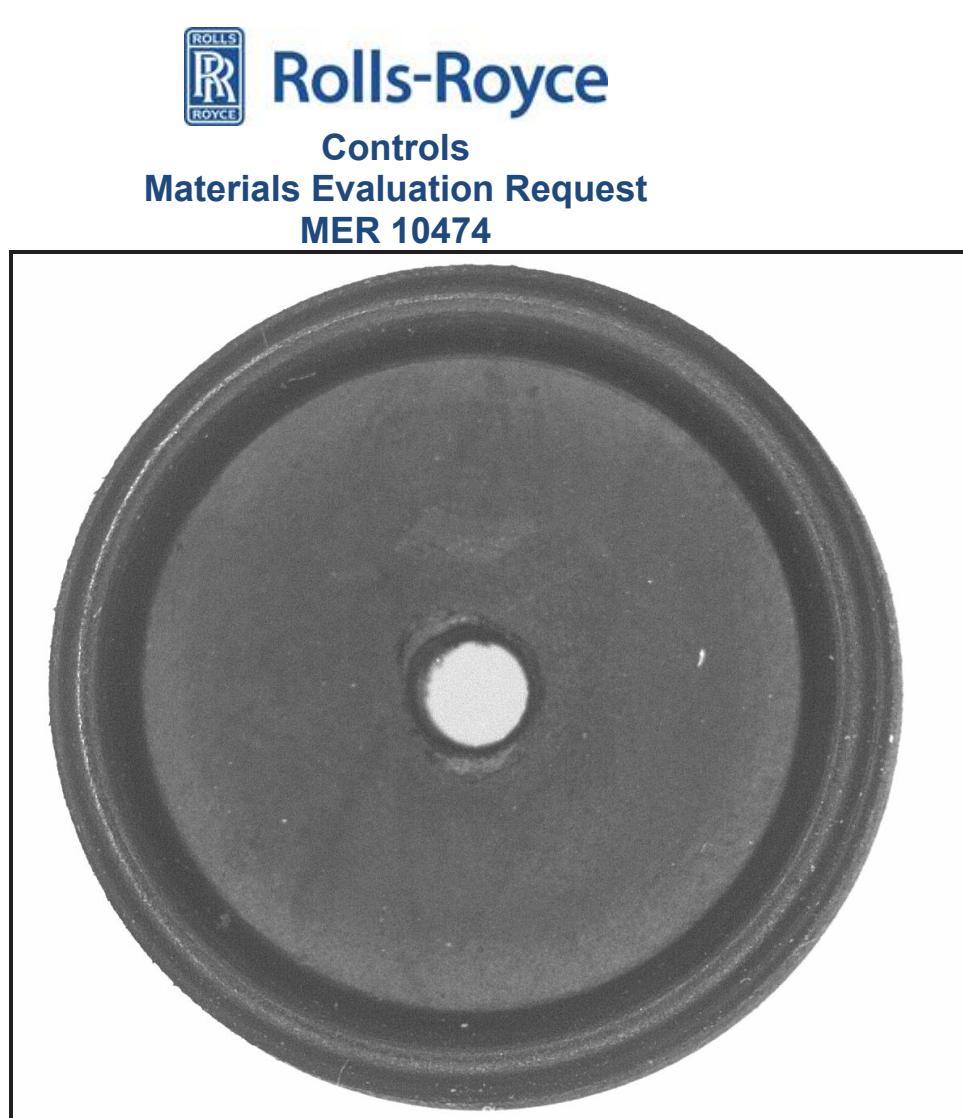
**Figure 21 Barometric Pressure Control Solid Diaphragm**

- 2.2.1 This diaphragm was manufactured from a Nitrile Rubber which has inherent resistance to aviation fuel.
- 2.2.2 Removal from fuel had not had a detrimental effect upon the diaphragm, see *figure-21*.
- 2.2.3 The rubber hardness of 73 IRHD was an acceptable value for a rubber material of this type and for the application.
