The Airbus Safety Magazine

FEBRUARY 2009

Braking system cross connections
Thierry Thoreau 10

Avoiding dual bleed loss
Patrick Grave, Christophe Mathe 26

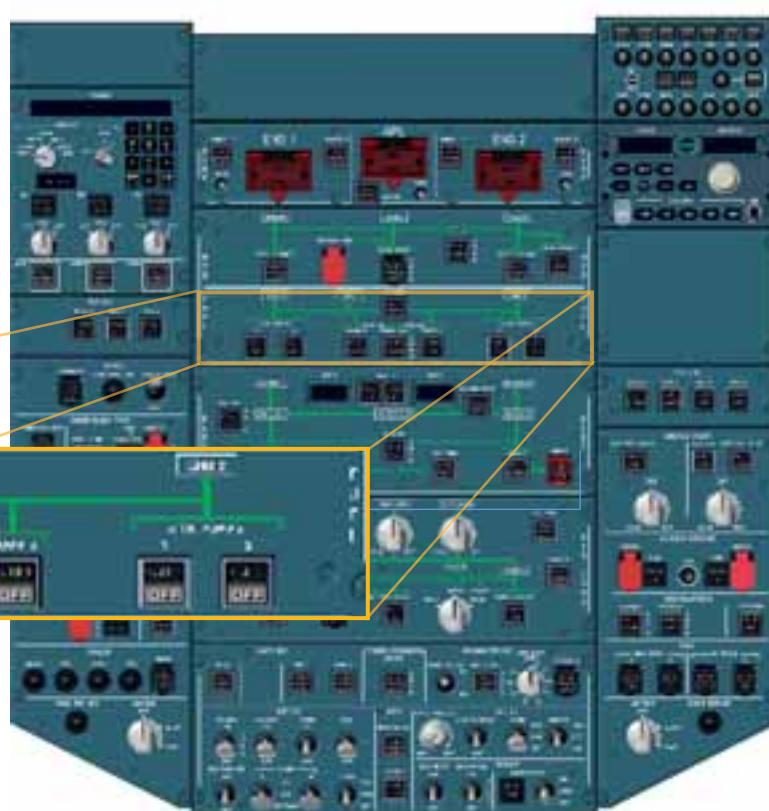
With the center tank and wing tank fuel pumps left in the OFF position, this is how the overhead panel would look like; notice the six illuminated white pushbutton lights:

At the beginning of the Cockpit Preparation checklist for the Overhead Panel, the SOPs request the crew to extinguish all white lights (pushbutton switches) on the overhead panel, as applicable during the scan sequence. This ensures that both the center tank and wing tank pushbutton switches are selected to the ON position prior to flight, except for the center tank if OEB 178 applies.

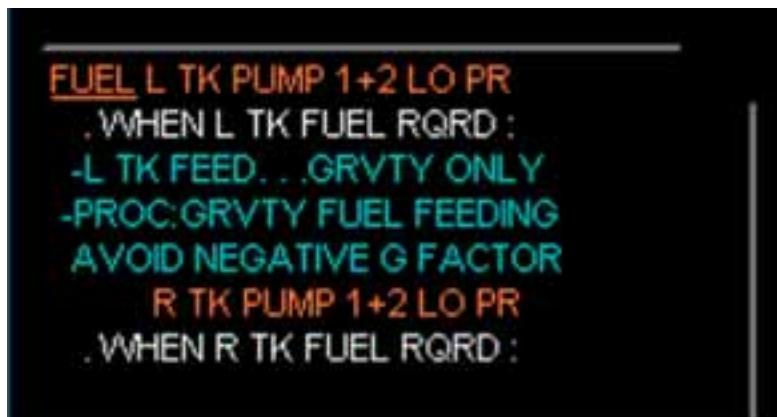
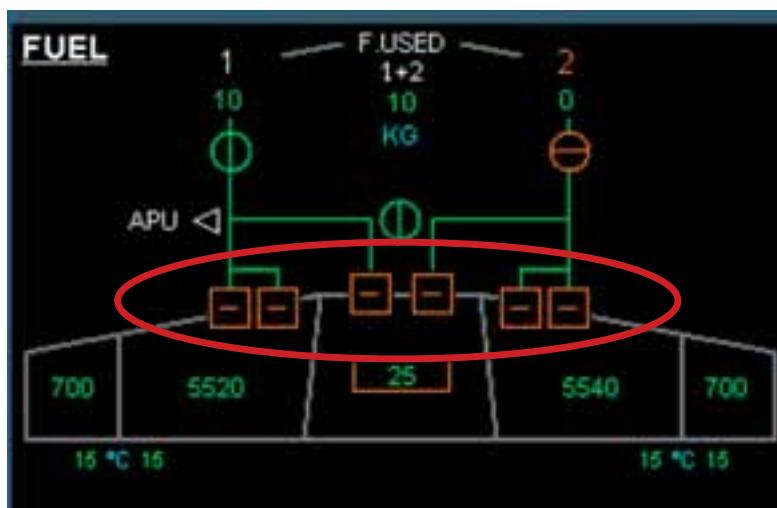
- Second barrier:
30 seconds after the first engine start (flight phase 2), if the wing tank fuel pumps are still

in the OFF position, the dedicated ECAM Caution will trigger, and the FUEL page will be displayed:
