AVIATION INVESTIGATION REPORT **A14Q0155**

Runway excursion

Air Canada

Airbus A330-343, C-GFAF

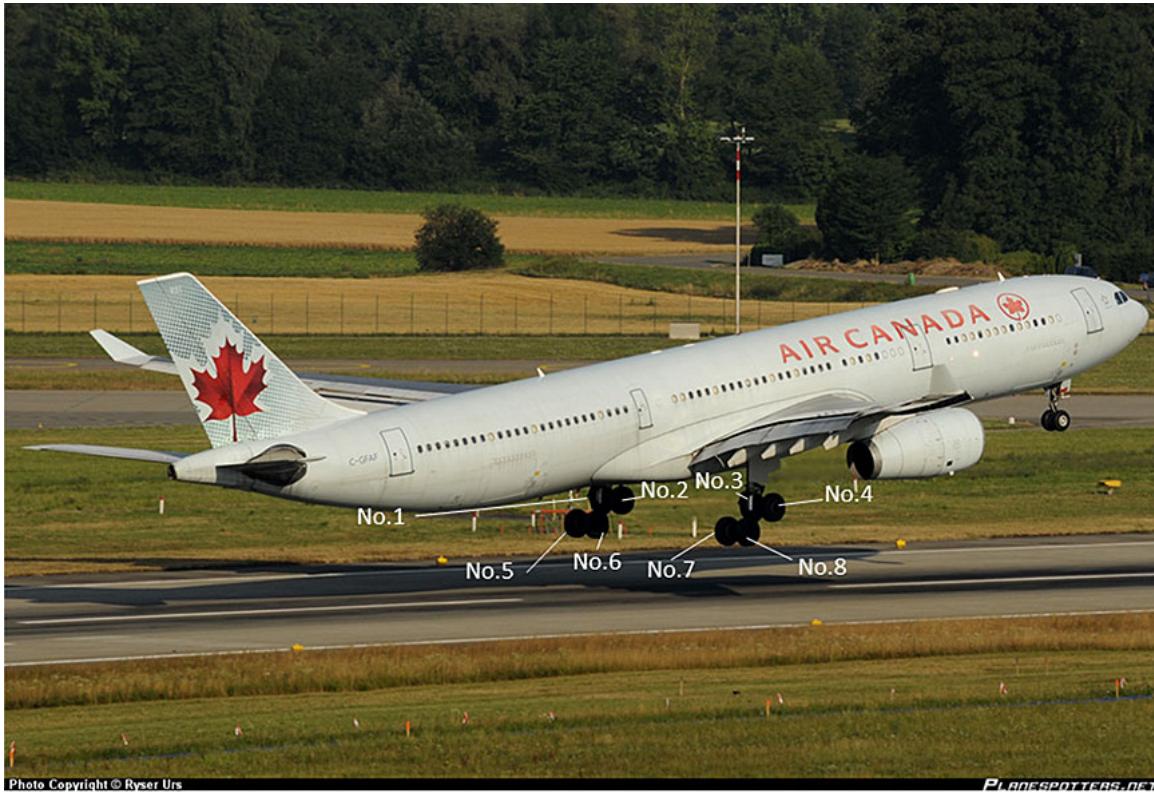
Figure 2. Numbering of the main landing gear tires on the A330 (Source: Ryser Urs, with TSB annotations)

The landing gear on the A330 is made up of 1 nose gear with 2 wheels, and 2 main landing gear assemblies with 4 wheels each in a double tandem configuration. In flight, the bogies are inclined such that the back tires touch the runway first. The wheels are numbered 1 to 8, from left to right, starting from the front (Figure 2).

The tires were examined and the pressure measured shortly after the incident. The condition of the tires and treads as well as the inflation pressure of the tires complied with the manufacturer's instructions.

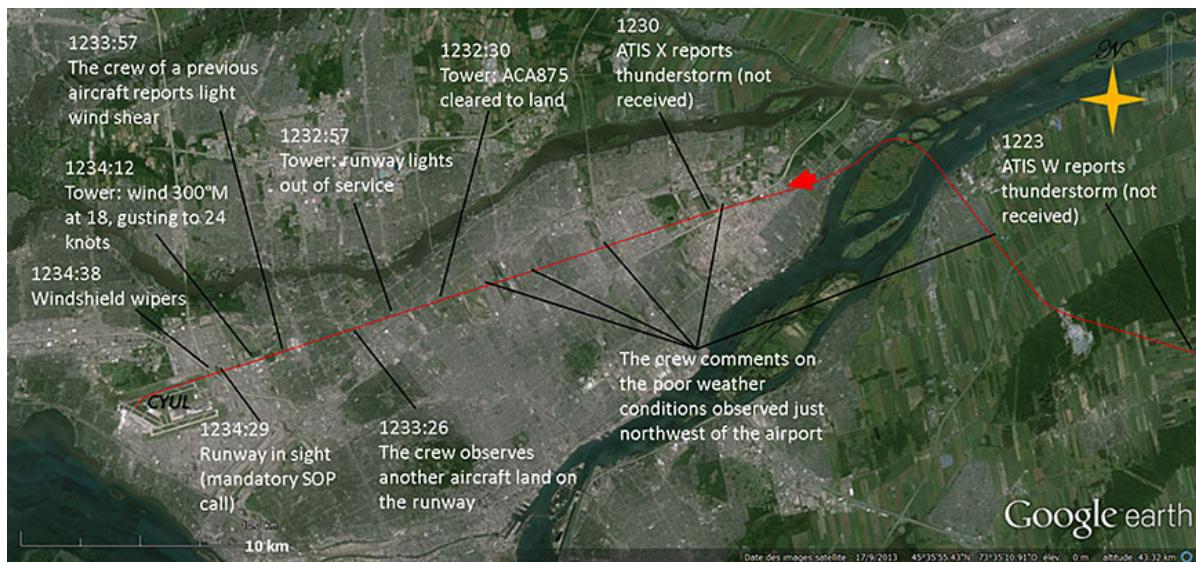
Figure 10. Aircraft flight path on approach to Montréal/Pierre Elliott Trudeau International Airport in relation to the available weather information (Source: Google Earth, with TSB annotations)

At 1223 and 1230 respectively, the ATIS Whiskey and ATIS X-ray messages reported a thunderstorm (these messages were not received (Figure 10).
