## **Aircraft Accident Investigation Final Report**

**Aircraft type:** AN.140-100

**Registration:** EP-GPA

**Crash Near Airfield Following Aircraft One Engine  
Failure Just Upon Lift-Off**

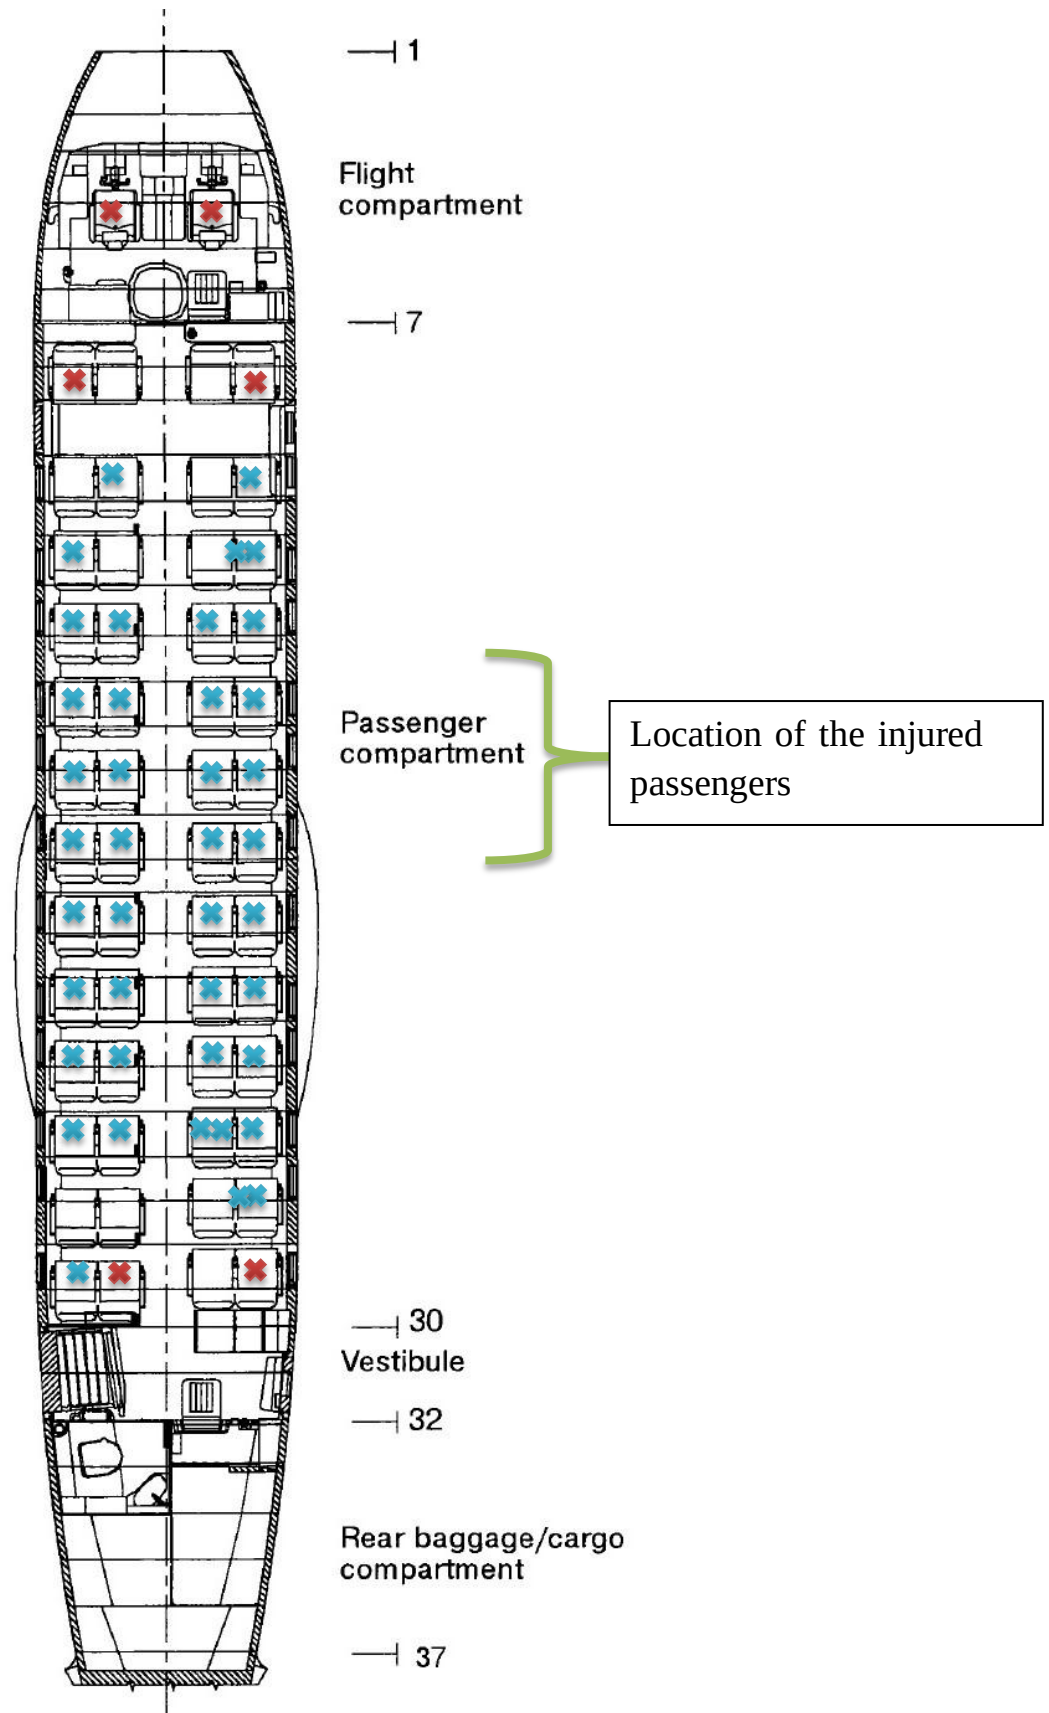
Figure 19: flight deck crew and passenger seats configuration

| 5 | <p><b>Page 42, Fig. 19</b></p> <p>There are no indications of the location of the killed and injured passengers on the aircraft compartment layout drawing.</p> | Comment partially agreed by the CAO.IR AAIB and draft of the Accident Final Report amended. |

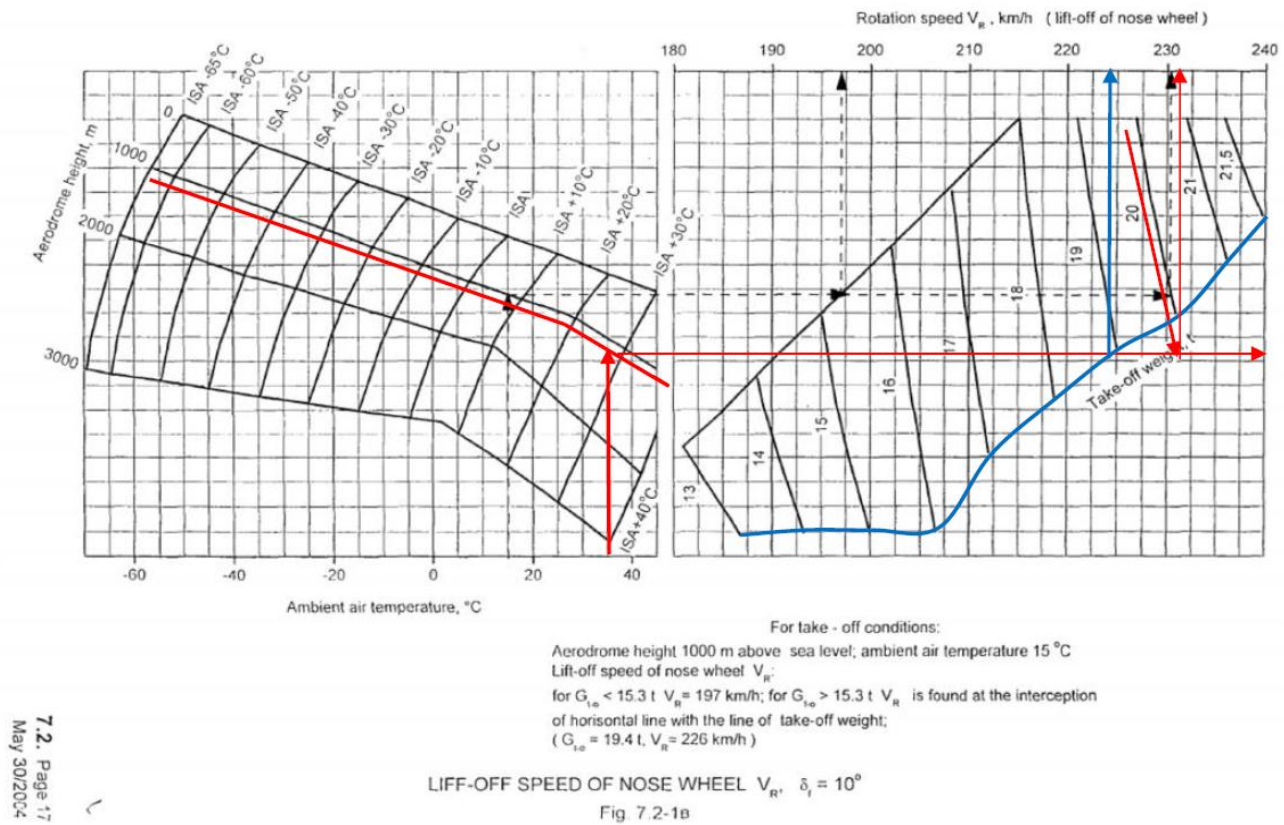
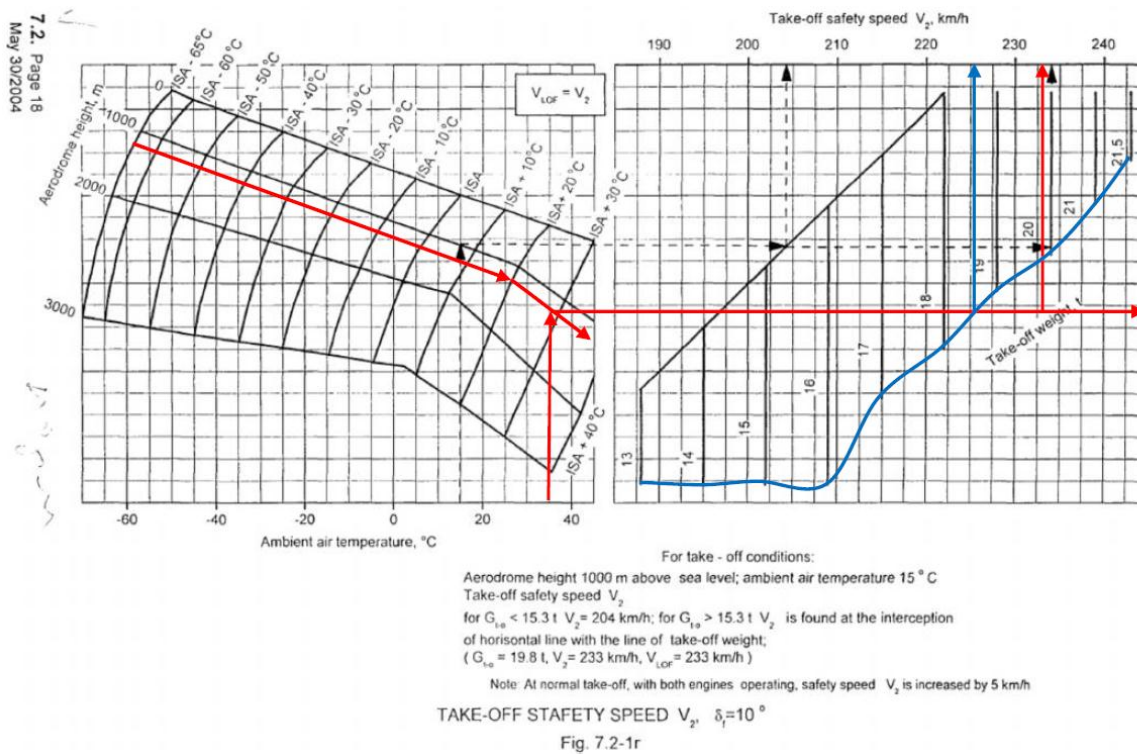
Figure 22: MTOM and  $V_R$  and  $V_2$  Limitation

Using chart of the AFM Fig.7.2-1B as shown in Figure 21 and 22 below, revealed that  $V_R$  must be at least 231 km/h, but because of even weight of 19500 kgf which by designer considered allowable is outside of graph limits. According to section 7.1.1 of the AFM which state the parameters should not be determined outside the limits stated in the graphs. Therefore, this weight will not be allowable. By using this chart following Information derived:

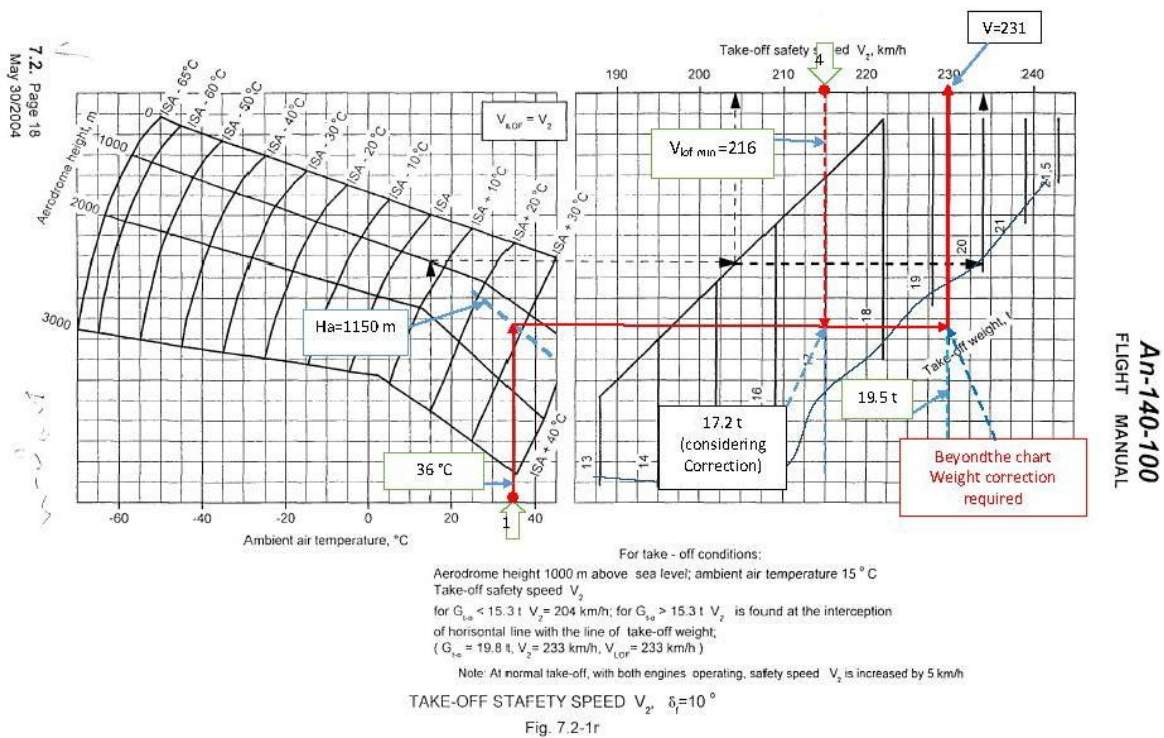
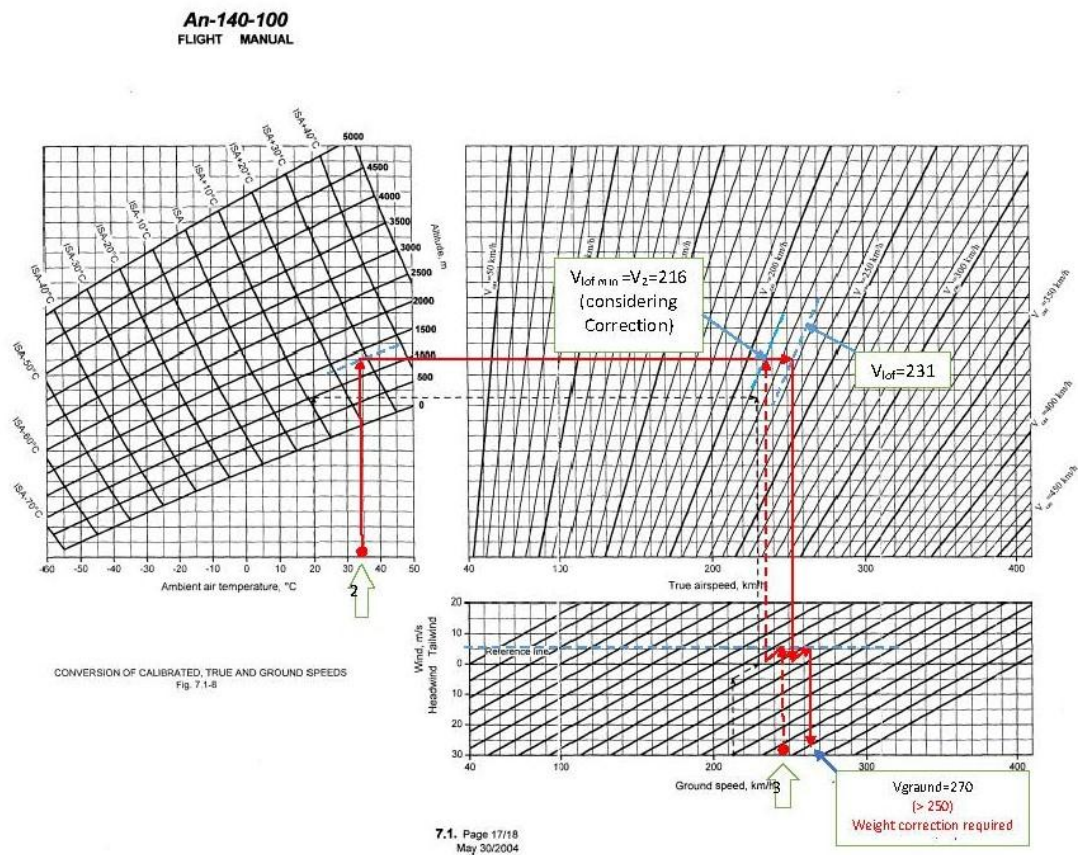
Figure 23: MTOM versus ground speed Limitation

Furthermore, if we use the chart of Fig. 7.2.8 of the AFM for compliance with *ground speed limitations* of 250 kmph, the MTOW of the aircraft will be 17200 kgf. (Figure 23: MTOM versus ground speed Limitation) This calculation shows 2600 kgf aircraft overweight.

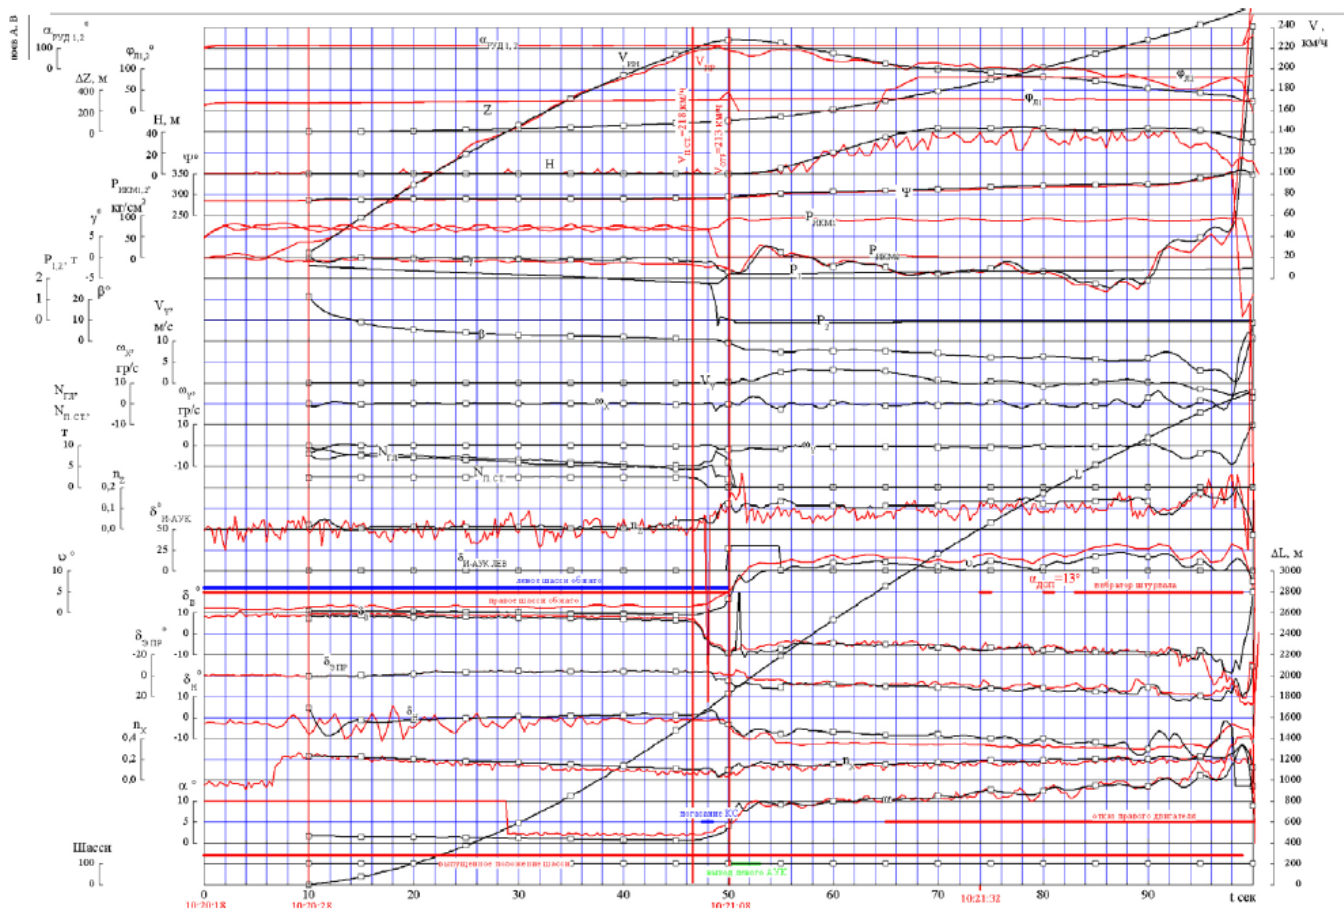
Fig. 5.1. Aircraft: An-140-100 No. 90-05. Flight 9515. Aug. 10, 2014.

Parameters of motion at continued takeoff:  $W=4\text{m/s}$ ,  $AMH=286^\circ$ ;  $AW=60^\circ$ ;  $\delta FL = 10^\circ$ ;  $G=19.866t$ ;  $\Delta t=30^\circ$ ;  $HA/D. = 1150\text{m}$ ;  $\mu \geq 0.6$ ;  $XT \sim 0.265$ ;  $PH=662\text{mmHg}$

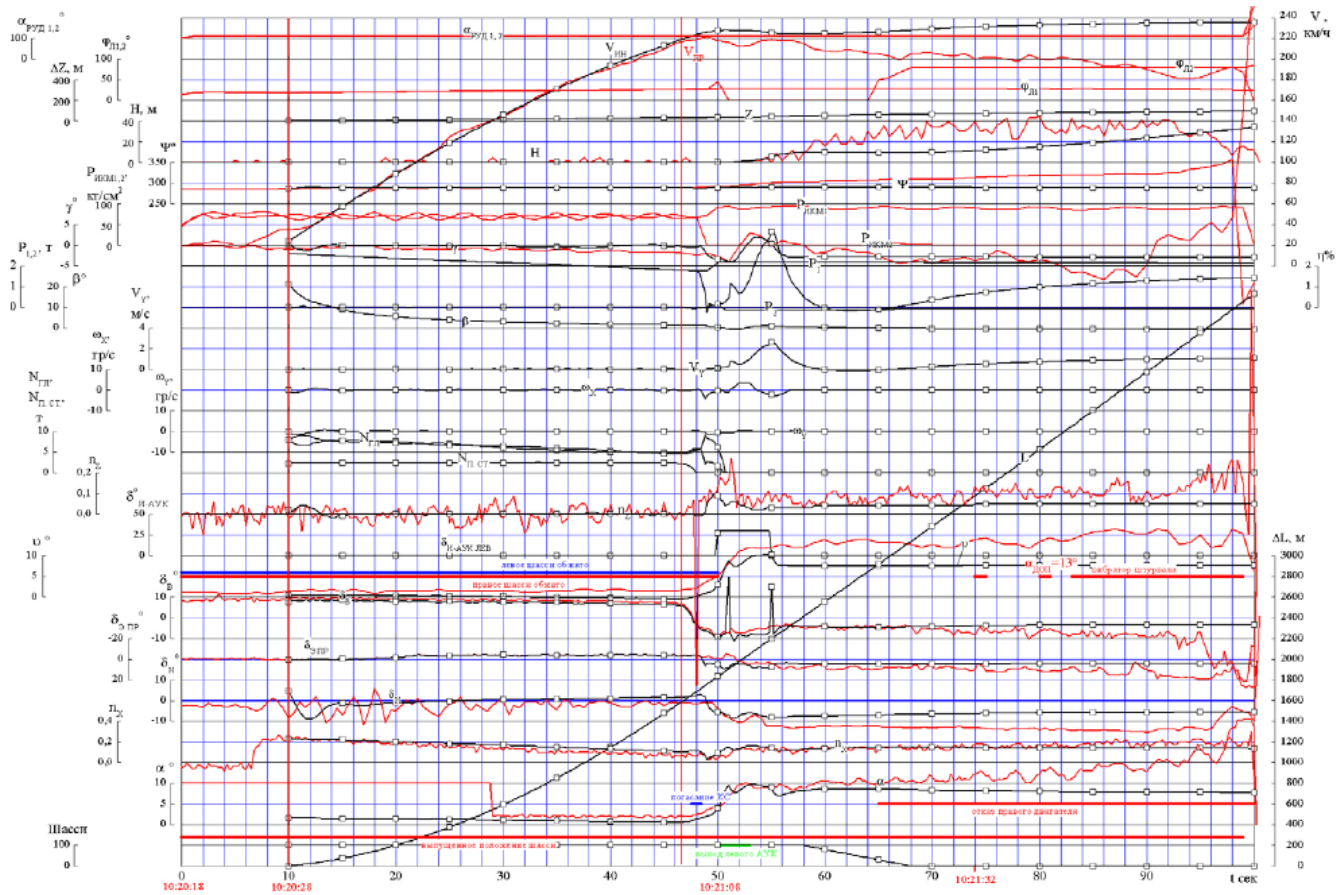
Fig. 5.2. Aircraft: An-140-100 No. 09005. Flight 9515. Aug.10, 2014.

Parameters of motion at continued takeoff:  $W=4\text{m/s}$ ;  $AMH=286^\circ$ ;  $AW=60^\circ$ ;  $\delta FL = 10^\circ$ ;  $G=19.866t$ ;  $\Delta t=30^\circ$ ;  $HA/D. = 1150\text{m}$ ;  $\mu \geq 0.6$ ;  $XT \sim 0.265$ ;  $PH=662\text{mmHg}$
