AIRPROX REPORT No 006/07

<u>Date/Time</u> :	26 Jan 1825	NIGHT
<u>Position</u> :	5118N 00017E	(9nm ESE BIG)
<u>Airspace</u> :	LTMA	(<u>Class</u> : A)
	<u>Reporting Ac</u>	<u>Reported Ac</u>
<u>Type</u> :	LR45	SR22
<u>Operator</u> :	Civ Comm	Civ Pte
<u>Alt/FL</u> :	↑5000ft (QNH 1023mb)	4000ft (QNH 1025mb)
<u>Weather</u>	IMC KLWD	IMC IICL

AIRPROX REPORT No 083/07

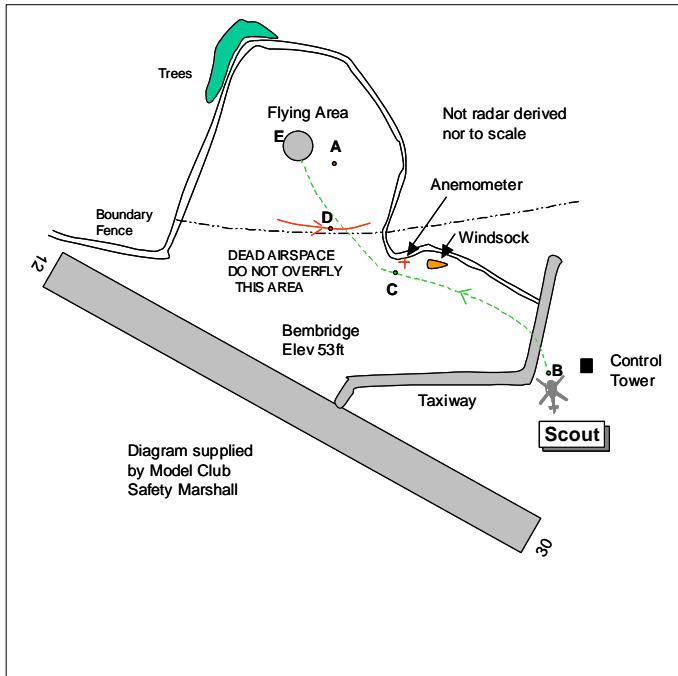
THE SCOUT PILOT reports that his helicopter was parked immediately in front of the Control Tower. After starting up he made an open broadcast on 123.25MHz of his intentions and hover taxied towards RW30, converging towards the mid-point of the RW on a W'ly heading. He maintained a height of about 10ft and allowed the speed to build to 20kt, intending to accelerate to climbing speed on RW heading at the point of interception. He suddenly became aware of a yellow model ac at a similar height crossing from L to R in front of him. It appeared to be about to clear his flightpath to the R when it turned R onto an E'ly heading and was now heading straight towards him, exacerbating the risk of collision. As it continued to turn R it began to cross his flightpath R to L so he broke hard R onto a N'ly heading, the model passing about 50m away, and he landed near the designated Model Flying Area so that the matter could be discussed. The model was operating at least 250yd S of the authorised model operating area.

Although both parties agreed that the minimum separation distance was about 50m, only those who were there at the time know exactly what had occurred. Without any further corroborating information available, with such disparate viewpoints about the incident reported by the individuals involved, the Board could not resolve this apparent anomaly and could only conclude that this had been a conflict over Bembridge aerodrome, which was resolved by both the Scout pilot and the Model Ac operator. Furthermore, in the Board's view, their combined actions had quickly and effectively removed any risk of collision.

Cause: Conflict over Bembridge aerodrome resolved by the Scout pilot and the Model Ac operator.

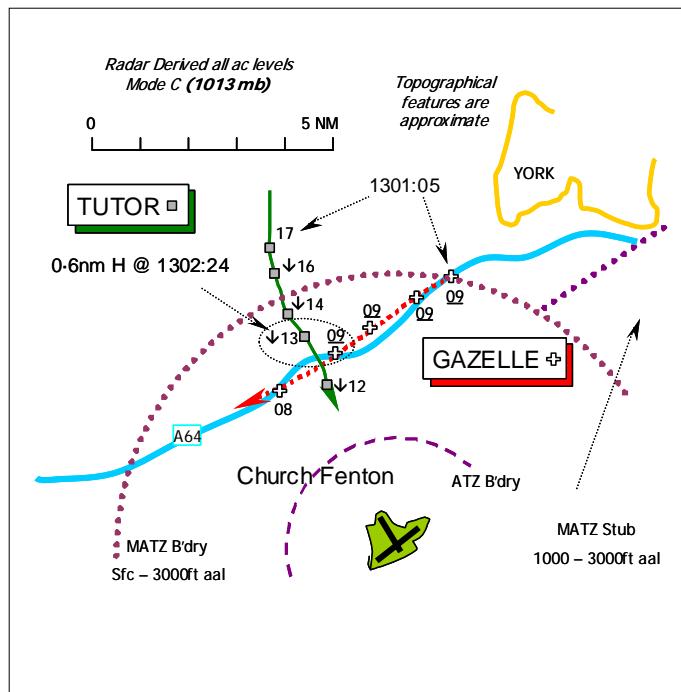
THE CHURCH FENTON ATCO I/C reports that he was also manning TALKDOWN 2 towards the end of a busy recovery period in poor weather conditions. The latest actual weather promulgated was colour code GREEN conditions – 3/8th SCT cloud at 700ft agl; visibility: 3700m. The Tutor ac was on an IFR approach to RW16 at Church Fenton and its pilot had requested and received a RAS, which in accordance with SOPs, was downgraded to a RIS once inside the Final Approach Fix at 5nm from touchdown.

Cause: Conflict in the vicinity of the final approach to RW16 at Church Fenton, resolved by ATC.

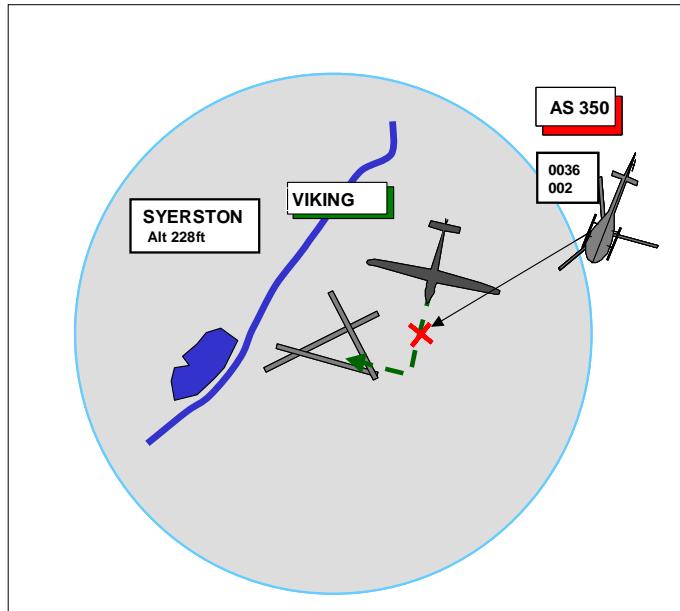
THE VIKING T1 GLIDER PILOT reports flying an instructor training flight from Syerston. While on the base leg for RW30 he saw a helicopter hovering at tree height about $\frac{1}{4}$ nm out on the final approach. The Duty Instructor was talking to the helicopter and made repeated requests for him to vacate the area immediately, however it continued to manoeuvre directly in his path. He was at 350ft AGL and maintained this height until he was clear of the helicopter and delayed opening the airbrakes to ensure maximum vertical separation, which caused him to land long. Due to his manoeuvre he assessed the risk of collision as being low.

Noting that both pilots agreed that the risk had been low and had also agreed the basic geometry, it seemed to the Board that this incident had been reported as an Airprox to make a point about 'infringements' rather than any collision risk. Unanimously, the Members attributed a cause of 'Sighting Report'.

Cause: Sighting Report.

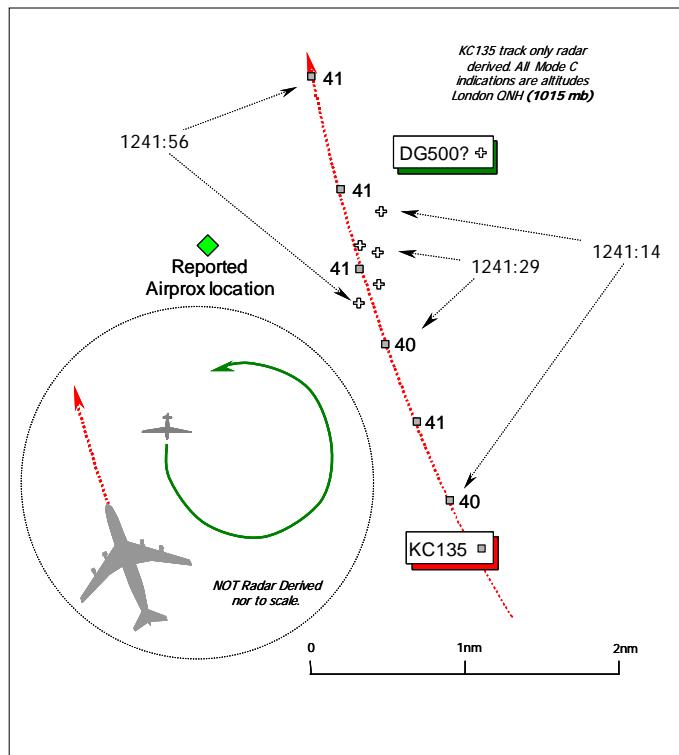
THE DG500 GLIDER PILOT reports he had departed from Gransden Lodge and was monitoring frequency 131.275MHz. After circling in a weak thermal he headed off to the S towards other clouds at 60kt in a level cruise at about 3200ft Gransden QFE (possibly 1005mb – Gransden elev: 254ft), flying some 2000ft below and 1-3nm clear of cloud with an in-flight visibility of 15nm+. About 1nm E of St Neots heading 180° at about 1245UTC, he sighted the other ac – a grey KC135 – about 1nm away some 50° R of the nose. He noted that it was definitely higher than him but estimated their paths would come close or cross. Concerned about possible turbulence from the turbofan ac, to avoid the KC135 he turned away to port and the jet passed behind his glider with a low risk of a collision. He estimated the minimum separation was about 400m horizontally and 500ft vertically and he saw it fly away as he came around the turn. It did not appear as though it's pilot had deviated from his course.

The glider pilot reported that he spotted the KC135 about 1nm away, but definitely higher than his glider's altitude at the time he said. The Board noted that the DG500 pilot had wisely elected to turn away from the large jet, which passed astern and no closer than about 400m horizontally and 500ft vertically above his glider at the closest point - with a low risk of a collision. Without complimentary SSR data it was not possible to confirm the glider pilot's assertion as to the minimum separation that pertained here independently, but there was no reason for the Board to doubt the veracity of the reporting glider pilot's account whatsoever. Whilst noting the DG500 pilot's concern about possible turbulence from the turbofan ac, the Board was charged with determining the risk of collision between the ac involved and not what might have resulted if the wake turbulence of the large ac had affected his glider in different circumstances. In the Board's view, the glider pilot had seen the KC135 in time to turn away from it and maintain his own separation well clear of the KC135, which passed 500ft above his glider thereby removing any risk of a collision. The Board concluded therefore, that this Airprox had resulted from a sighting of traffic operating in Class G airspace, where no risk of a collision had existed in these circumstances.

Cause: Sighting Report.

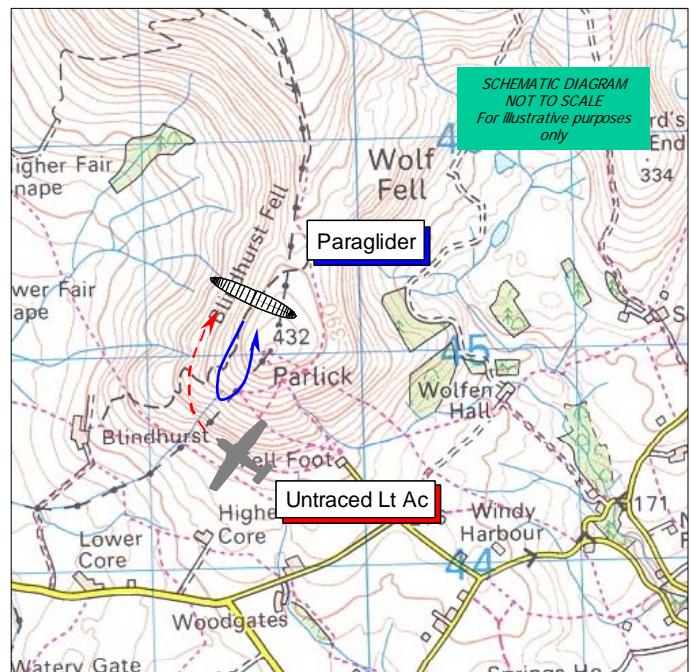
THE GIN ZULU PARAGLIDER PILOT reports he was soaring the hill at Parlick on his own, parallel to the western facing slopes in a southerly wind, at about 420-430m [~1377-1410] just level with the top when he heard a light ac (LA) coming around the corner to the S. He expected it to cut straight across the bowl away from the ridge to the W, but the LA just turned N and contoured the hill at about his level or slightly higher. Knowing about the 'rotor' wash a paraglider can take from a LA he became very worried as the ac headed "straight for him" with no avoiding action. He had two choices, try and ride the 'rotor' and risk a collapse or turn into the hill onto a downwind leg, which he did. He turned L NNE'ly at 10-20kmph and landed hard, taking quite a knock. At the closest point the LA passed about 20yd to the W. He assessed the risk as "high".

Cause: Conflict resolved by the Paraglider pilot.

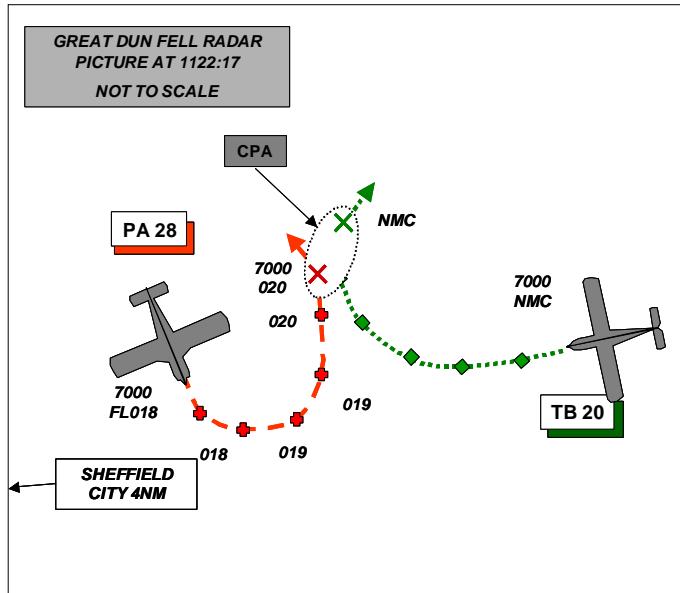
THE TB20 PILOT reports that he was flying a transit from Gamston to Sheffield accompanied by a friend. He had all lights on and was squawking 7000 with Mode C [he thought]. He was heading 280° at 105kt having just left Doncaster Radar and switched to Sheffield Radio (A/G). When they were about 5-8nm from Sheffield VRP, he saw a white ac to the N and tracking S. He asked his friend to check with Sheffield about the traffic and they said they were the only ac on frequency. They continued to watch the ac and it appeared to track between VRP and Sheffield City, then headed E towards the VRP and commenced orbits around the VRP. (See radar analysis at UKAB Note (1)) Again Sheffield was asked about traffic and they repeated that they were the only ac on frequency. He set the landing configuration and became further concerned as the ac's orbit seemed to vary and as they approached the VRP the ac was in their 10 o'clock just above them heading directly towards them but in a slight left turn. He then made an avoiding action right hand descending turn and reconfigured the ac bringing the gear and flaps up. They then called Sheffield again to advise them of avoiding action and if they were in contact with the ac as they had not heard it on the frequency.

Cause: Sighting report.

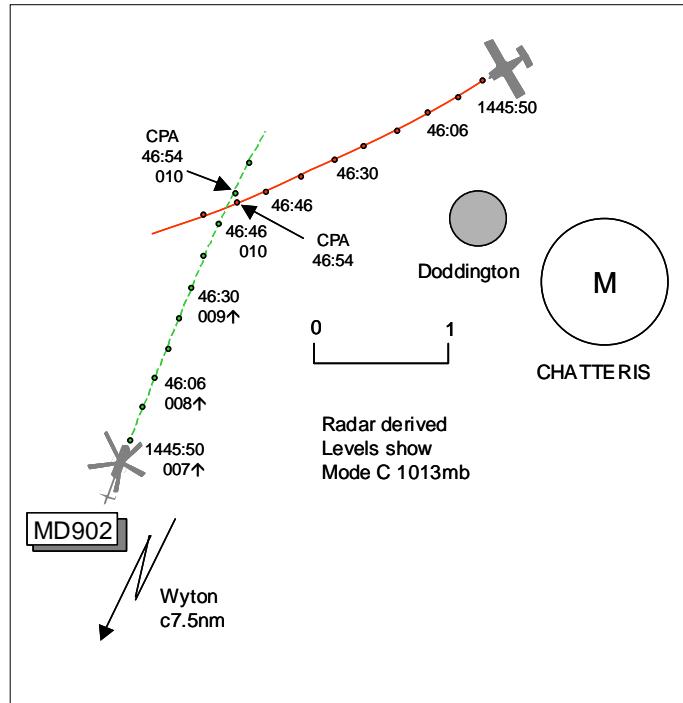
THE MD902 PILOT reports heading 025° at 125kt at 1000ft QNH 1017mb and not in communication with any ATSU squawking a discrete code with Mode C. The visibility was 30km in SKC VMC and the helicopter was coloured blue/yellow with anti-collision, nav and strobe lights all switched on. Passing 1.5nm W of Doddington he and his 2 observers were all 'eyes out' maintaining a good lookout in the cruise with A/P engaged, when a low-wing white-coloured single-engined ac was seen at the very last minute in their 1-2 o'clock about 0.5nm away converging. An immediate descent was made to avoid the red-nosed light ac which was seen to pass 150-200ft above flying straight and level. This target was not showing on TCAS and he assessed the risk as 'B'.

Cause: Conflict in Class G airspace resolved by the MD902 pilot.

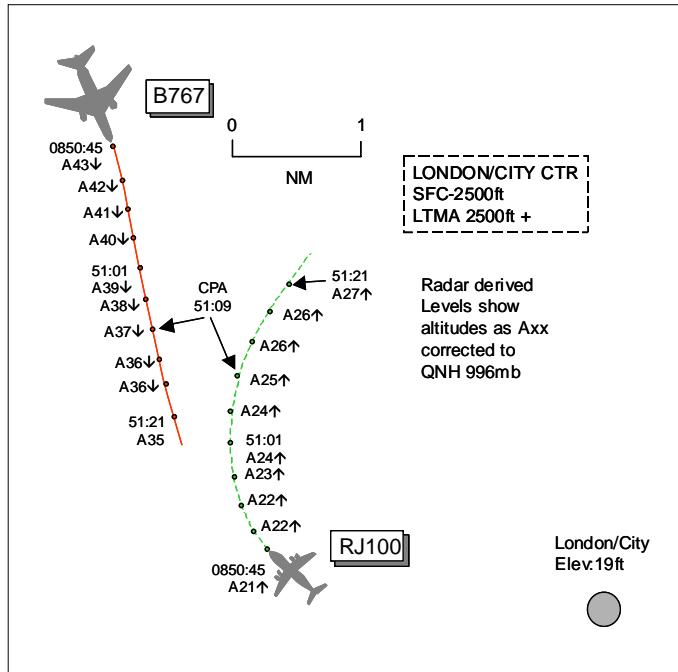
THE RJ100 PILOT reports carrying out a DVR 3T departure from RW28 at London/City and in communication with Thames Radar on 132.7MHZ squawking 5242 with Mode C. Tracking 050° at 190kt to intercept the 083° radial from the LON VOR and climbing through 2000ft a TCAS contact was noted as proximate traffic 3nm away 1700ft above descending towards O/H. This became a TA alert approximately +1300ft then proximate traffic again, always descending, to +500ft before finally passing 1nm behind. At the time of the incident, their ac entered a cloud layer at 1500ft and was IMC in cloud. They advised Thames and were informed that the other ac was descending into Heathrow and had 'level bust'.

Cause: The B767 crew did not set the QNH and descended below their cleared altitude.

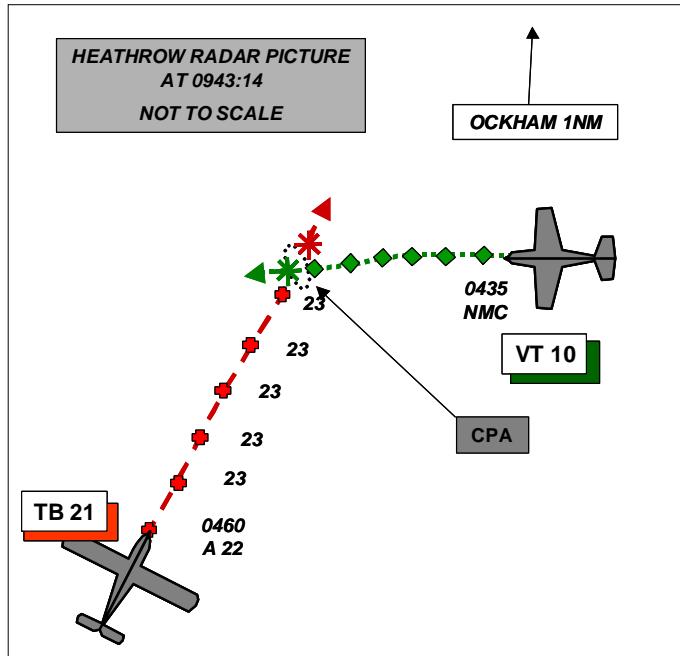
THE VICTA AIRTOURER (VT10) PILOT reports flying a red and white ac with the red beacon switched on, on a private flight from Rochester to Compton Abbas. SSR was fitted but with no Mode C. After leaving Rochester to the W he contacted Biggin Hill for a FIS and he passed Biggin Hill to the S along the M25 at 105kt and then to the N of the London Gatwick TMA at 2400ft. He continued on a heading of 270° and once S abeam Kenley he contacted Farnborough Radar who told him to squawk 0435. He was identified and given FIS, passed his route and was 'cleared' direct to OCK, remaining at 2400ft on the London QNH of 1011mb.

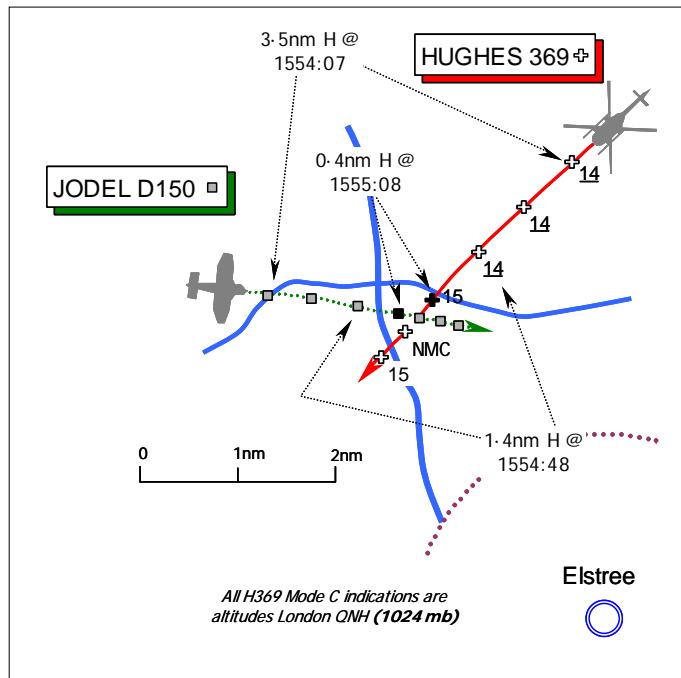
THE JODEL D150 MASCARET PILOT provided a comprehensive and candid account, reporting that he was enroute under VFR from Sleep to Headcorn routeing direct to LIC, thence to DTY, BNN & LAM. A squawk of A7000 was selected but Mode C is not fitted (NMC). At the time of the Airprox, weather conditions were very good and he was flying in VMC, with a visibility of 10km+ and a good horizon, but with some relatively low stratus - base of about 2000ft – visible to the NE.
