FINAL REPORT

Investigation of a serious incident related to a loss of separation, realized on September 8, 2016 with involved Airbus by A321-211 aircraft, registration marks TC-ATF, and Boeing B737-8F2 aircraft, registration marks TC-JVS in the controlled air space of the Republic of Bulgaria.

2017

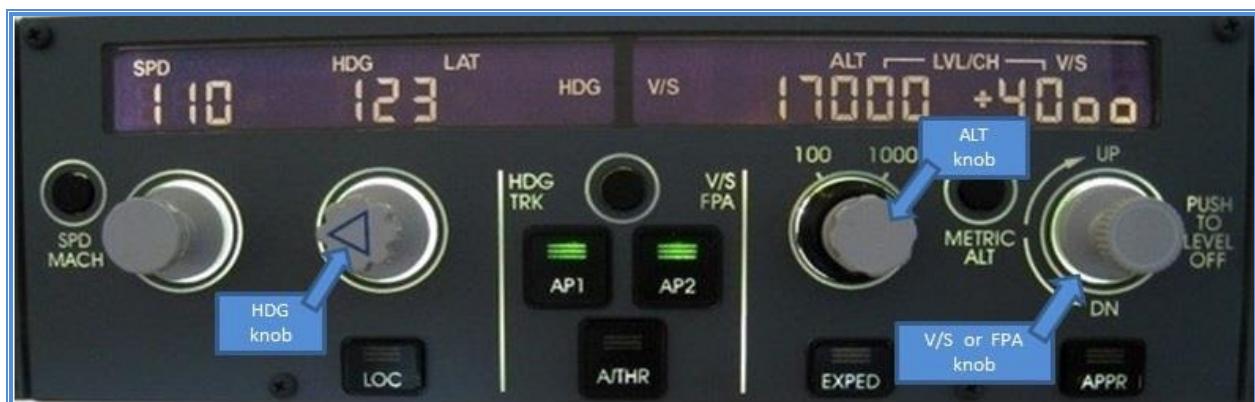
Since the occurrence is associated with a change in altitude and heading of A321 aircraft, the information below is given for these modes only.

On the Fig. 6 is shown a panel of FCU on board of A321 aircraft.

The change of selected altitude is performed by FCU. The selected altitude is set by rotation of ALT knob, followed by:
