# Incident Investigation Final Report

**State File Number:** 950524EPTTA  
**Type of Occurrence:** Serious Incident  
**Date of Occurrence:** August 13, 2016  
**Place of Occurrence:** Tehran Mehrabad Airport  
**Aircraft Type:** A320  
**Registration:** EP-TTA  
**Operator:** Atrak Airlines

**Final Report**

State File Number: S950523EP-TTA  
Type of occurrence: Serious incident  
Date of occurrence: August 13, 2016  
Place of Occurrence: Islamic Republic of Iran (Mehrabad International Airport)  
Aircraft Model: A320-231  
Registration: EP-TTA  
Operator: ATRAK Air

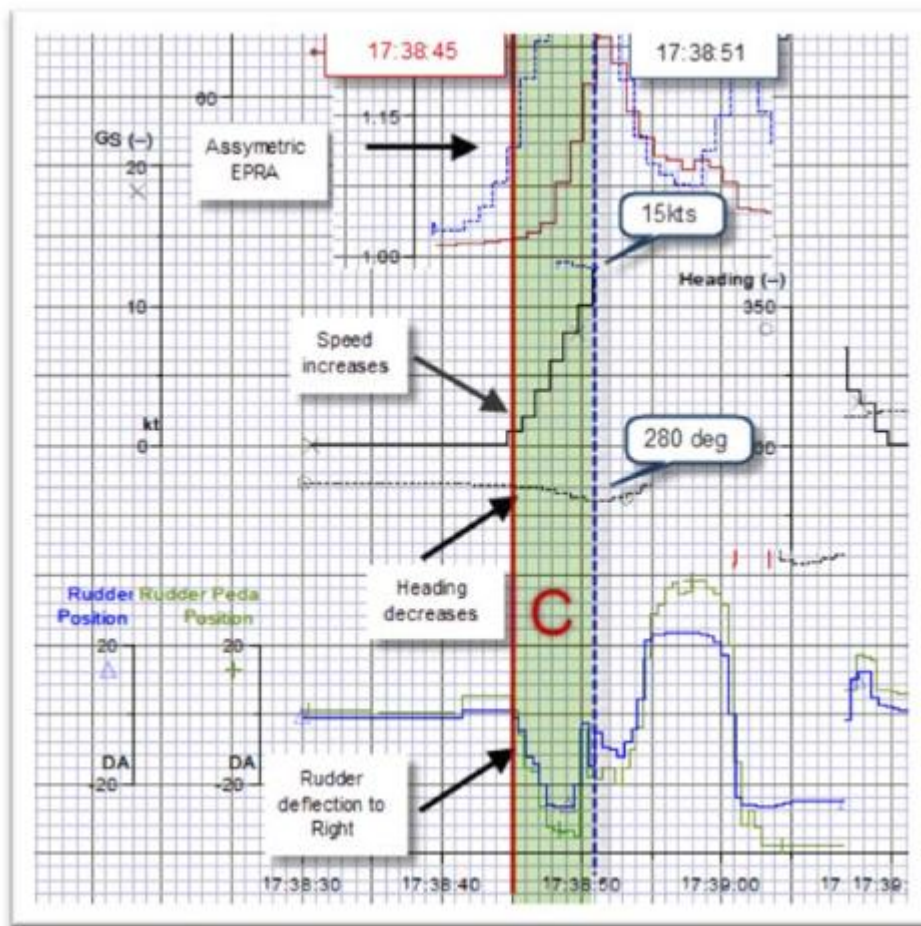
- EPRA1 was at 1.02 while EPRA2 was at 1.12
- • N2A1 was at 69.5% while N2A2 was at 84.9%

Ground speed started to increase and heading started to decrease. A right rudder pedal input was applied, reaching -34.7° within 3s; rudder deflected to the right at 26.0° max

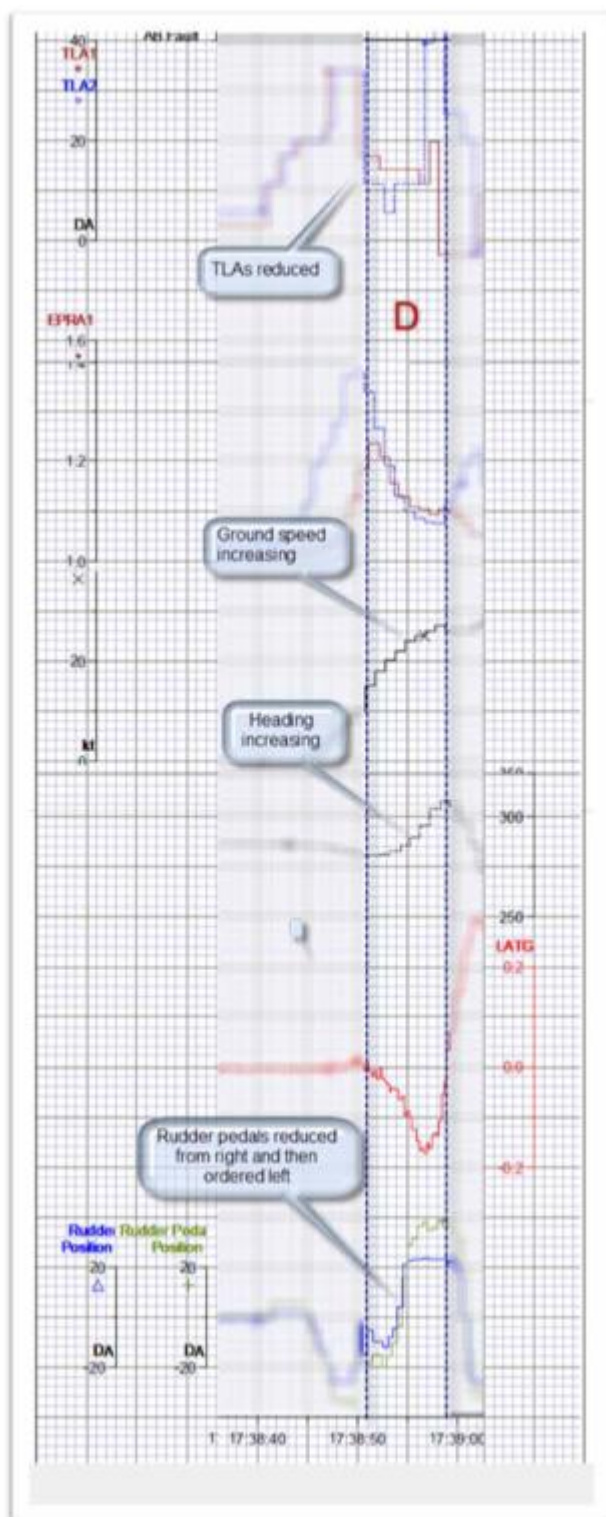
*During the event, the ground speed did not exceed 31kt, therefore rudder deflection would not have any influence on the aircraft handling. However rudder pedal inputs would also be directed to the nose wheel steering. Below 40kts, this is upto +/- 6°*

As the aircraft started to move forward, the heading decreased (aircraft turning towards the left). A thrust dissymmetry leads to a yawing moment towards the engine with the lowest thrust. Rudder pedal deflection resulted in the NWS steering to the right hand side to counter the veer towards the left. The overall result is a slight left yawing moment, as heading was recorded decreasing.

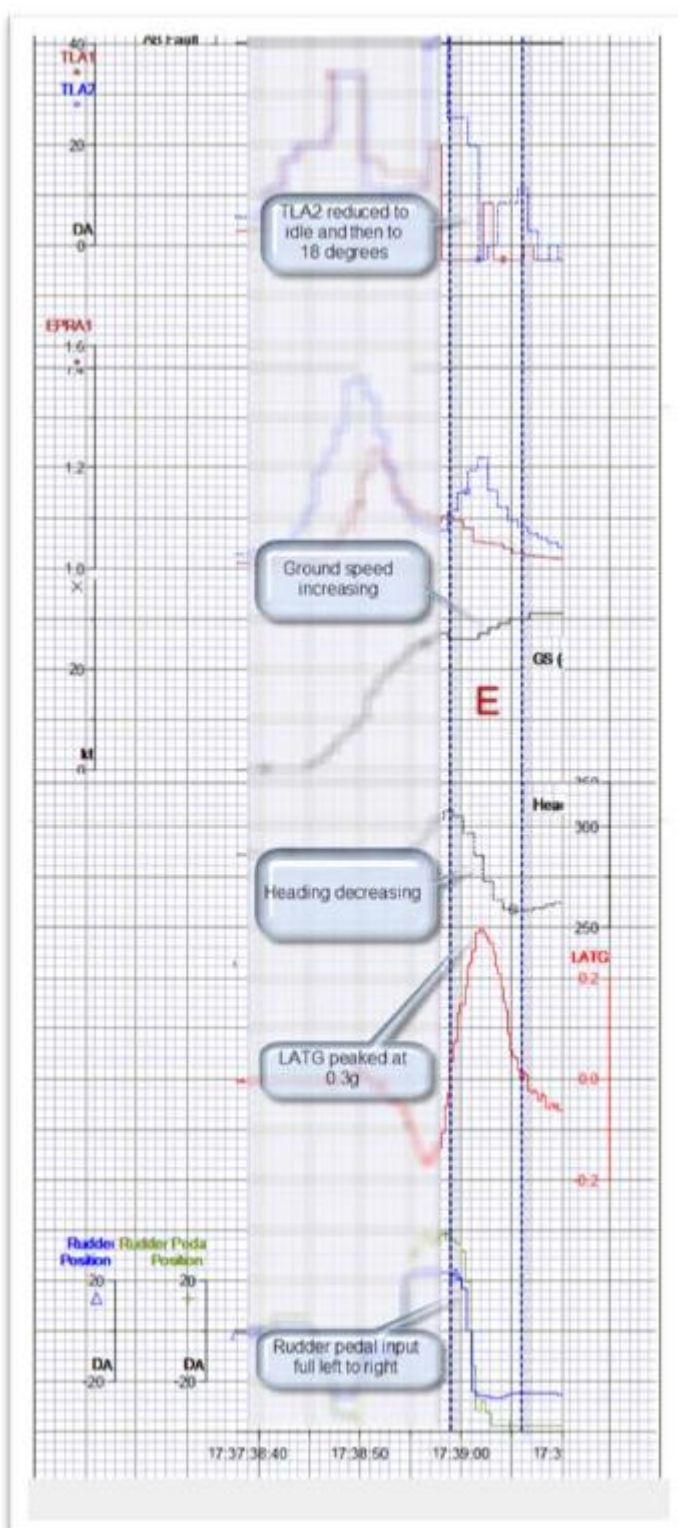
When the rudder pedal input to the right was reduced, the aircraft veered to the right.

**17:38:54 UTC:** At 22kt (GS) increasing, while A/C was turning to the right, a left rudder pedal order was applied up to +38.9°.

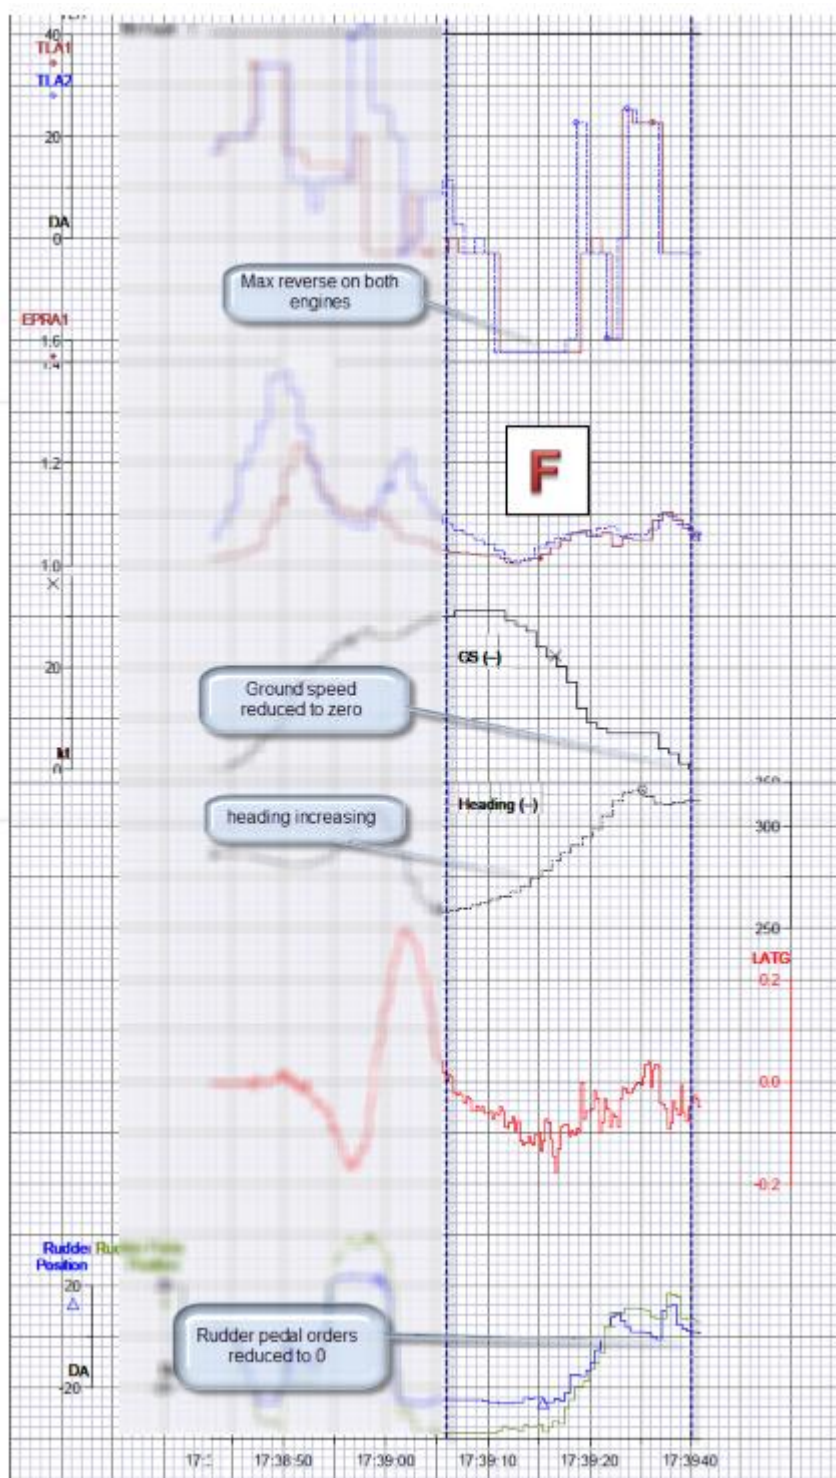
**17:39:06 UTC:** At 30kt (GS), heading reached a minimum of  $258.4^\circ$  then started to increase again; LOC reduced to  $\sim$ as at  $+20 \mu\text{A}$  (left side of the runway).

**17:39:10 UTC:** At a maximum of 31kt (GS), both thrust levers were pulled on MAX REV notch

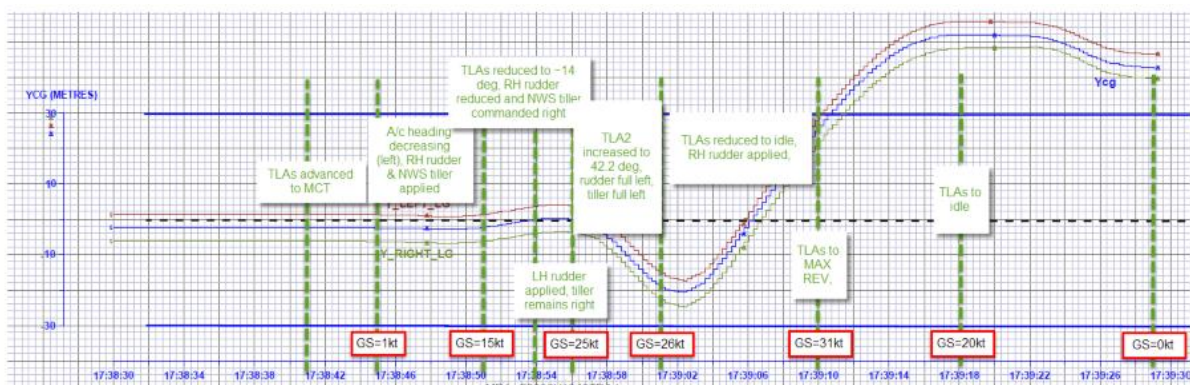
## Aircraft Trajectory vs Time.

- That the actual trajectory is only possible with the use of the NW tiller deflection of the nose-wheel steering is commanded, firstly to the left and then to the right.
