# AIRCRAFT ACCIDENT REPORT 2/2018

Report on the serious incident to  
**Boeing 737-86J, C-FWGH**  
Belfast International Airport  
on 21 July 2017

### Air Accidents Investigation Branch

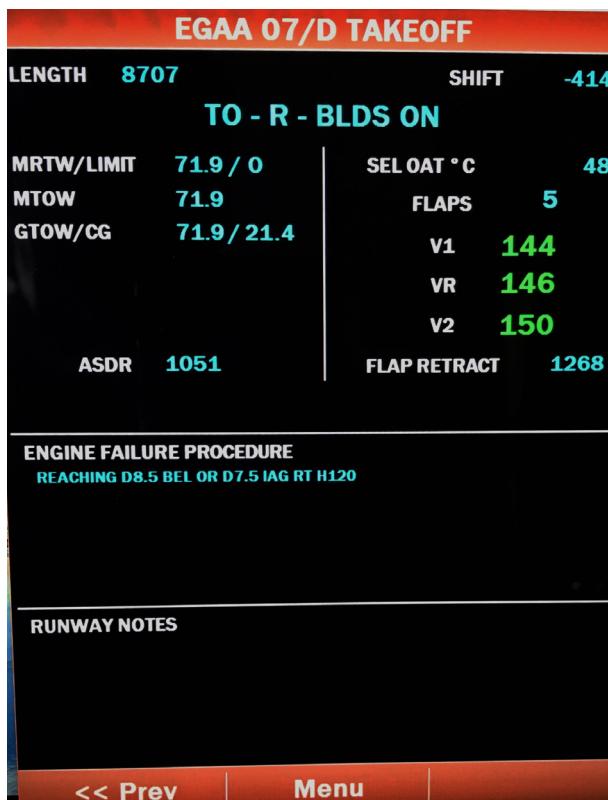
Figure 9

Using an assumed temperature of +48°C, the EFB calculated an  $N_1$  target of 92.7% for the takeoff from Runway 07, Taxiway D. This information was not available to the crew, however, because the calculation output page did not display  $N_1$  (Figure 9).

The EFB performance calculation output page

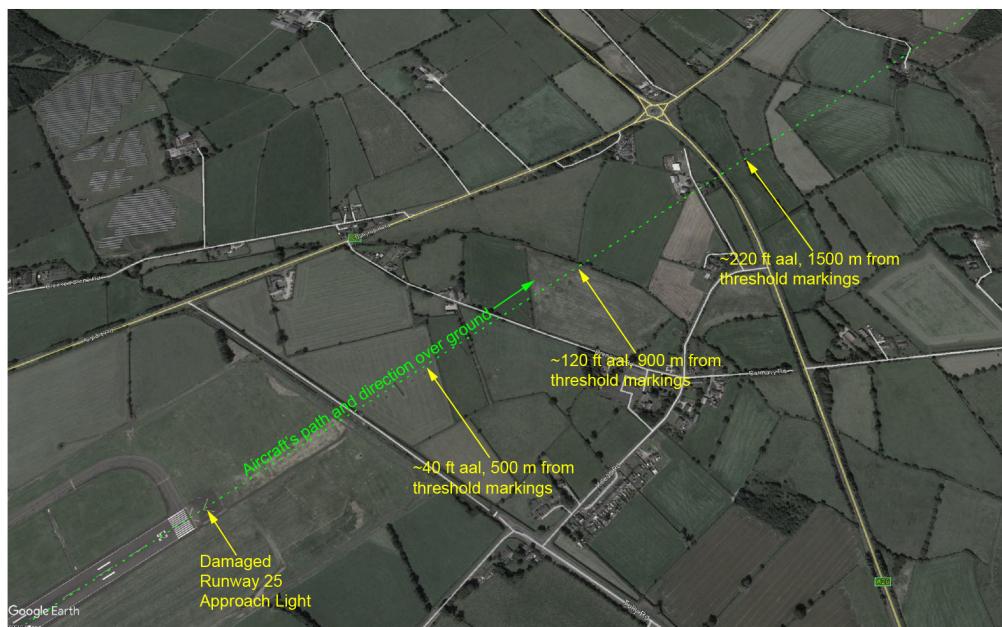
**Figure 11**

Figure 11 shows spot heights above the elevation of BFS (268 ft amsl) for the aircraft's initial climb, derived from the aircraft's ADS-B reports.

Vertical profile for the initial climb-out  
 © 2018 Google

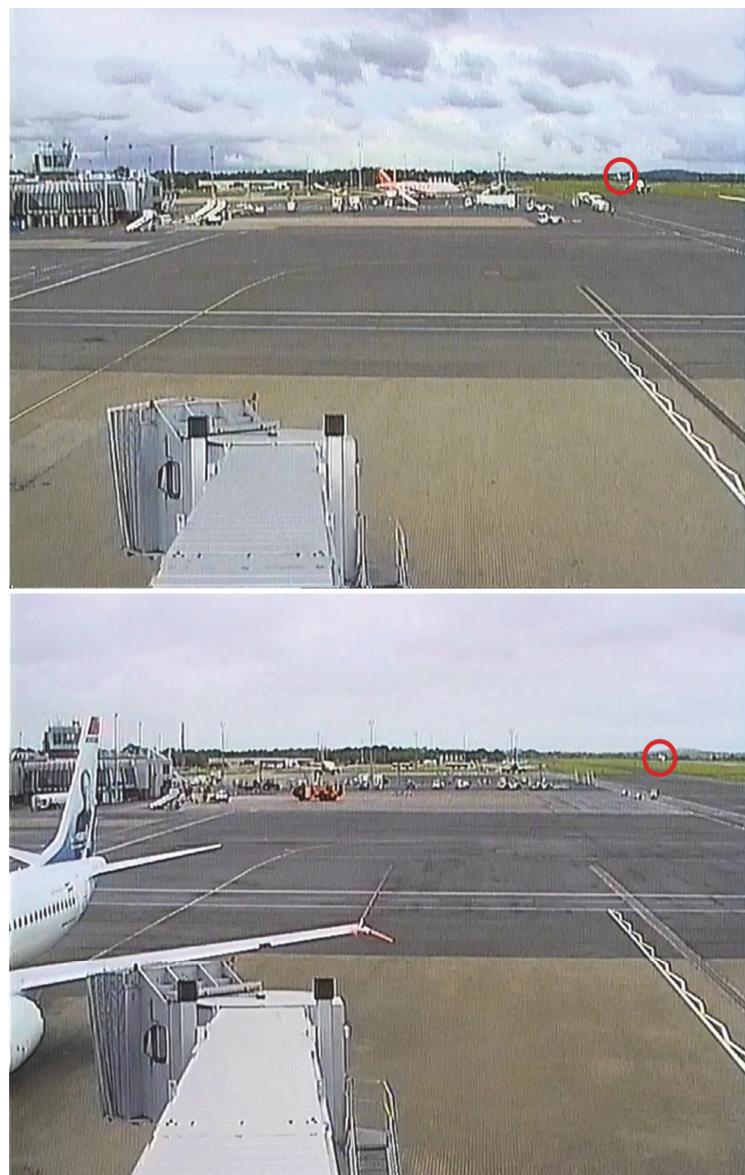
**Figure 13**

The second camera captured the rotation, lift off and initial climb-out of C-FWGH. The resolution and sightline angle of this CCTV recording did not allow calculations of distance to be made, but the airport operator provided another CCTV recording from the same camera of an aircraft lined up for departure on the reciprocal Runway 25. Using this recording, and the recording showing C-FWGH's departure, it was possible to confirm that C-FWGH lifted off at the extremity of Runway 07. Figure 13 shows a comparison of these recordings; C-FWGH is shown immediately after lift-off at the top of the figure, compared with the aircraft lined up on Runway 25 ready to depart at the bottom of the figure. In both images, the aircraft have been highlighted by a red circle.

The second CCTV recording showing C-FWGH's lift off at the top, compared with an aircraft lined up for departure on the reciprocal runway at the bottom

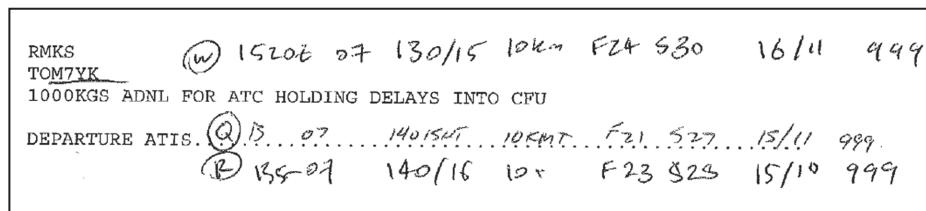
**Figure 21**

At some point during the cockpit preparation, a figure of  $-47^{\circ}\text{C}$  was entered into the FMC as the outside air temperature (OAT)<sup>1</sup>. The FMC uses the OAT when calculating the value of  $N_1$  which will produce the engine's rated thrust<sup>2</sup>. At a lower OAT, the engine will require a lower value of  $N_1$  to achieve this rated thrust. Therefore, entering an incorrect and abnormally low OAT, causes the FMC to calculate a value of  $N_1$  (and therefore thrust) significantly below that required to produce rated thrust in the actual conditions. Neither pilot noticed the error. Having completed the performance calculations, the crew reduced the takeoff thrust further by entering into the FMC a correctly-calculated assumed temperature thrust reduction of  $47^{\circ}\text{C}$ <sup>3</sup>.

ATIS as recorded by PM on the pilot's log
