# Protecting Aircraft and Passengers from Cargo Fires

Cargo compartment linings are designed to provide an air-tight space, and are essential in protecting the aircraft and its occupants from fire and smoke.

This article looks at how these composite components have come to play such an important role in Safety, and what can be done to make sure they stay in good condition.

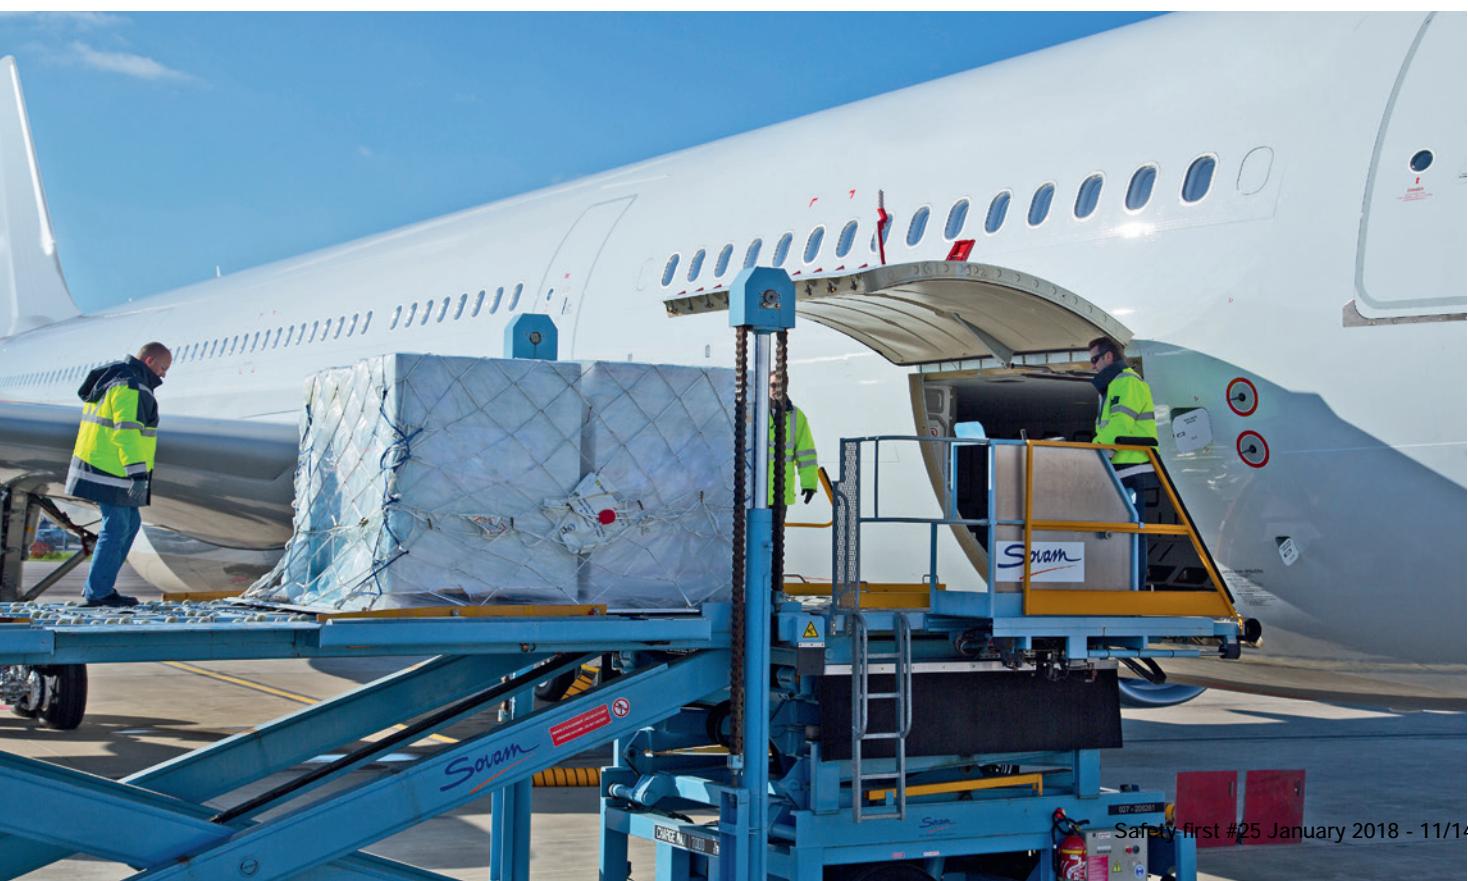
Small dents to the skin of the lining panels are not considered as damage as long as the upper skin is not damaged, and there is no visual debonding of the upper skin from the panel core.

Additionally, a small number of missing fasteners for ceiling, sidewall and partition linings (but not decompression panels) are often considered temporarily acceptable, as per limits defined in the Cargo Hold Visual Inspection tasks. Pending replacement of the fastener within the specified time period, the holes left by the missing fasteners must be sealed in line with the maintenance procedures.
